## REPAIR CASE: TANK BULKHEAD

### DEFINITION OF A DAMAGE

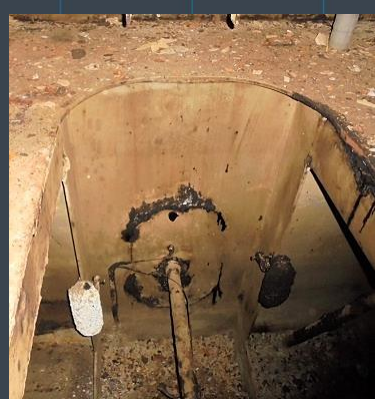
**Fuel leakage** appeared between water ballast and heavy fuel tanks. The ship needed a fast repair service without losing the unnecessary time for replacing the plating. COMPA Repairs team was asked to assess the damage and recommend a suitable, **cost-effective repair solution** to prevent the leakage.

CONDITION  
BEFORE REPAIR

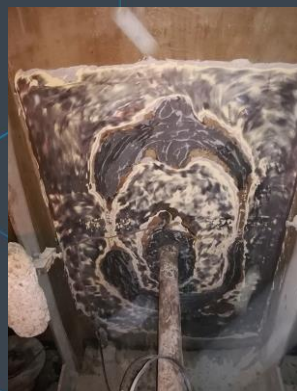
SURFACE  
PREPARATION

**Surface preparation** – a proper surface preparation consists of mechanical and chemical treatments. It is mandatory to remove the remains of rust and coating and then to treat the surface to the appropriate roughness level. The surface preparation is essential to ensure good bonding between the steel surface and composite patch.

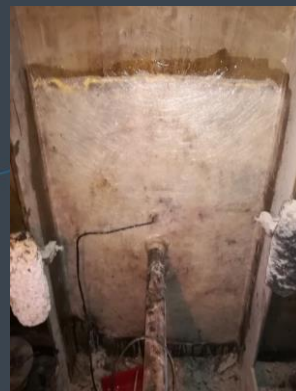
APPLICATION OF  
GLASS FIBRES

**Application of fibres** – multiple carbon and glass fibre layers mixed with the epoxy resin were placed onto the damaged plating. The cured resin permanently bonded the fibres to the plating, creating a strong and fully solid composite patch.

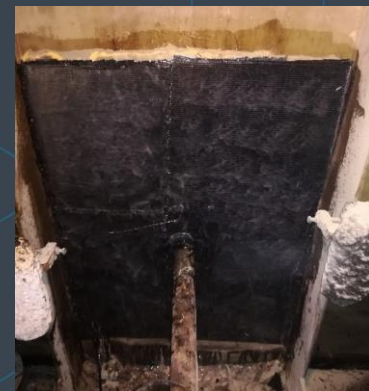
APPLICATION OF  
CARBON FIBRES
