COMPAREPAIRS
Repairs and
Reinforcements with
Composite Materials

**Technology Overview and
Application Cases**

COMPA Repairs cases of completed repairs

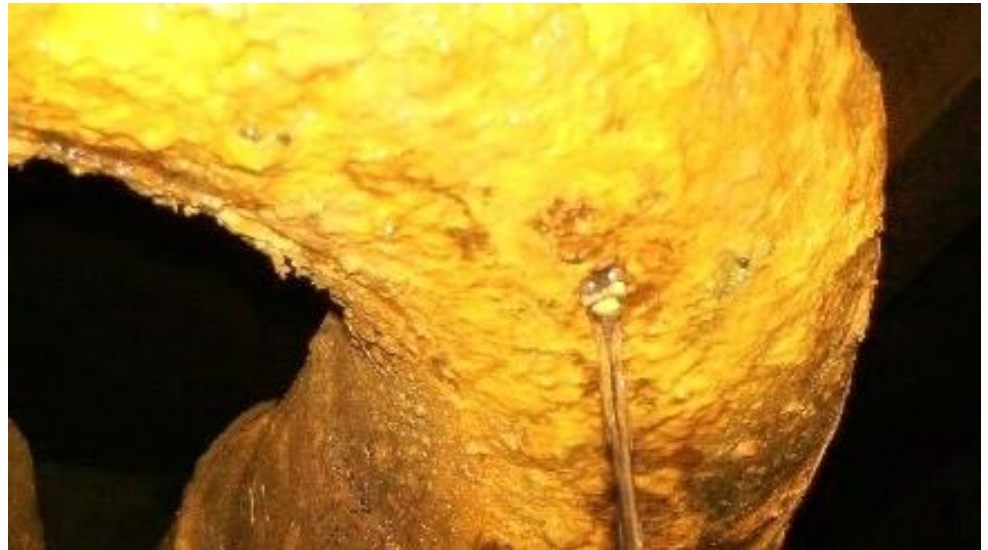
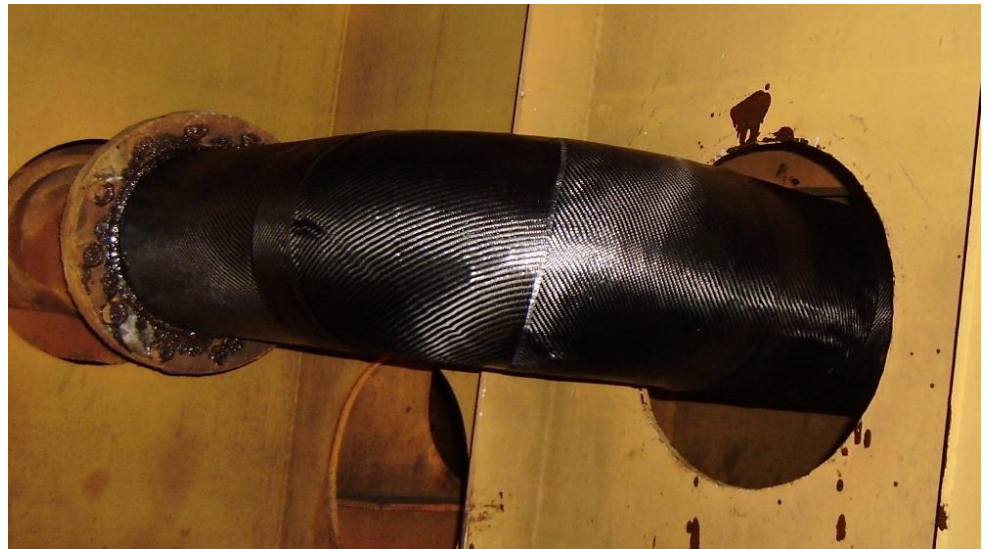
500m of BALLAST PIPING

Problem: 500m of corroded piping was leaking sea water.

Solution: The repair was conducted during the vessel's dry docking.

Repair Duration: 12 days

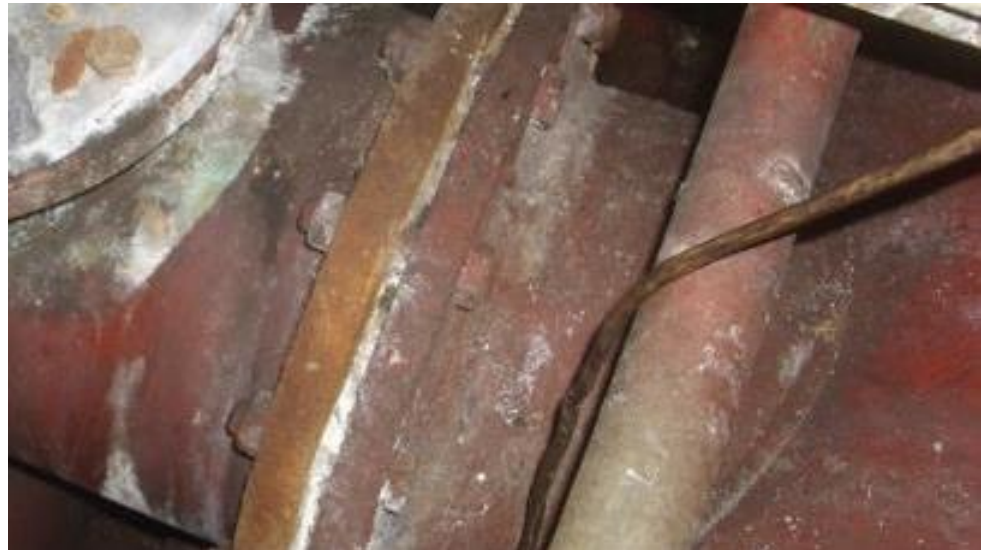
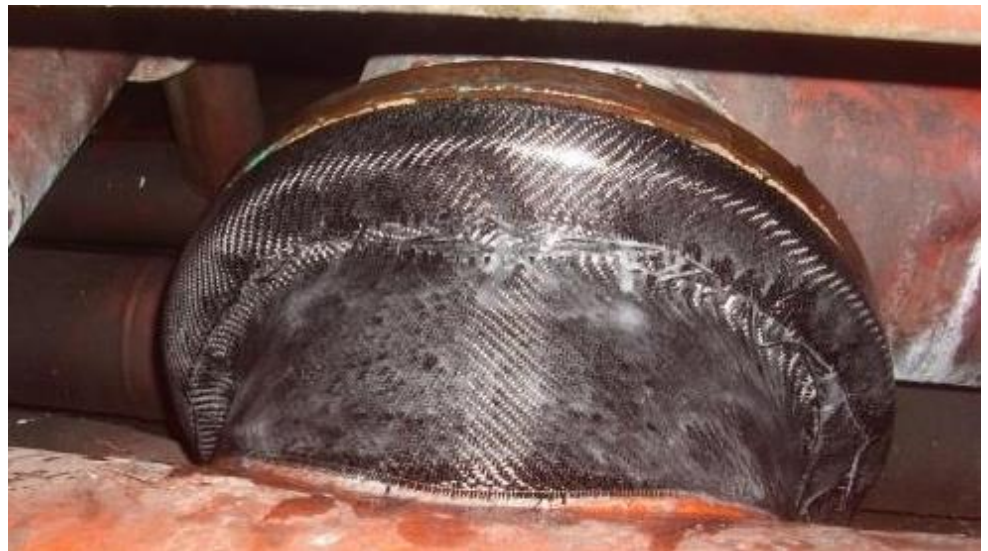
FLANGE ON MAIN SEA WATER INTAKE PIPE

Problem: Corroded flange was leaking sea water.

Solution: COMPA repair was conducted during the vessel's stay in port of Valencia.

Repair Duration: 4h

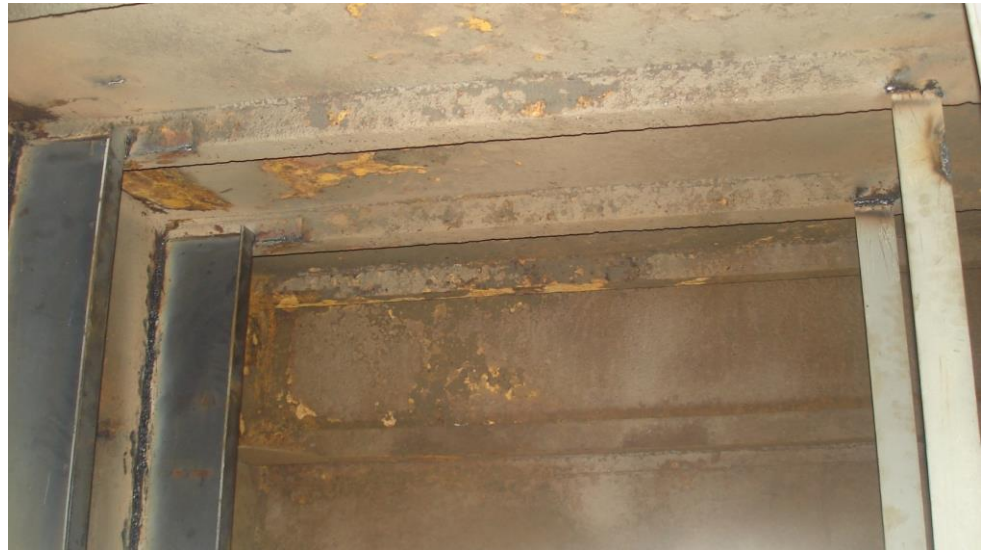
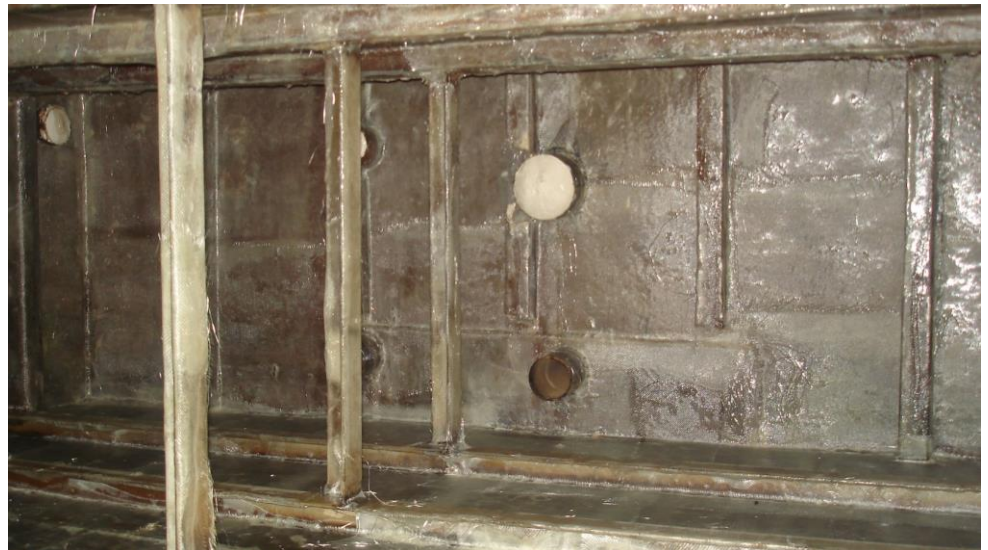
SEWAGE TANK

Problem: Sewage tanks' plating and profiles have undergone extensive corrosion.

Solution: The repair of the 300m² was conducted during the vessel's dry docking in Luxor, Egypt.

Repair Duration: 3 days

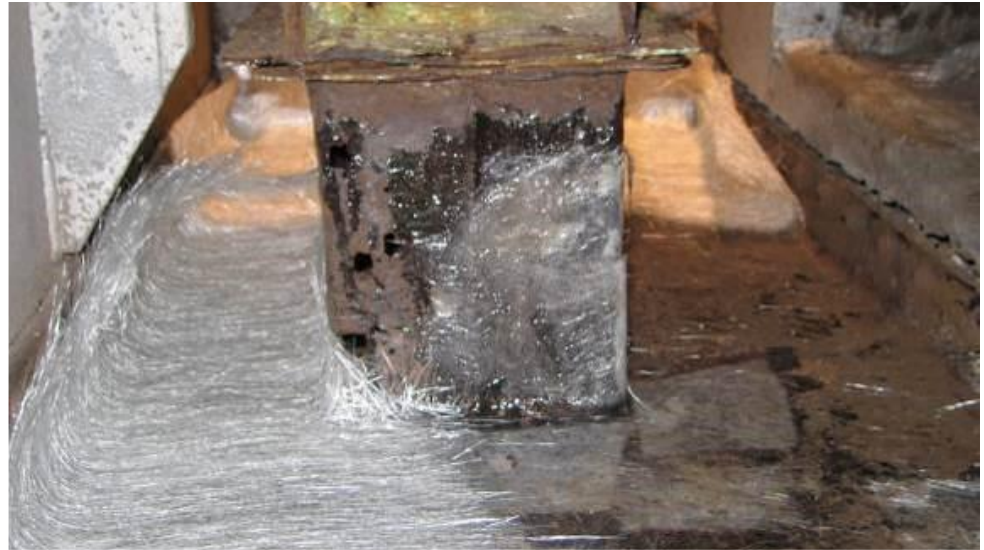
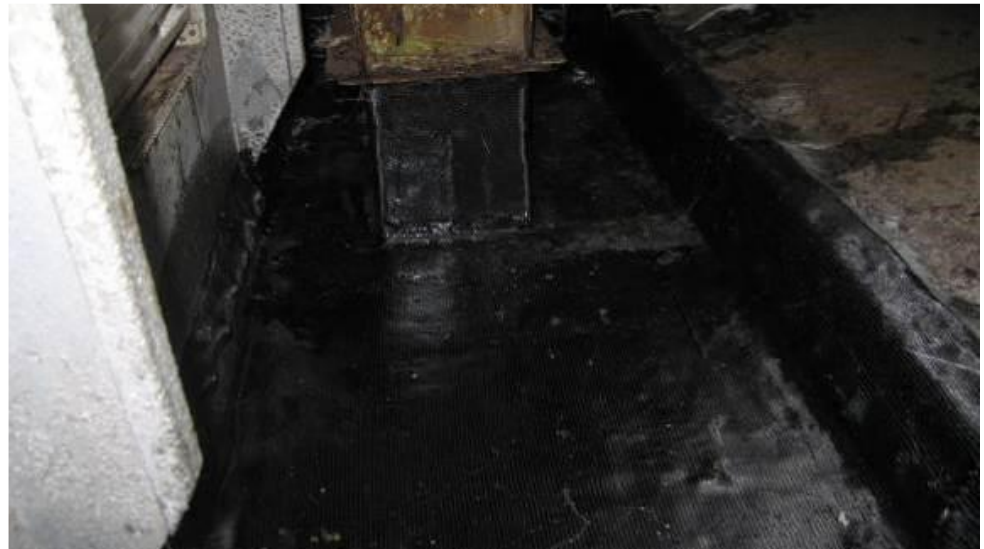
AIR-CONDITIONING UNIT SPACE

Problem: Air-conditioning unit's steel flange and floor exhibited heavy corrosion.

Solution: The repair was conducted during the vessel's dry docking.

Repair Duration: 1 day

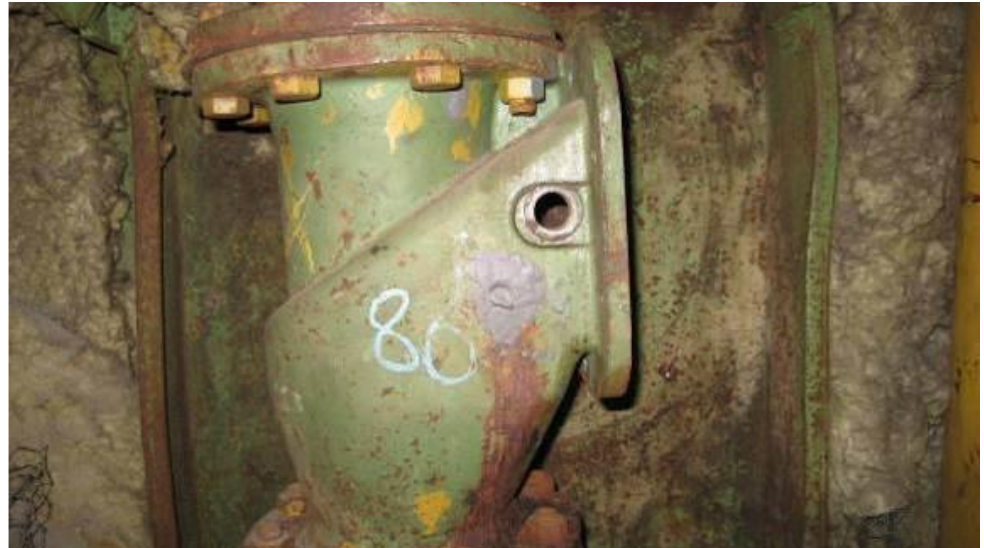
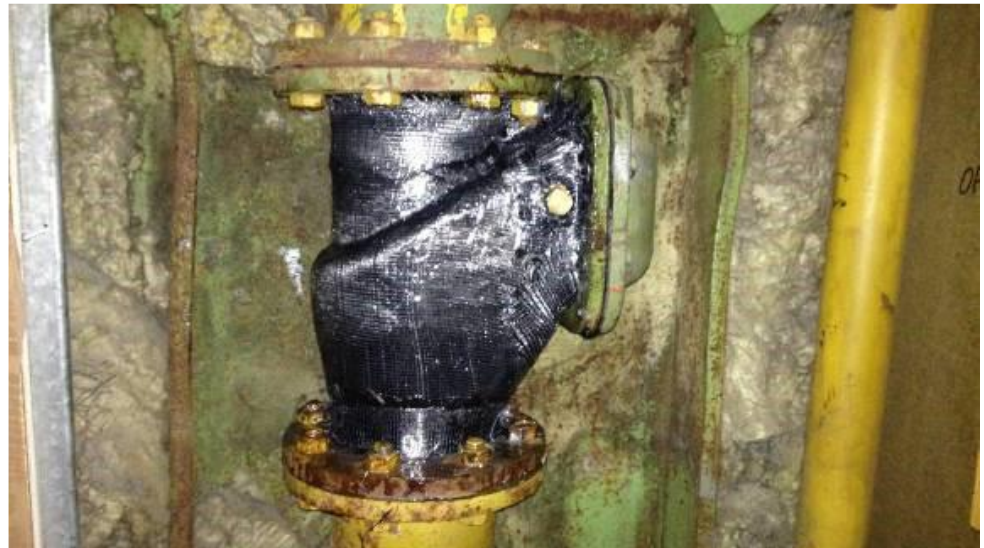
CLAPET VALVE

Problem: Two clapet valves have undergone extensive corrosion.

Solution: The repair was conducted during the vessel's dry docking.

Repair Duration: 1 day

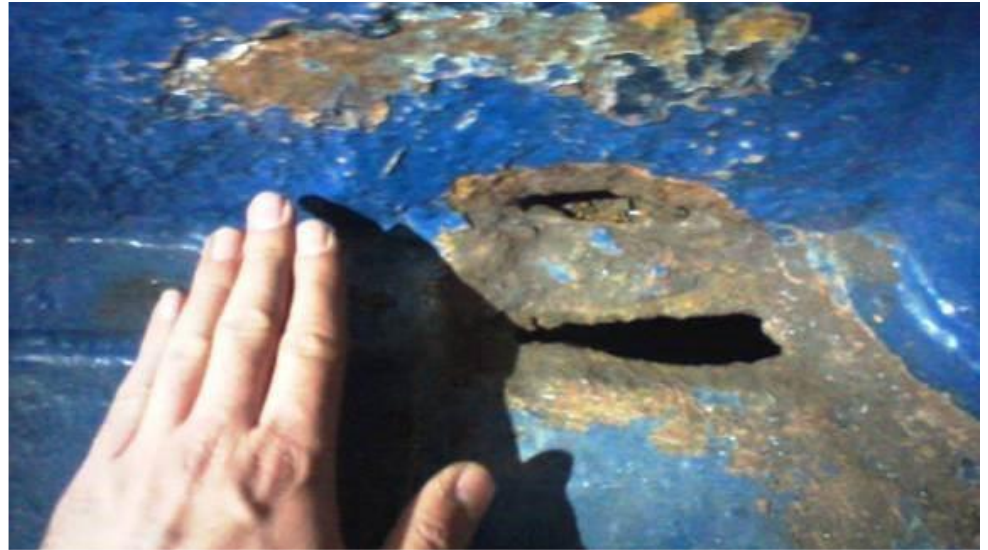
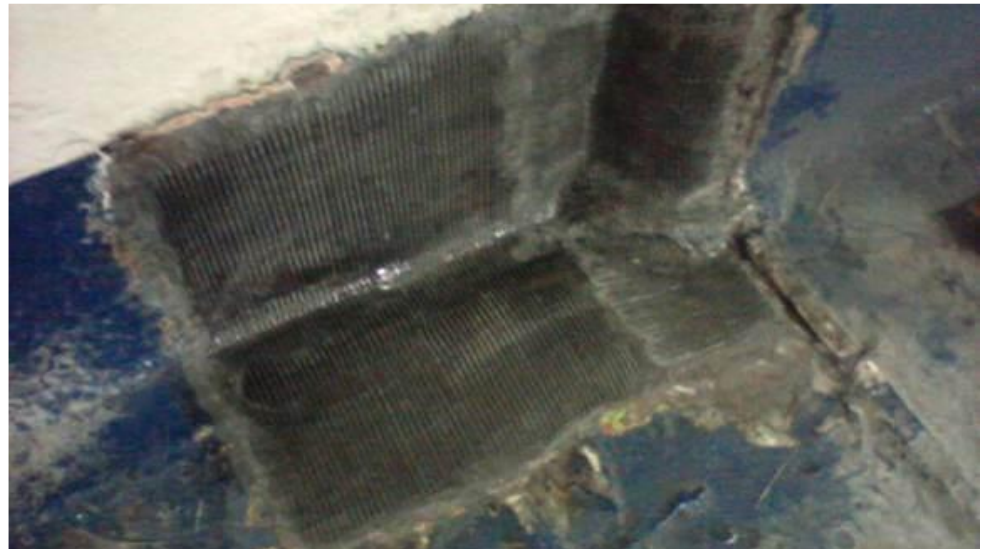
GARAGE FLOOR DETAIL

Problem: The damage on the garage floor was caused by severe corrosion in the corners where the water collects due floor inclination.

Solution: The repair was conducted during the vessel's dry docking.

Repair Duration: 1 day

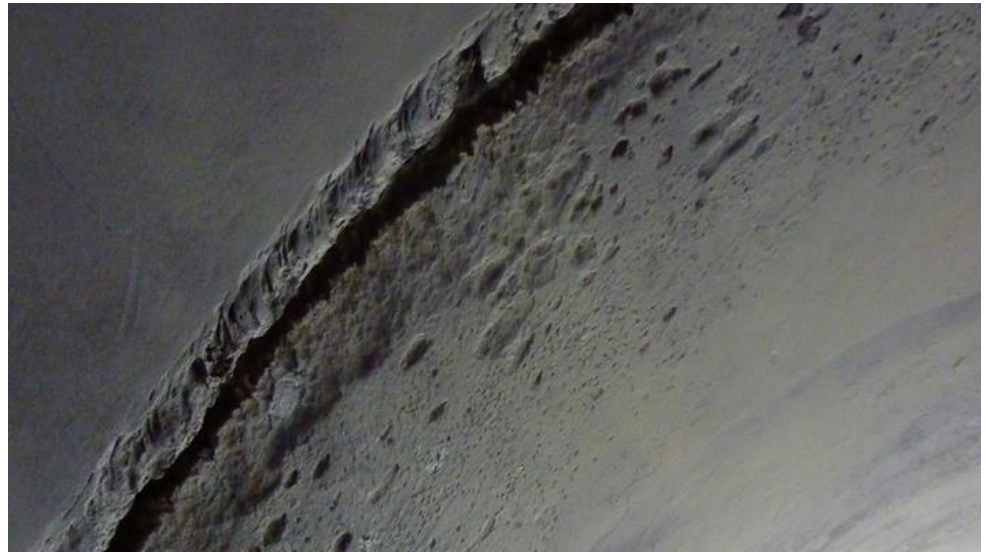
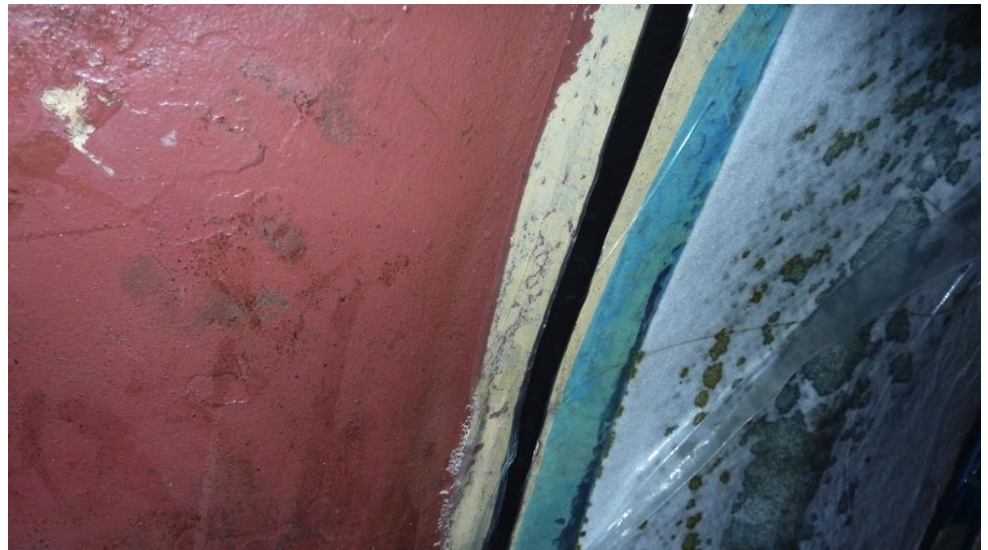
BOW THRUSTER TUNNEL

Problem: Bow thruster tunnel surface damage.

Solution: The repair was conducted during the vessel's dry docking.

Repair Duration: 1 day

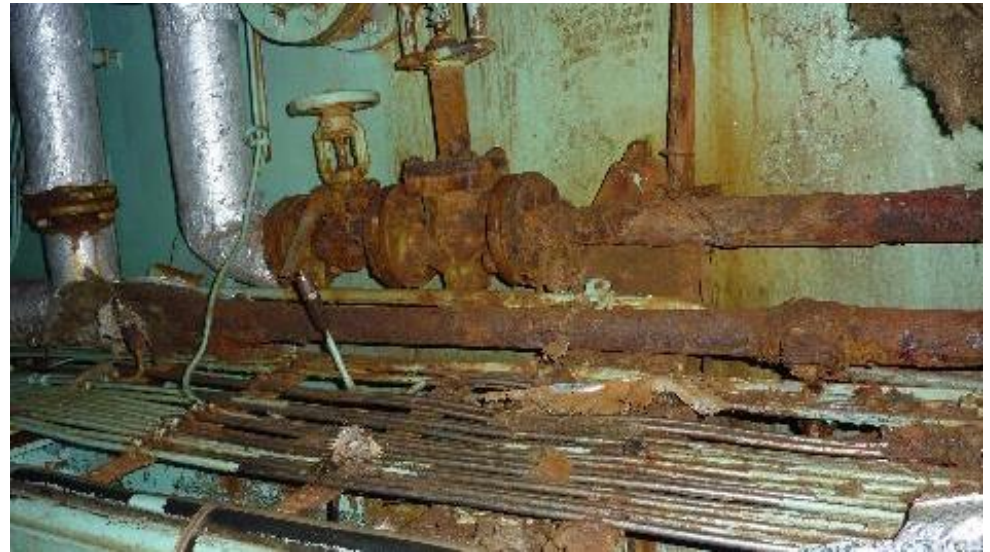
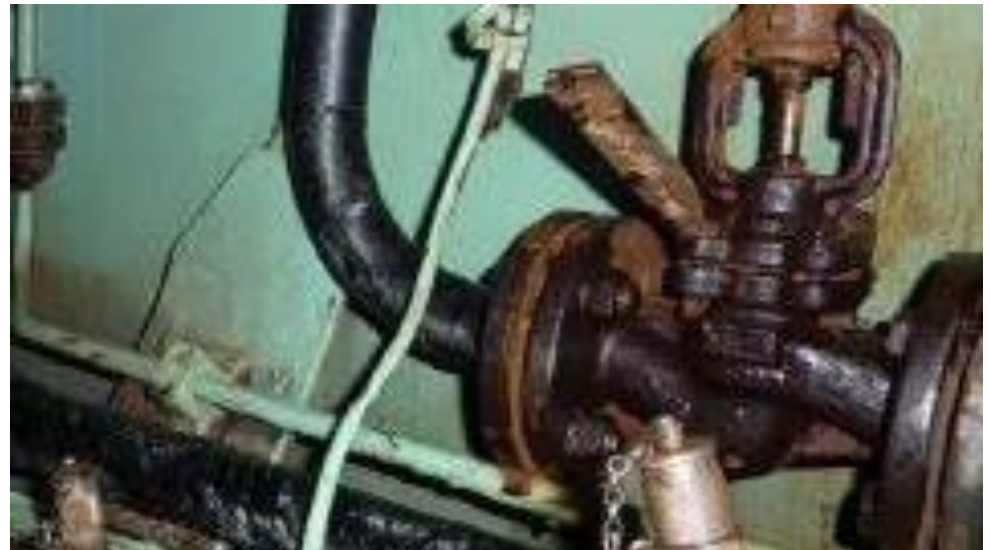
20m OF THERMAL OIL PIPING IN KEEL TUNNEL

Problem: The mineral-oil pipes, located in keel tunnel, were heavily corroded.

Solution: The repair was conducted during the vessel's dry docking.

Repair Duration: 4 days

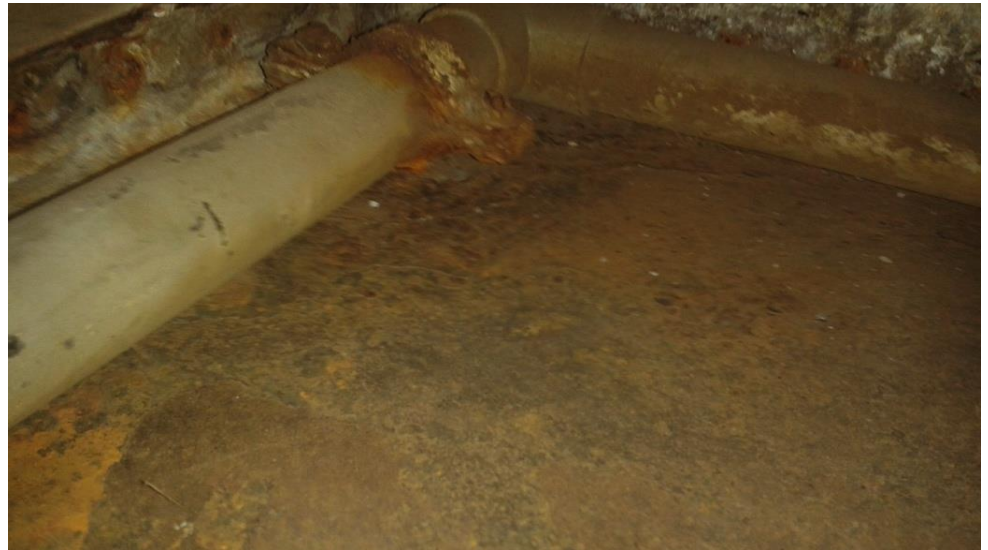
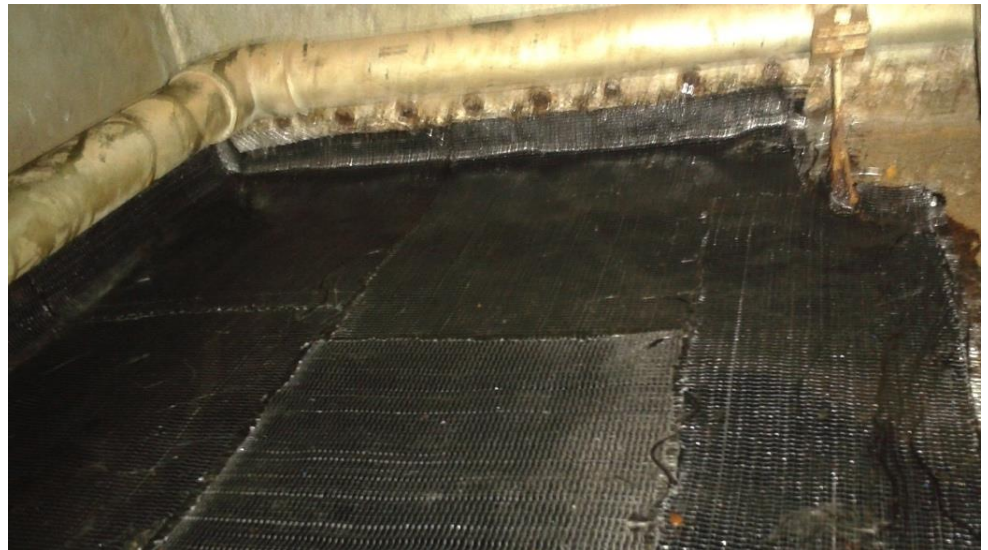
DECK UNDER AC STATION

Problem: Deck under AC station was leaking sea water.

Solution: The repair was conducted during the vessel's stay in port.

Repair Duration: 7h

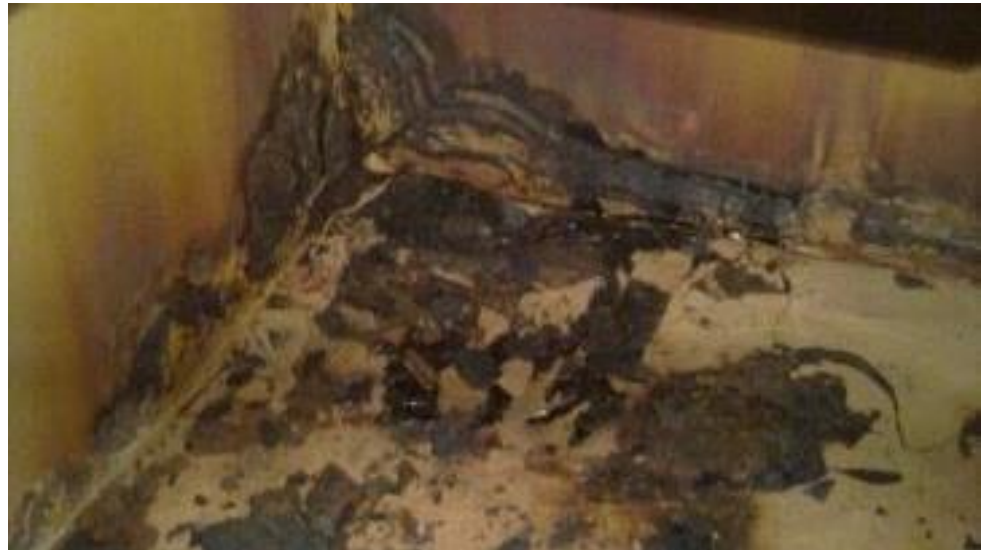
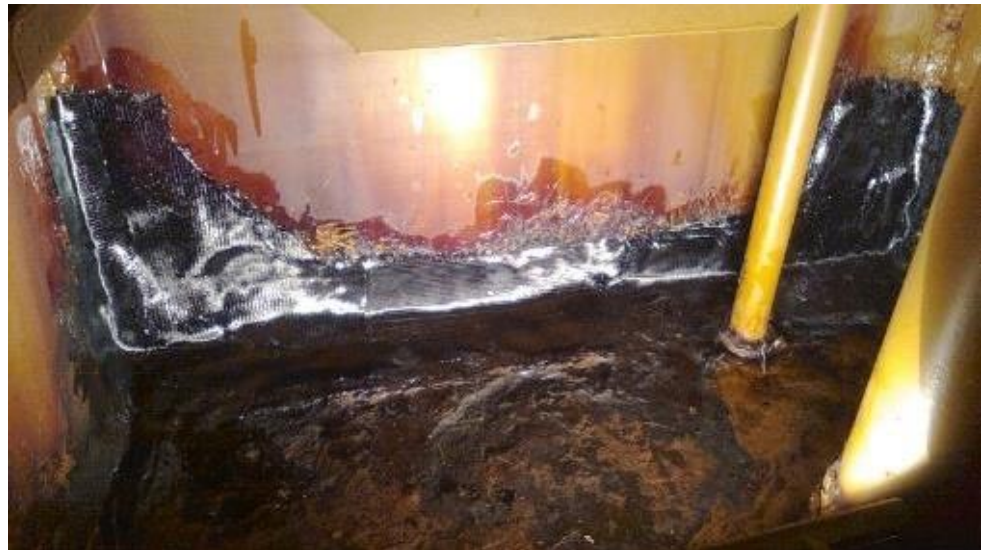
BULKHEAD OF THE BALLAST TANK

Problem: Heavily corroded bulkhead was leaking HFO.

Solution: The repair was conducted during the vessel's stay in Savona port.

Repair Duration: 7h

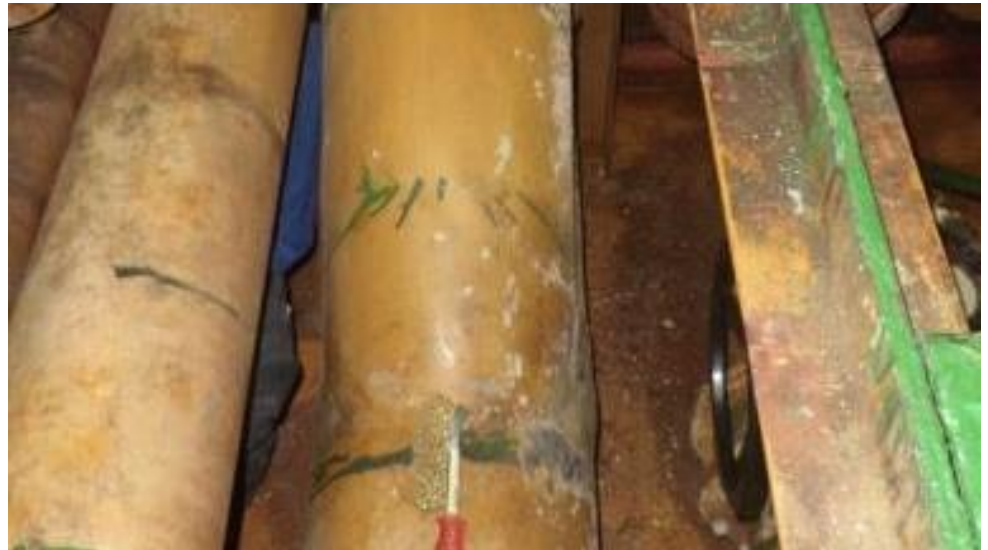
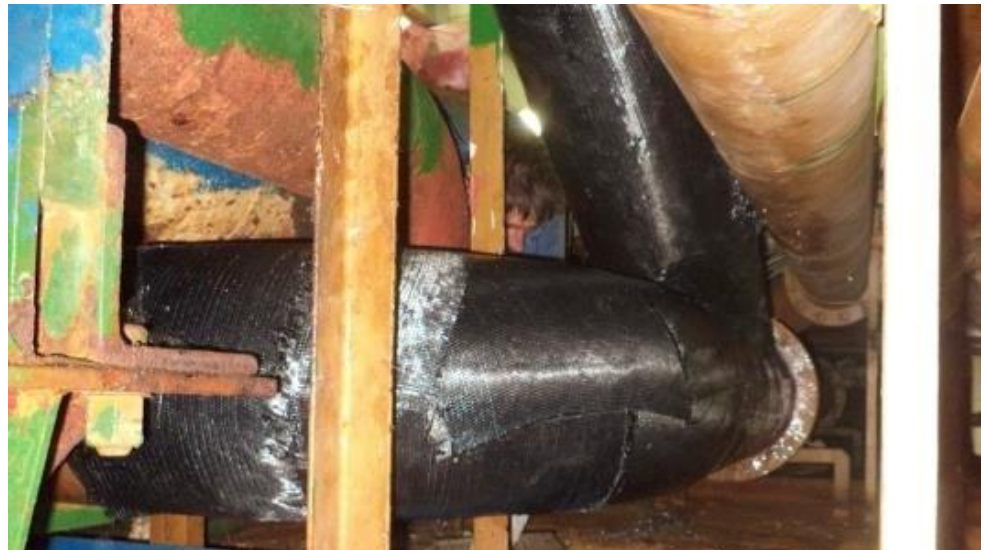
Y-JUNCTION BALLAST INTAKE PIPE

Problem: Heavily corroded Y-junction was leaking sea water.

Solution: Conducted during the vessel's stay in Salerno port.

Repair Duration: 6h

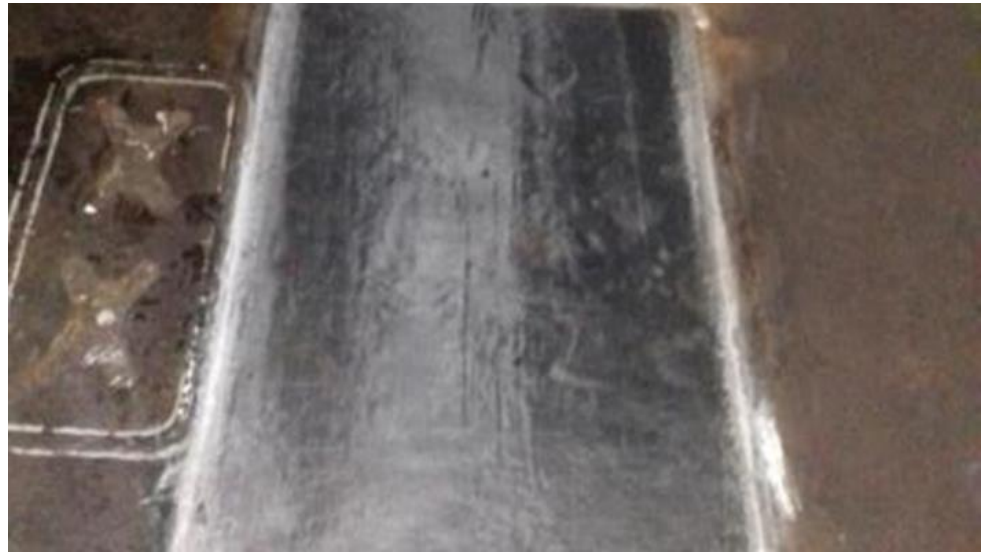
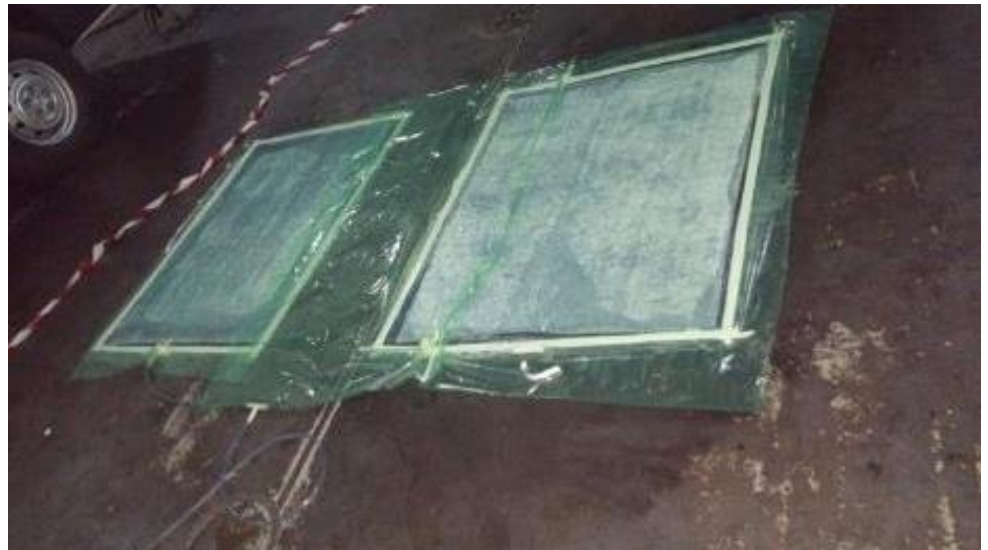
HFO TANK TOP

Problem: Cracked tank top was leaking HFO in rough seas.

Solution: Conducted during the vessel's stay in Savona port.

Repair Duration: 4h + 12h vacuuming

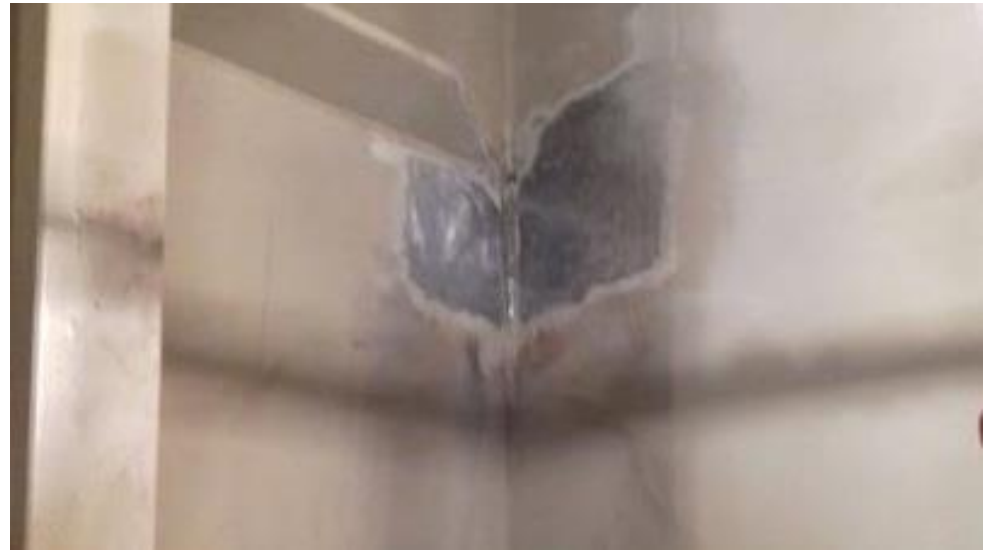
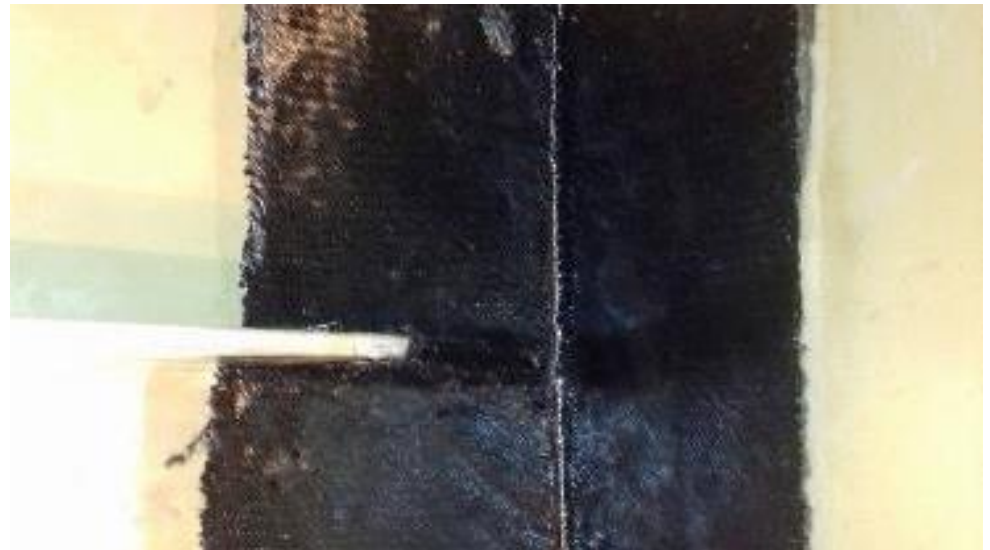
BULKHEAD OF THE MDO FUEL TANK

Problem: Cracked bulkhead was leaking MDO.

Solution: Repair was conducted during the vessel's stay in Antwerp port.

Repair Duration: 3h

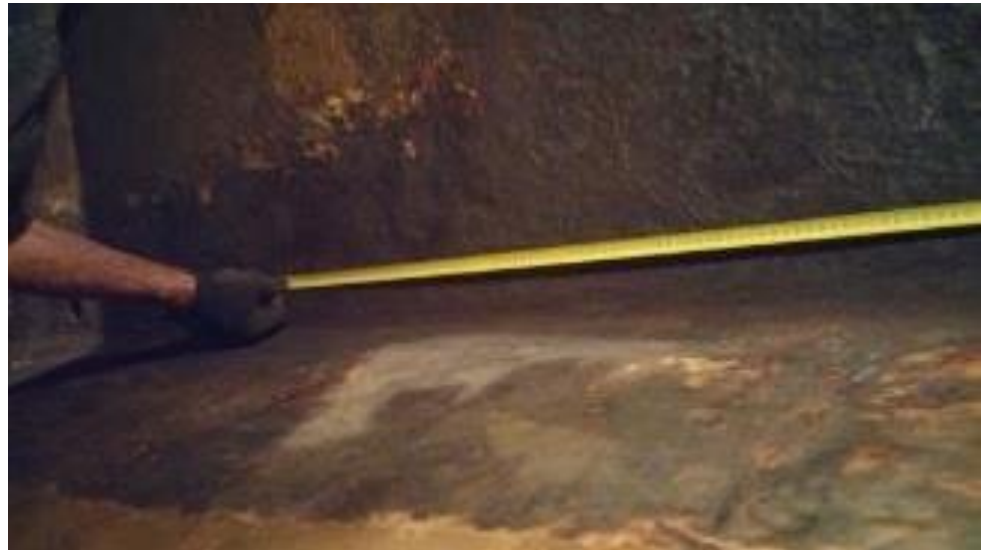
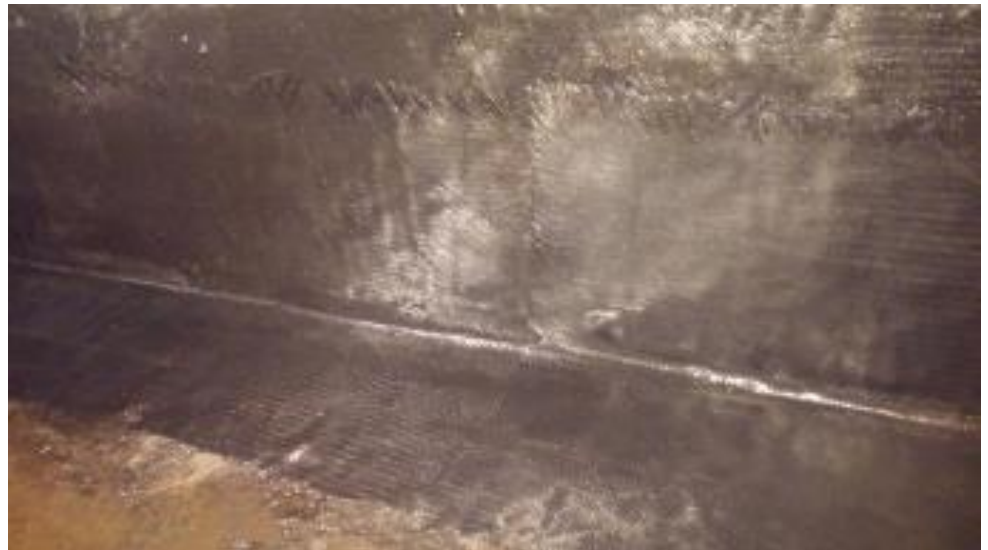
BULKHEAD OF THE HFO FUEL TANK

Problem: A heavily corroded bulkhead was leaking HFO.

Solution: Repair was conducted during the vessel's voyage from Le Havre to Antwerp.

Repair Duration: 1 day

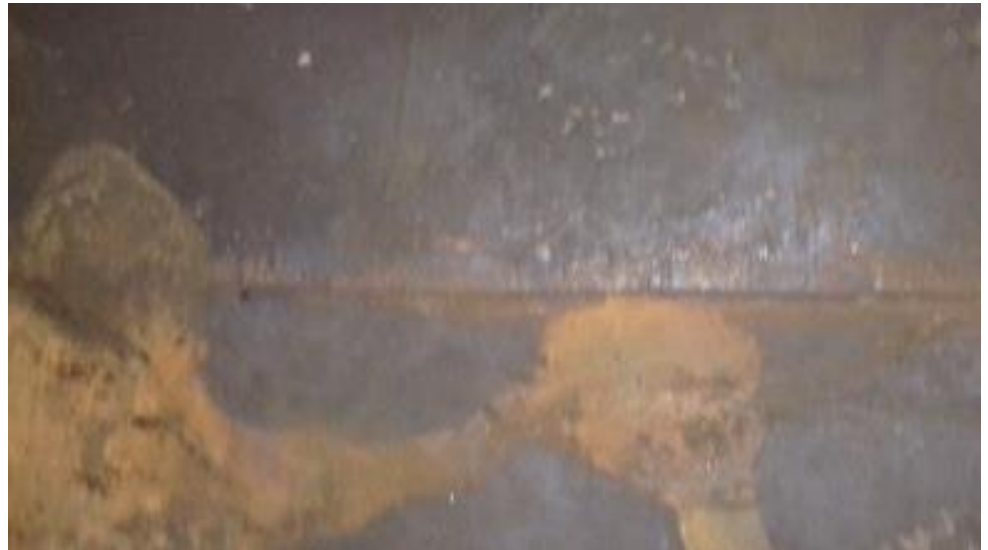
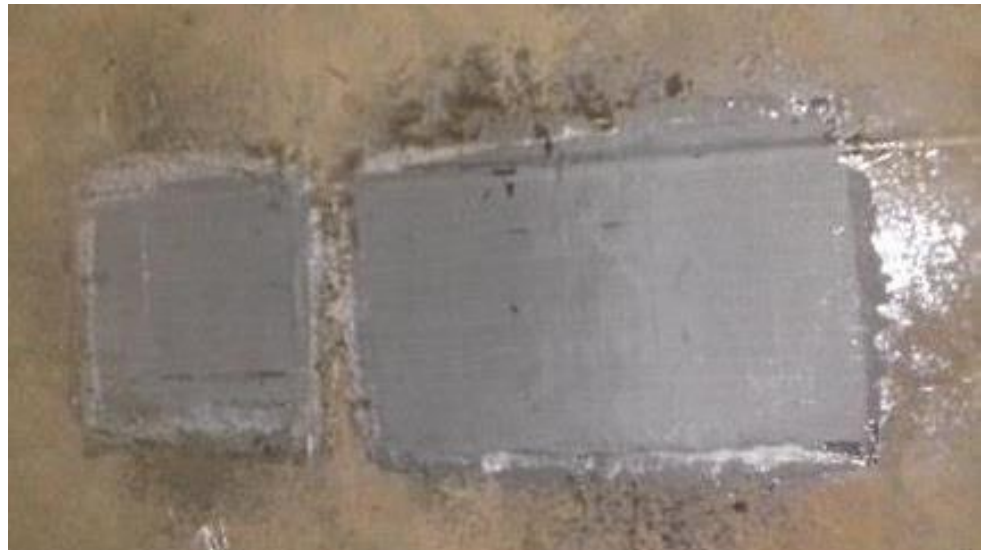
HFO TANK TOP

Problem: A heavily corroded bulkhead was leaking HFO.

Solution: Repair of 5 cracks was conducted during the vessel's stay in Antwerp port.

Repair Duration: 2 days

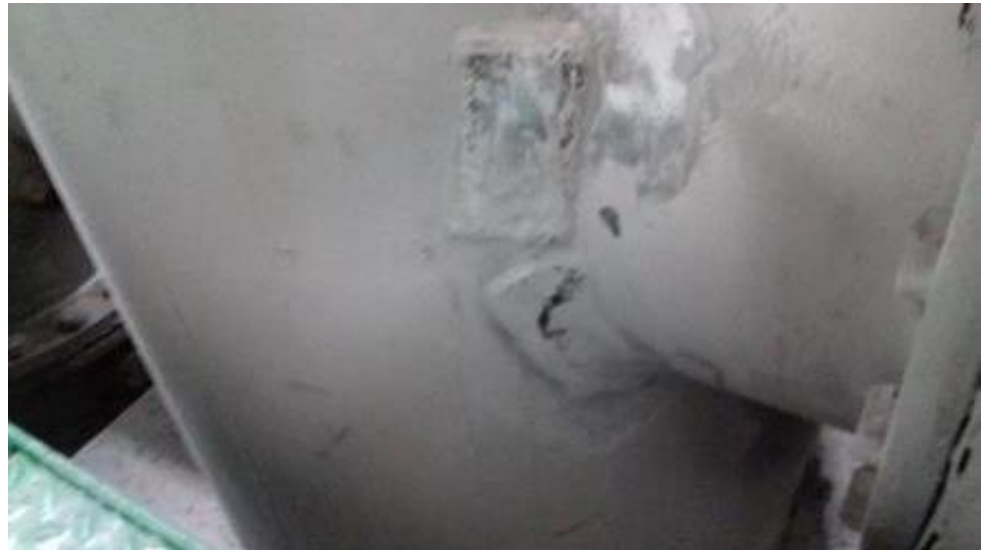
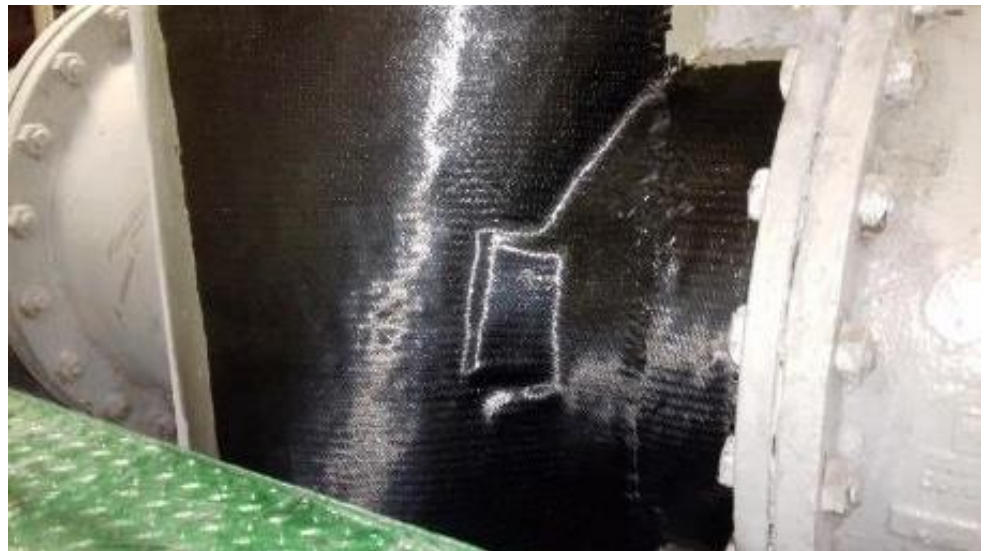
SEA CHEST

Problem: Corrosion on the inner side caused leakage of the sea water.

Solution: Repair was conducted during the vessel's stay in Antwerp port.

Repair Duration: 5h

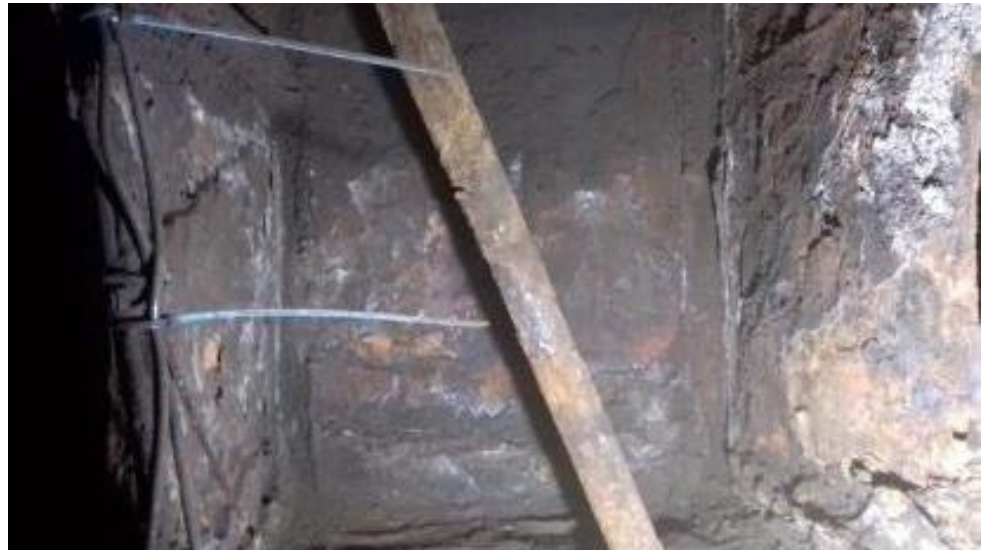
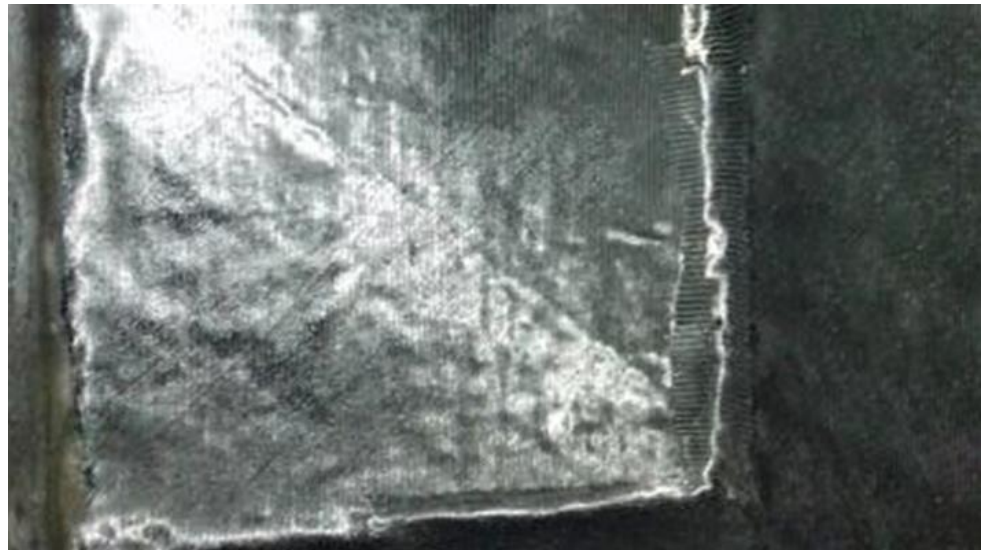
BALLAST TANK IN DOUBLE BOTTOM

Problem: Multiple bulkheads and the tank top were corroded and leaking sea water.

Solution: Repair was conducted during the vessel's voyage from Hamburg to Antwerp.

Repair Duration: 2 days

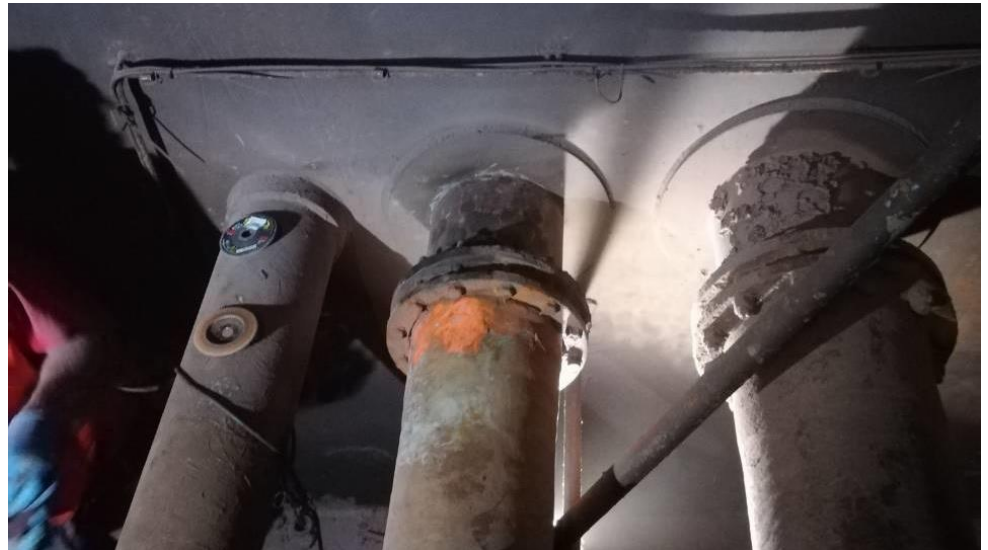
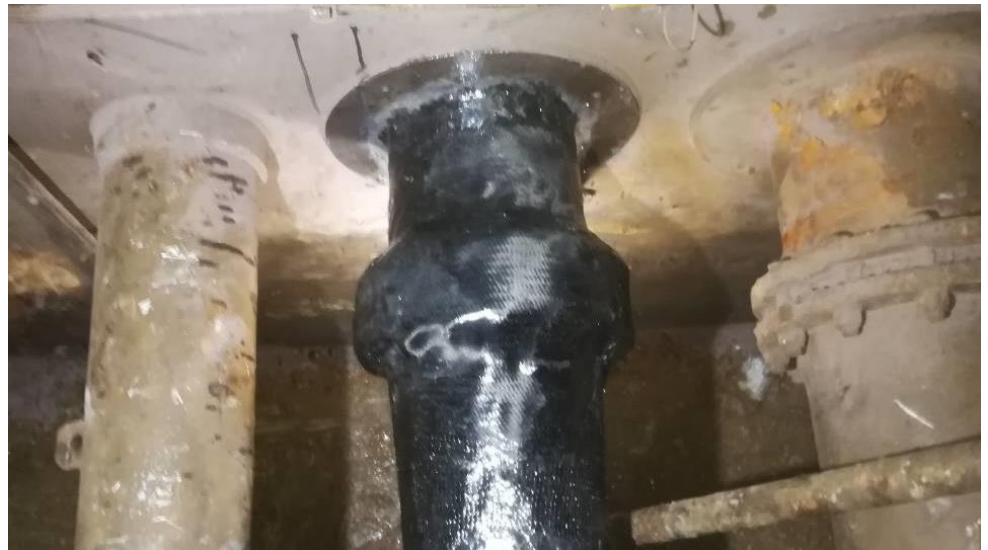
BALLAST PIPE IN HEELING TANK

Problem: Flange connecting steel and fibreglass pipe was corroded and leaking sea water.

Solution: Repair was conducted during the vessel's stay in Antwerp port.

Repair Duration: 6h

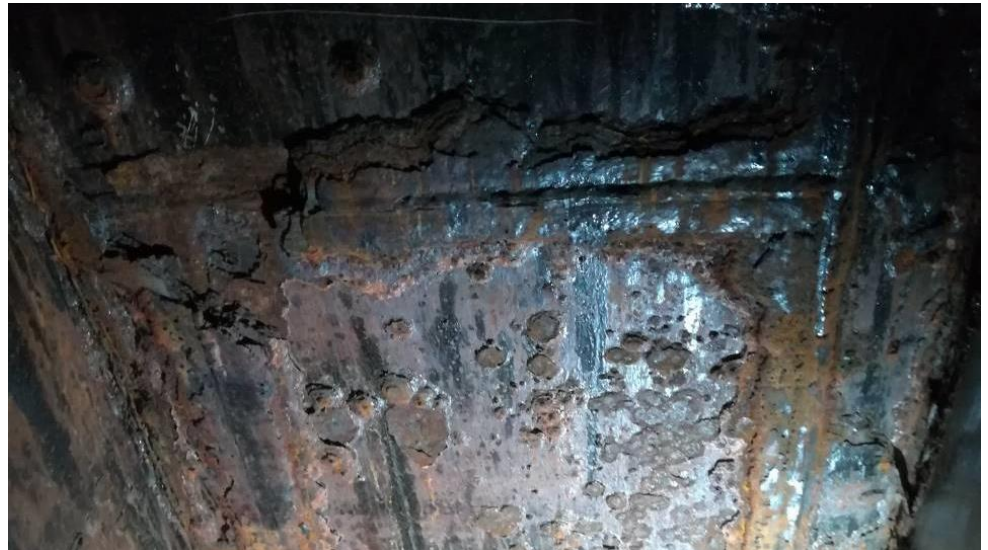
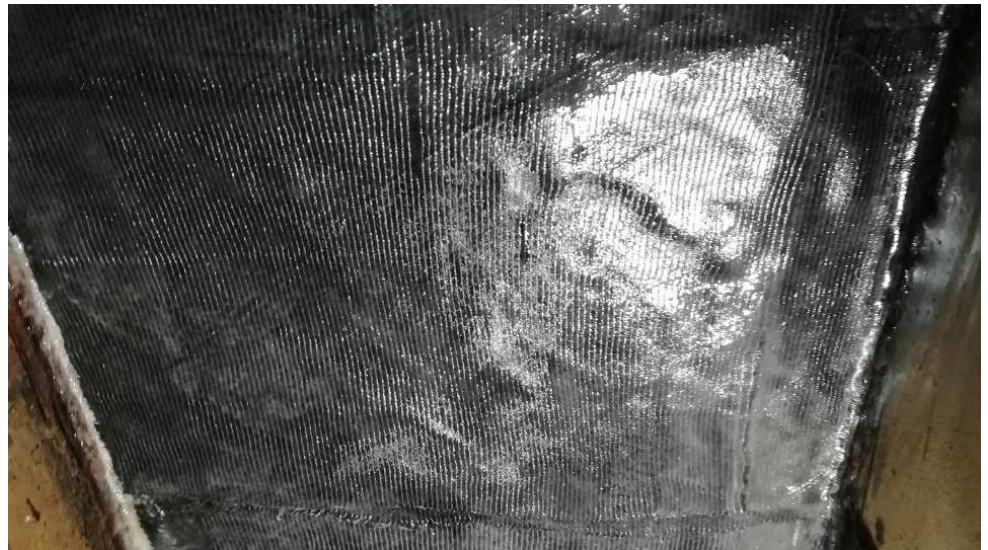
BULKHEAD BETWEEN BALLAST AND HFO TANK

Problem: The bulkhead was corroded and it was leaking HFO into the ballast tank.

Solution: Repair's conducted during the vessel's stay in Antwerp port.

Repair Duration: 8h

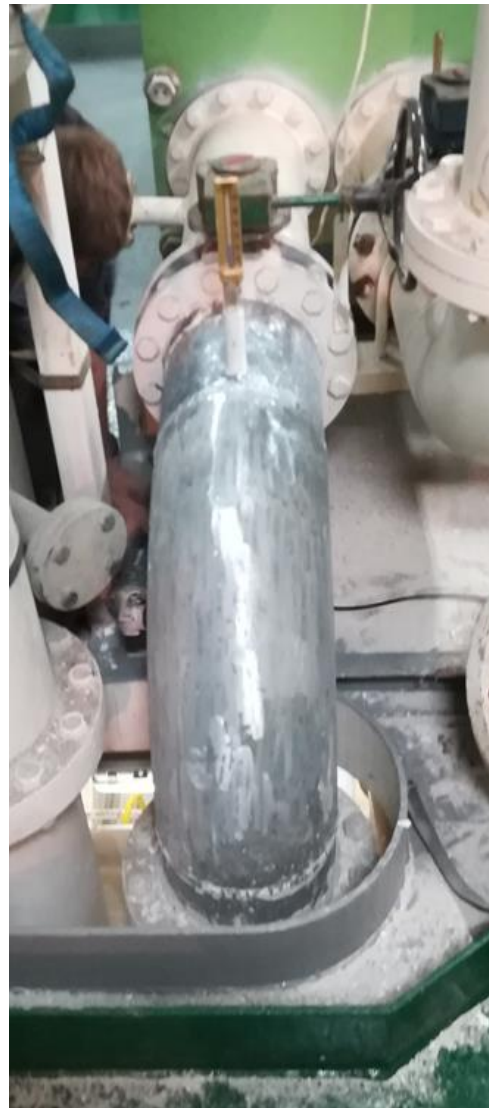
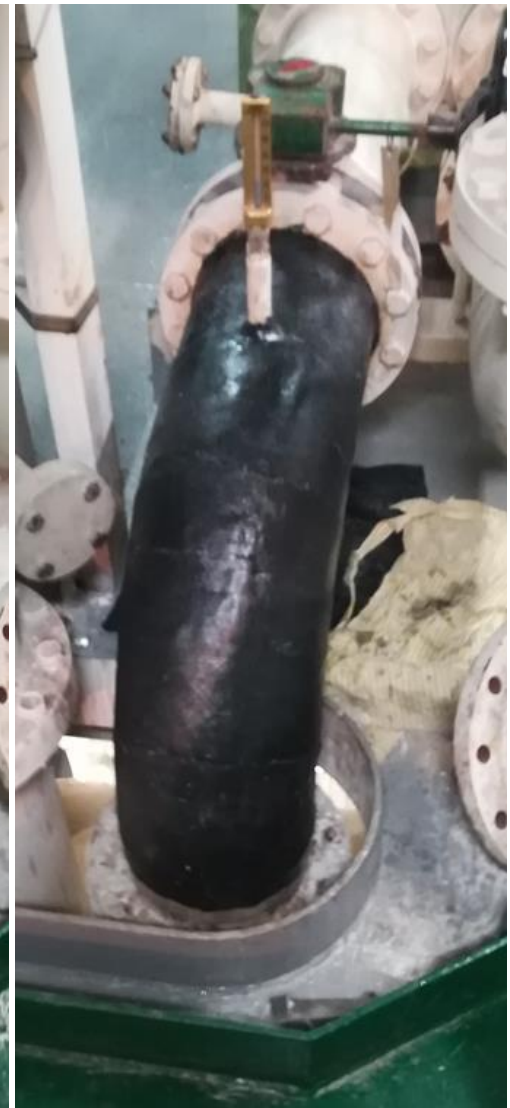
BALLAST PIPE IN ENGINE ROOM

Problem: Multiple pipe were corroded and leaking sea water.

Solution: Repair was conducted during the vessel's stay in Antwerp port.

Repair Duration: 14h
