COMPAREPAIRS
Repairs and
Reinforcements with
Composite Materials

**Technology Overview and
Application Cases**

COMPA Repairs cases of completed repairs

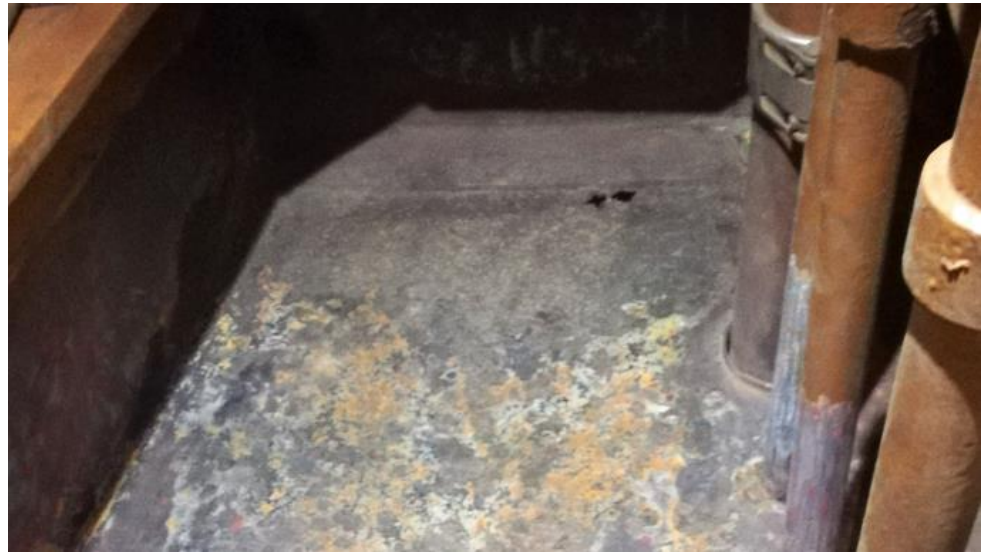
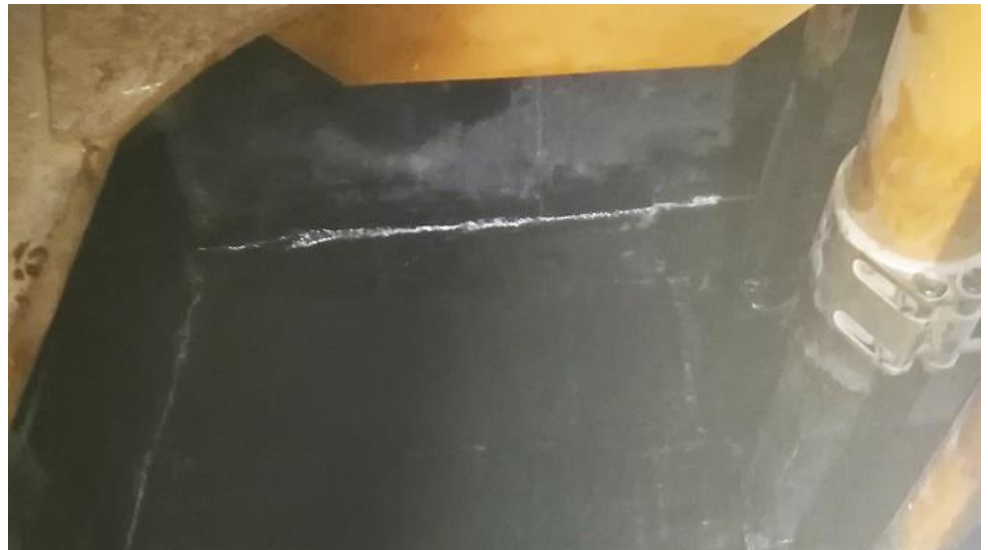
HEELING TANK FLOOR, AND BALLAST TANK BULKHEAD

Problem: The ballast tank floor and bulkhead were corroded and HFO was leaking into the ballast and heeling tanks from adjacent tank.

Solution: Repair was conducted during the vessel's sail.

Repair Duration: 3 days

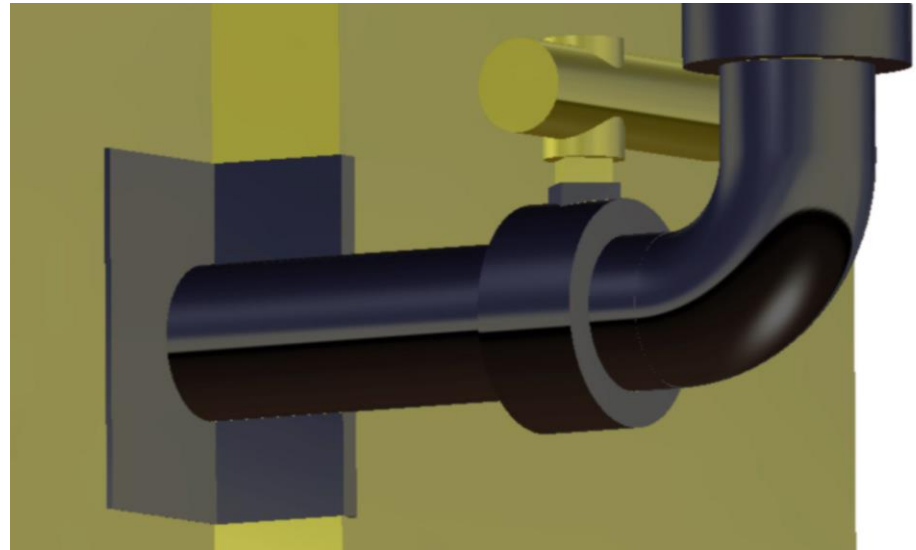
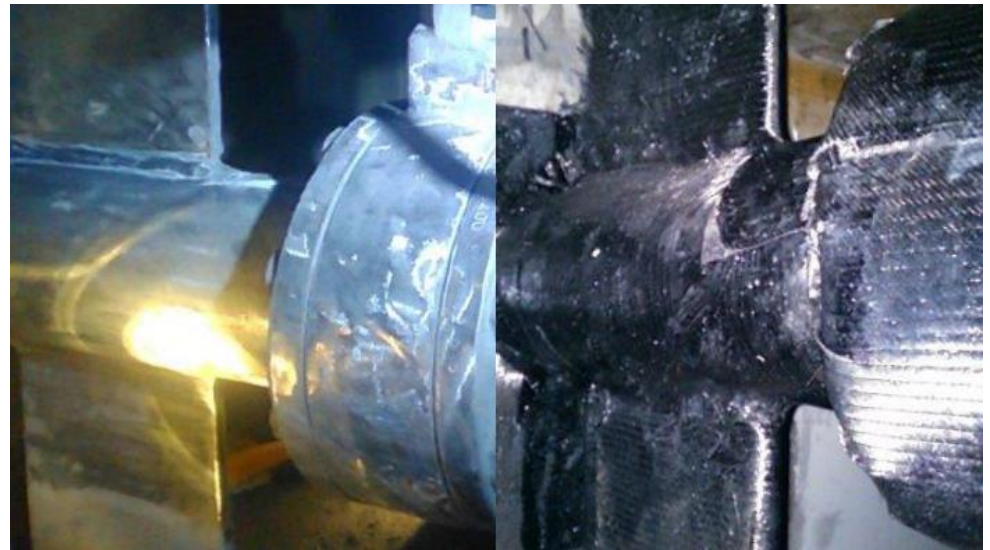
SEA WATER PIPE ON AN LNG CARRIER

Problem: Sea water pipe was corroded and leaking water.

Solution: Repair was conducted during the vessel's stay in Rotterdam port.

Repair Duration: 10h
