COMPAREPAIRS
Repairs and
Reinforcements with
Composite Materials

**Technology Overview and
Application Cases**

COMPA Repairs cases of completed repairs

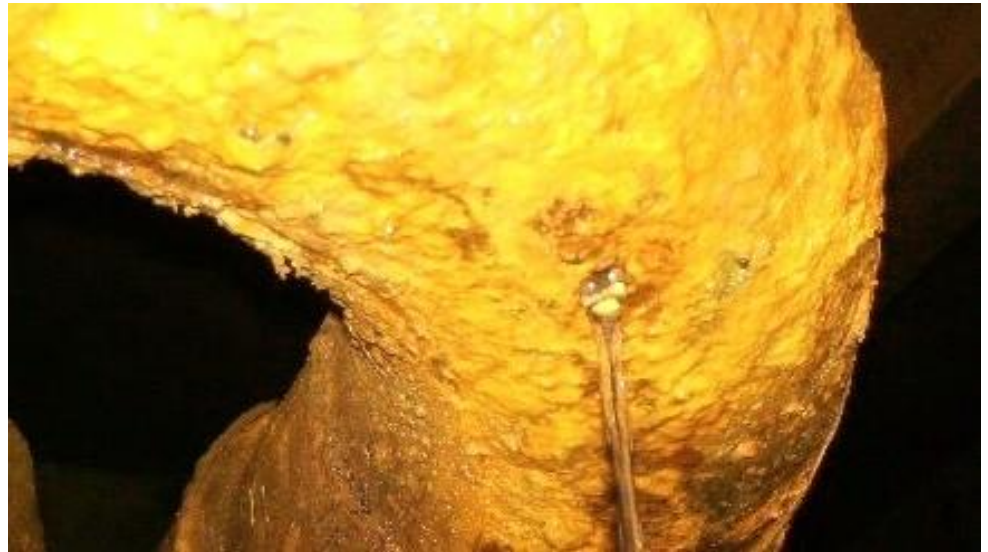
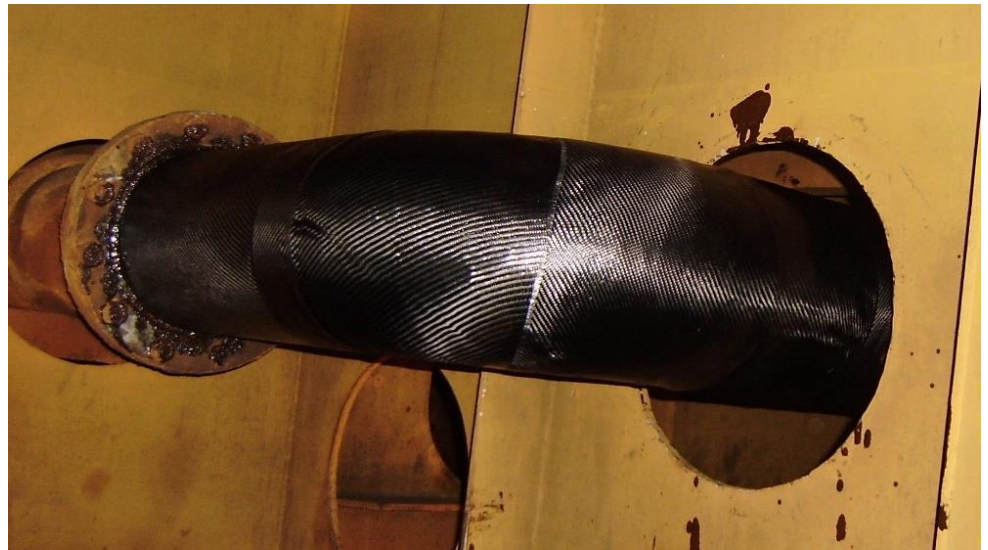
500m of BALLAST PIPING

Problem: 500m of corroded piping was leaking sea water.

Solution: The repair was conducted during the vessel's dry docking.

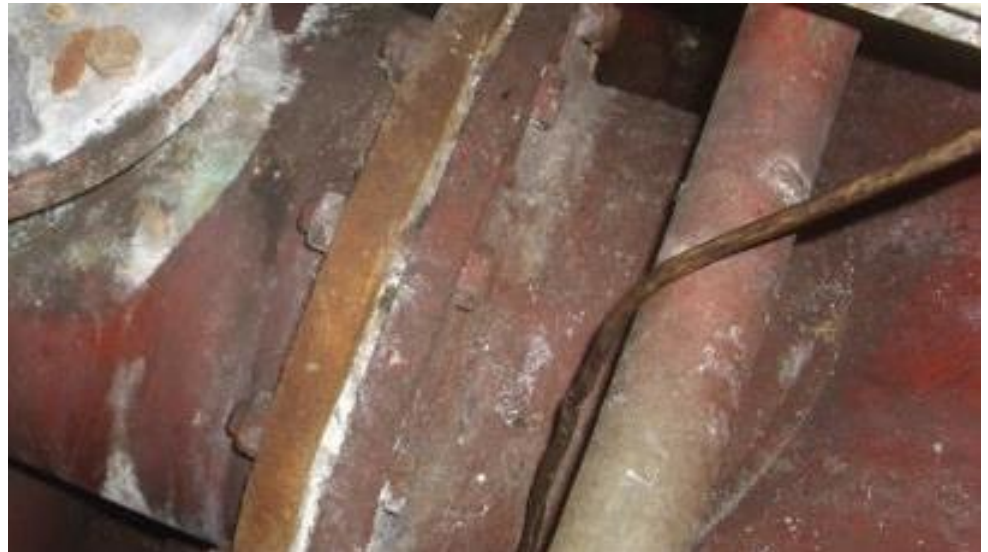
FLANGE ON MAIN SEA WATER INTAKE PIPE

Problem: Corroded flange was leaking sea water.

Solution: COMPA repair was conducted during the vessel's stay in port of Valencia.

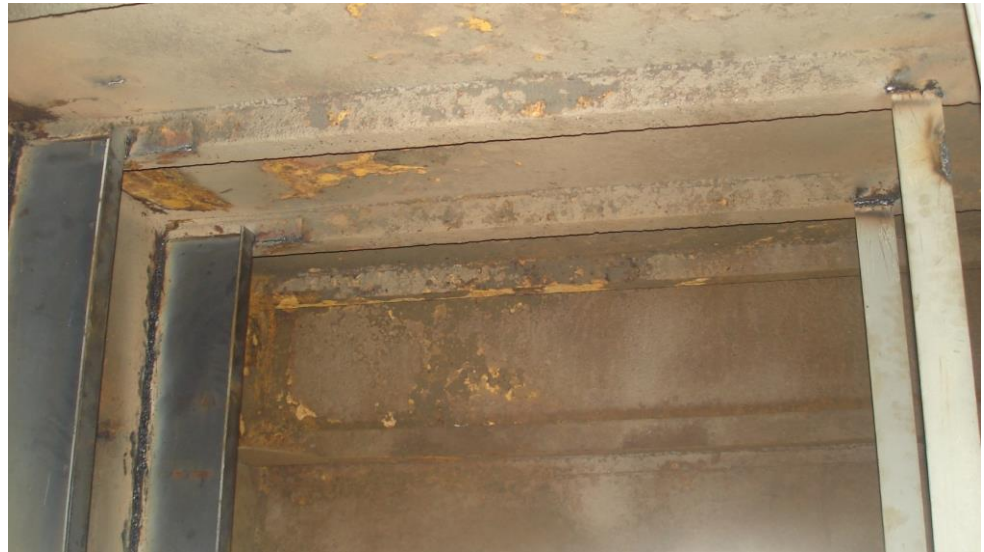
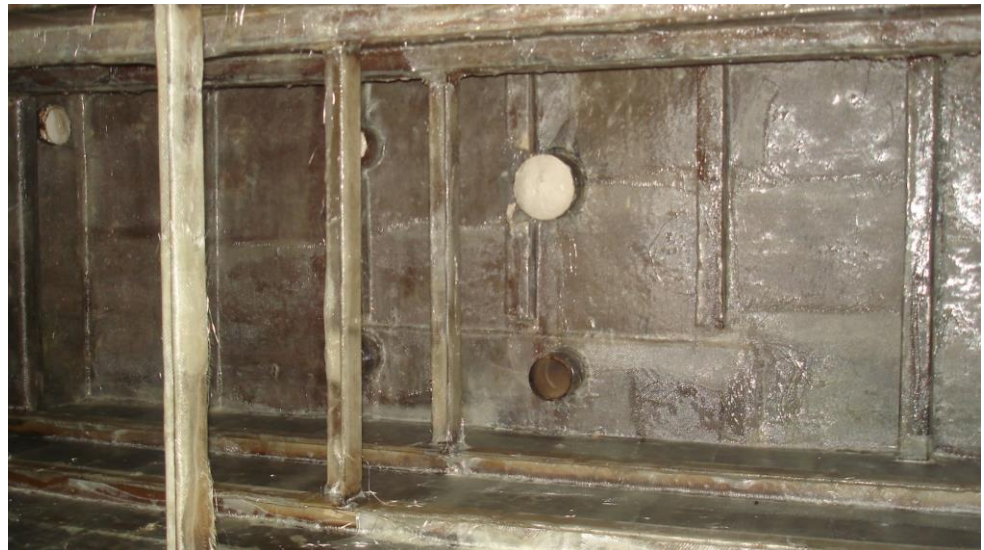
SEWAGE TANK

Problem: Sewage tanks' plating and profiles have undergone extensive corrosion.

Solution: The repair of the 300m² was conducted during the vessel's dry docking in Luxor, Egypt.

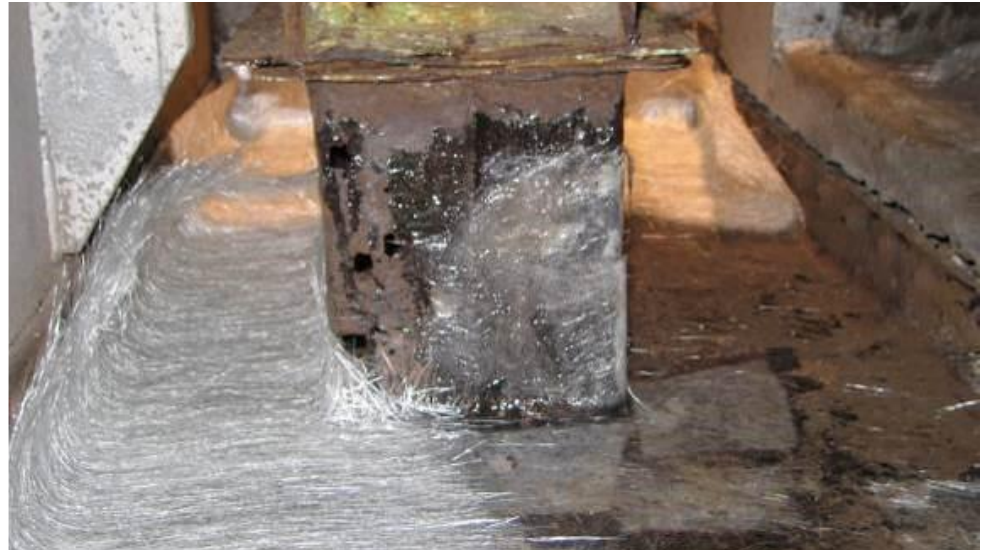
AIR-CONDITIONING UNIT SPACE

Problem: Air-conditioning unit's steel flange and floor exhibited heavy corrosion.

Solution: The repair was conducted during the vessel's dry docking.

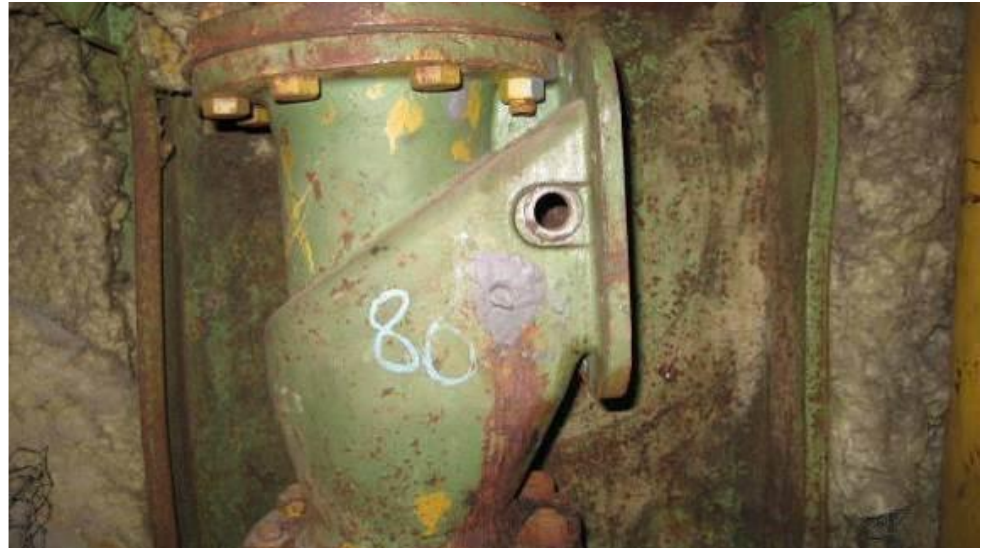
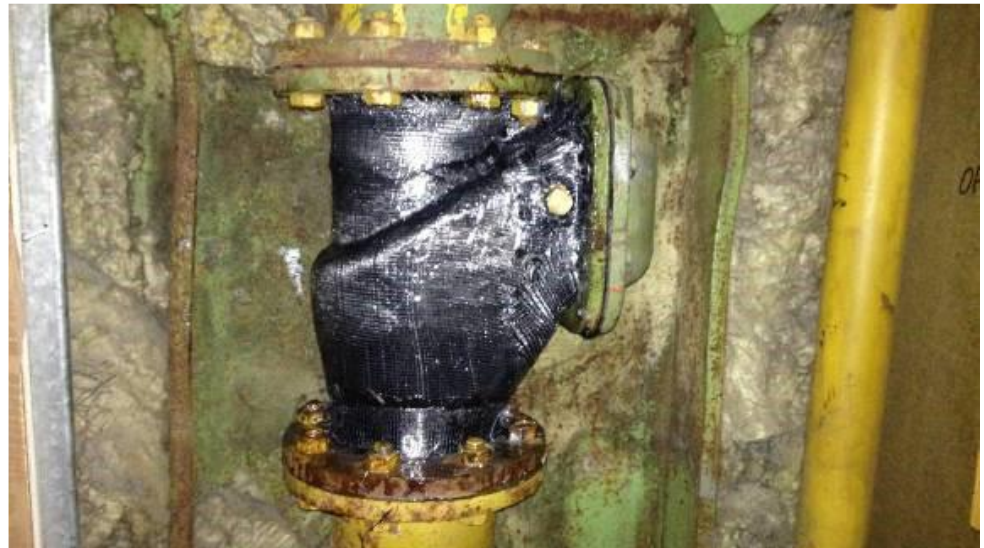
CLAPET VALVE

Problem: Two clapet valves have undergone extensive corrosion.

Solution: The repair was conducted during the vessel's dry docking.

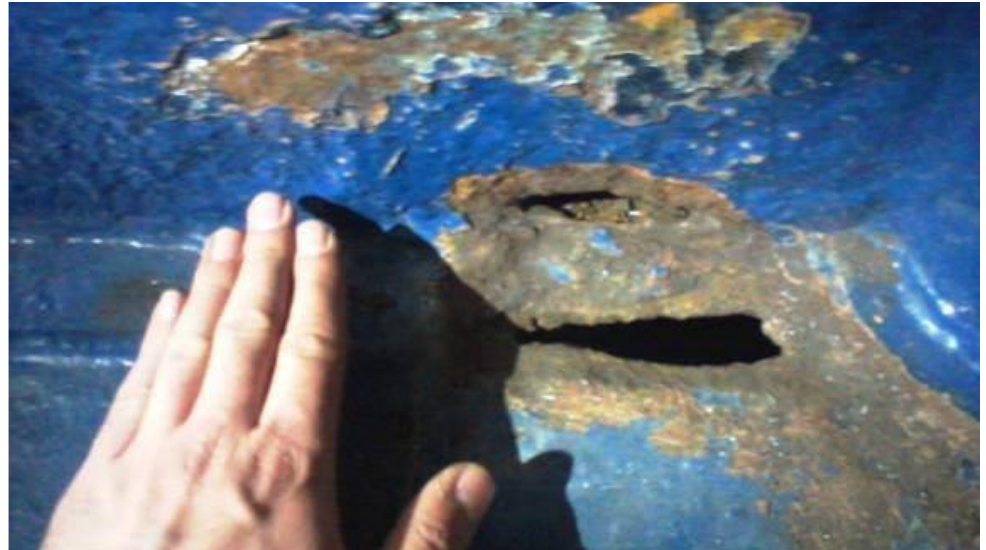
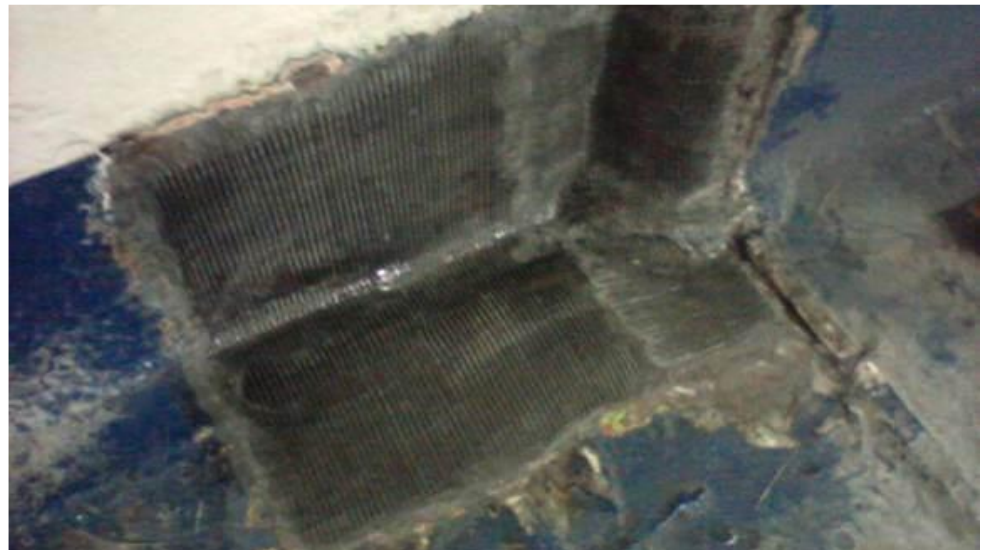
GARAGE FLOOR DETAIL

Problem: The damage on the garage floor was caused by severe corrosion in the corners where the water collects due floor inclination.

Solution: The repair was conducted during the vessel's dry docking.

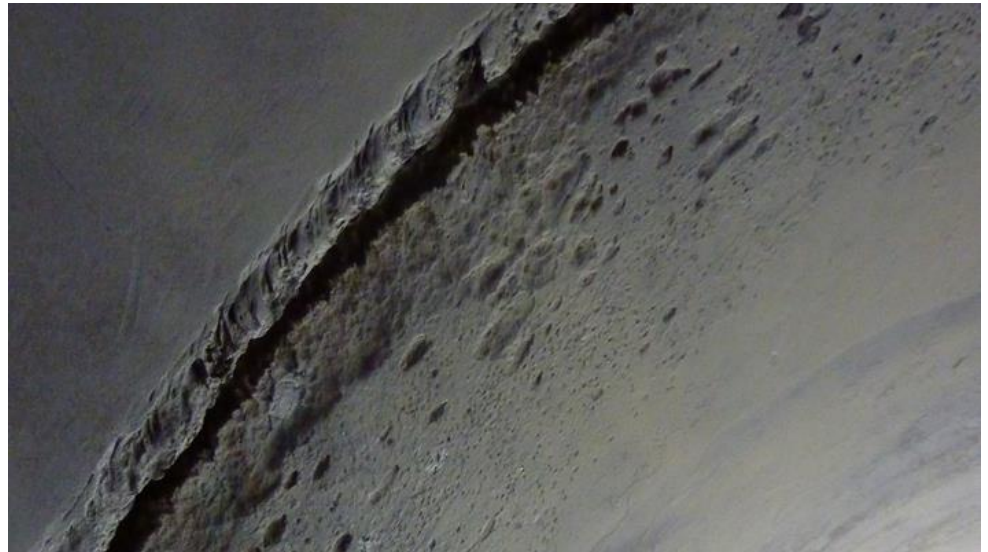
BOW THRUSTER TUNNEL

Problem: Bow thruster tunnel surface damage.

Solution: The repair was conducted during the vessel's dry docking.

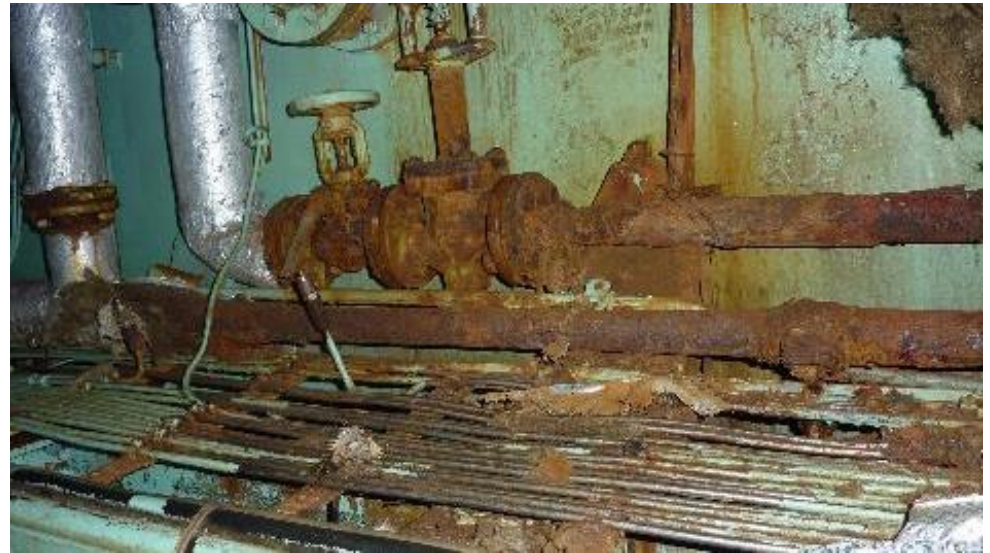
20m OF THERMAL OIL PIPING IN KEEL TUNNEL

Problem: The mineral-oil pipes, located in keel tunnel, were heavily corroded.

Solution: The repair was conducted during the vessel's dry docking.

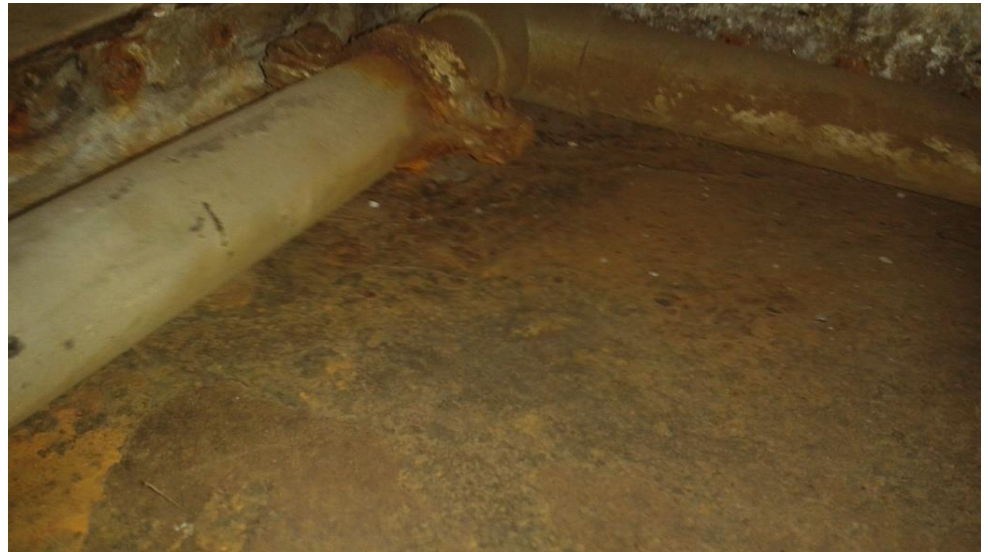
DECK UNDER AC STATION

Problem: Deck under AC station was leaking sea water.

Solution: The repair was conducted during the vessel's stay in port.

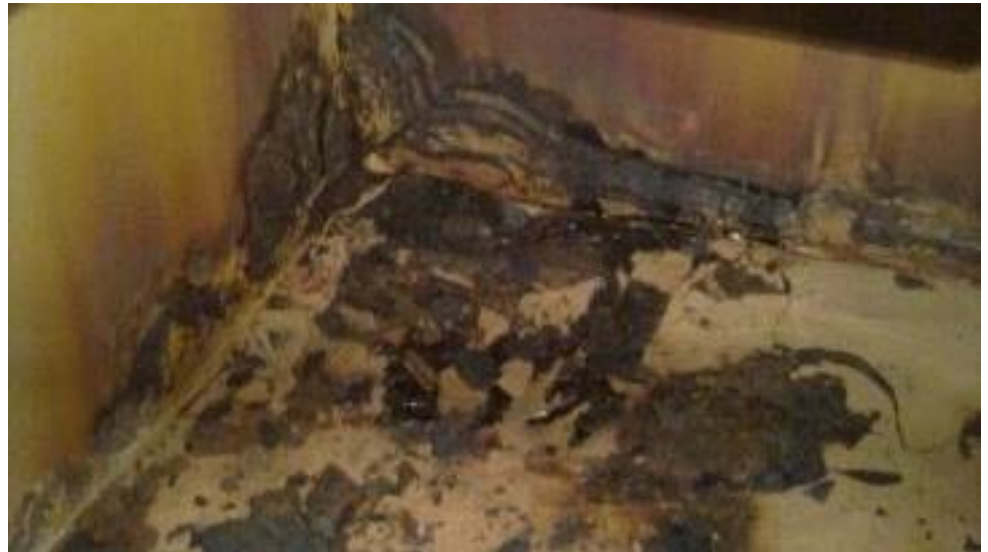
BULKHEAD OF THE BALLAST TANK

Problem: Heavily corroded bulkhead was leaking HFO.

Solution: The repair was conducted during the vessel's stay in Savona port.

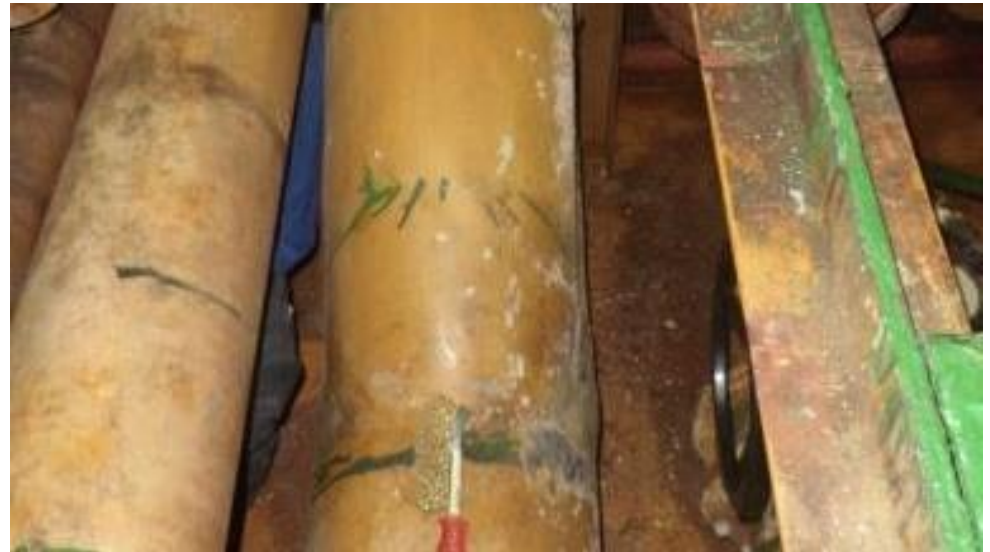
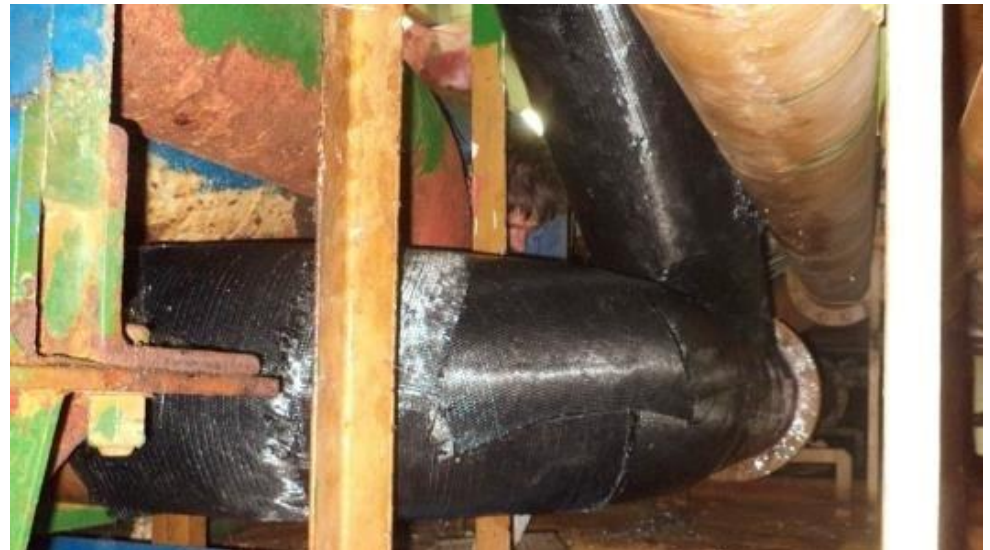
Y-JUNCTION BALLAST INTAKE PIPE

Problem: Heavily corroded Y-junction was leaking sea water.

Solution: Conducted during the vessel's stay in Salerno port.

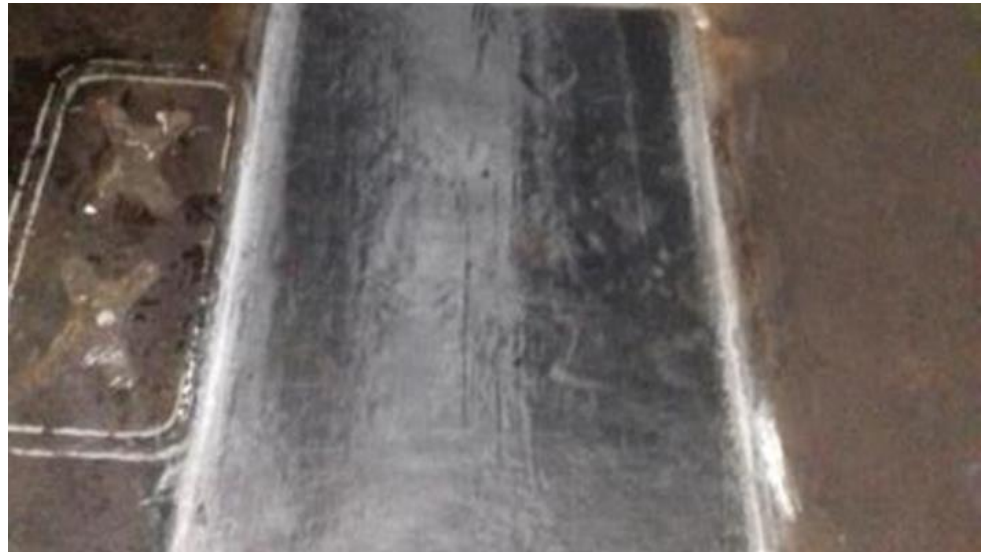
HFO TANK TOP

Problem: Cracked tank top was leaking HFO in rough seas.

Solution: Conducted during the vessel's stay in Savona port.

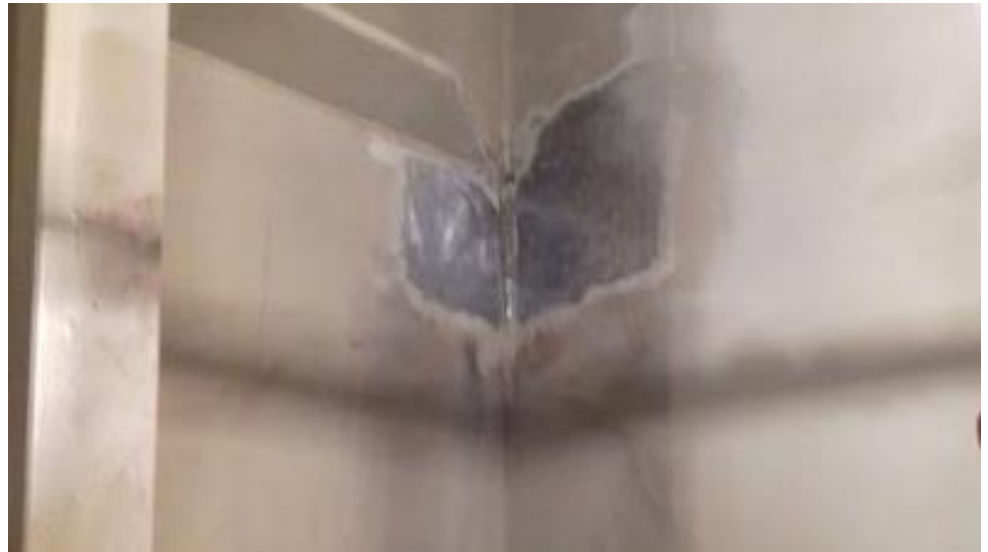
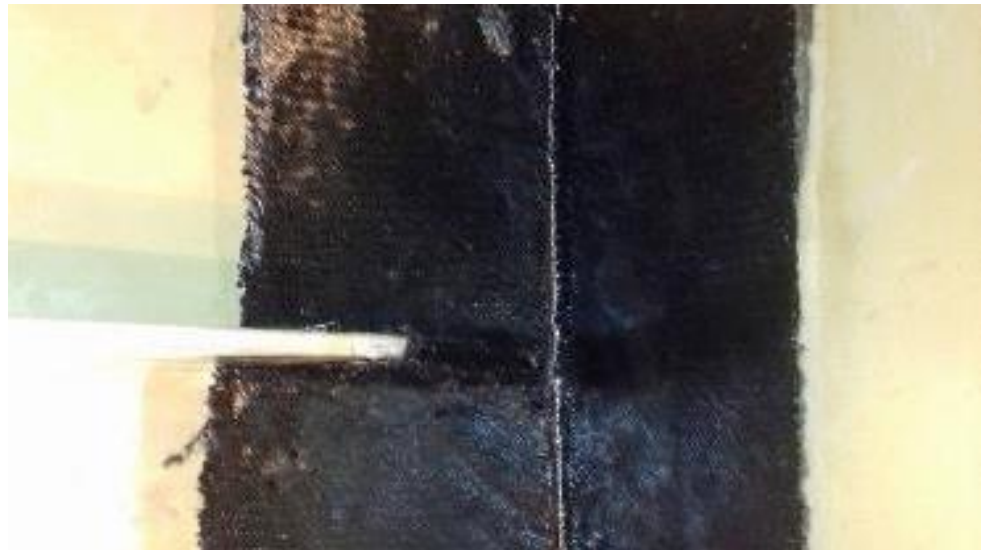
BULKHEAD OF THE MDO FUEL TANK

Problem: Cracked bulkhead was leaking MDO.

Solution: Repair was conducted during the vessel's stay in Antwerp port.

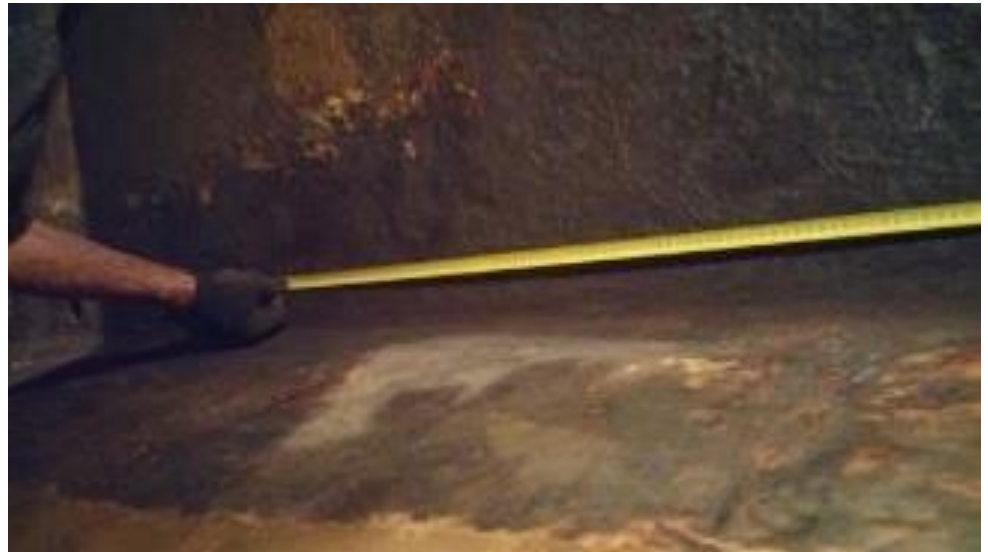
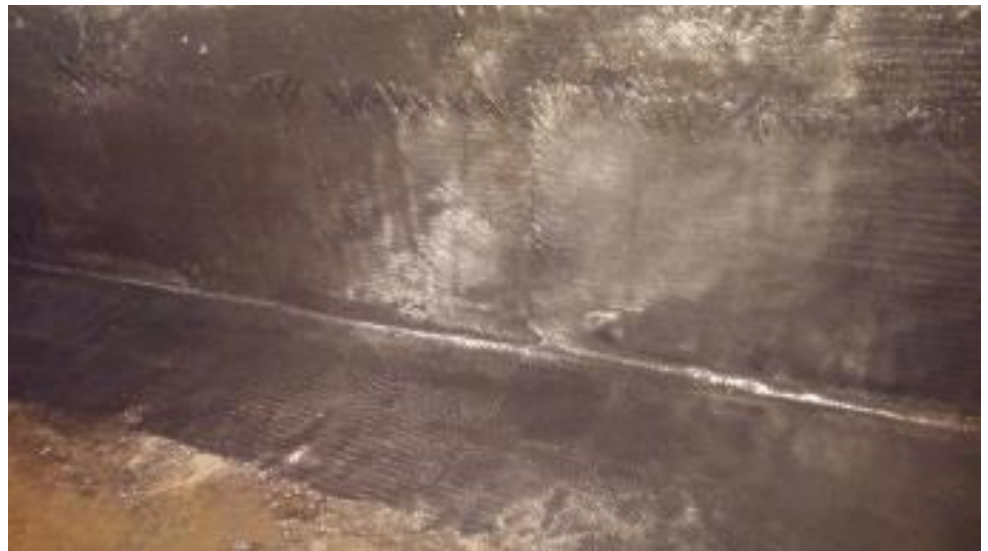
BULKHEAD OF THE HFO FUEL TANK

Problem: A heavily corroded bulkhead was leaking HFO.

Solution: Repair was conducted during the vessel's voyage from Le Havre to Antwerp.

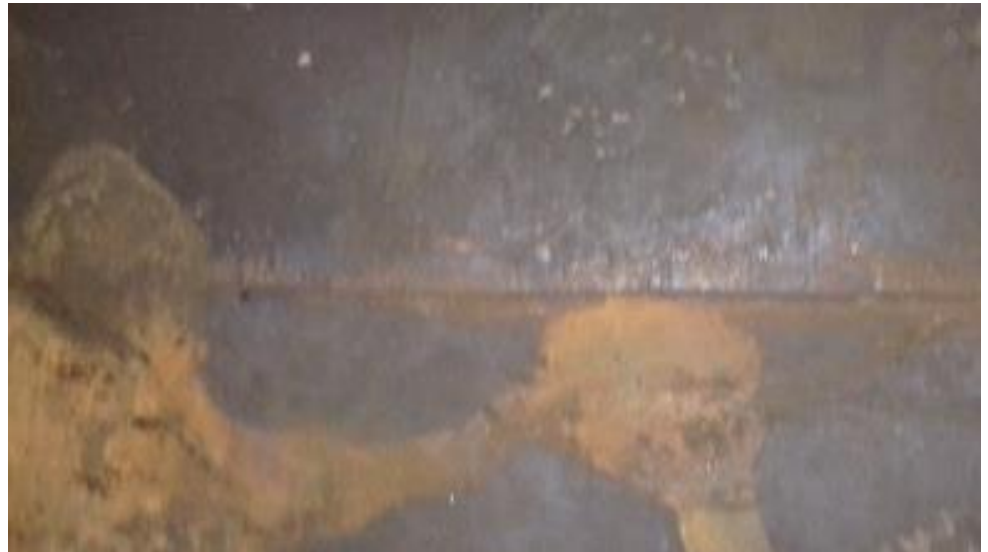
HFO TANK TOP

Problem: A heavily corroded bulkhead was leaking HFO.

Solution: Repair of 5 cracks was conducted during the vessel's stay in Antwerp port.

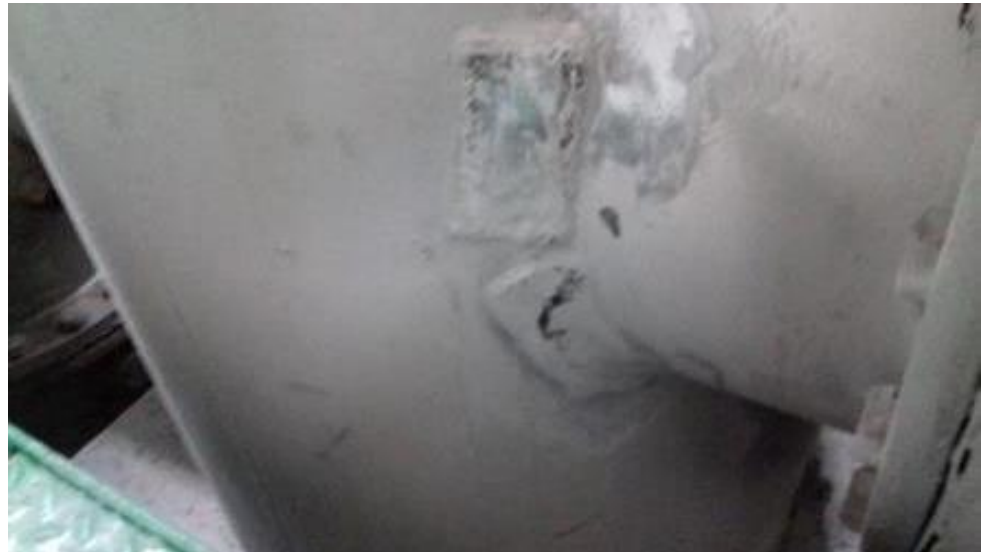
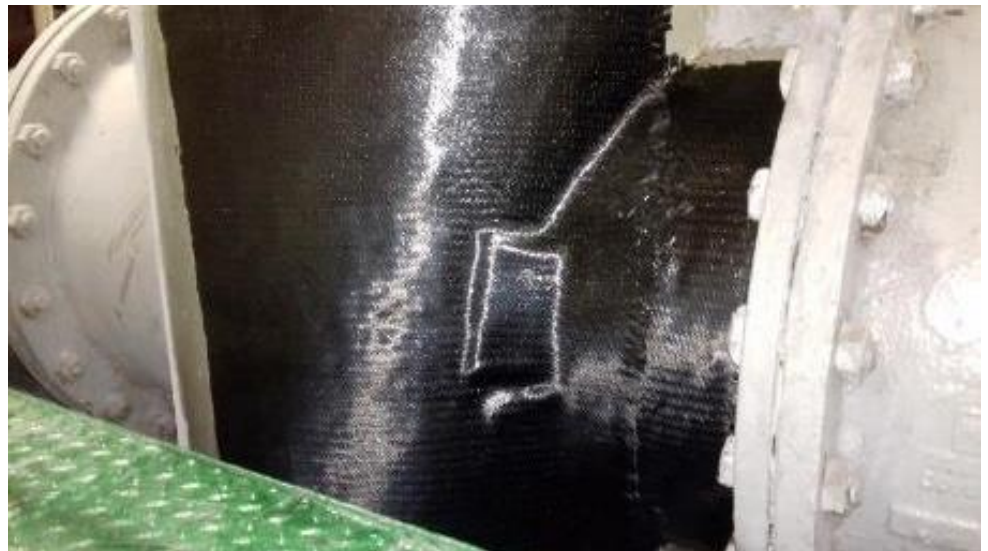
SEA CHEST

Problem: Corrosion on the inner side caused leakage of the sea water.

Solution: Repair was conducted during the vessel's stay in Antwerp port.

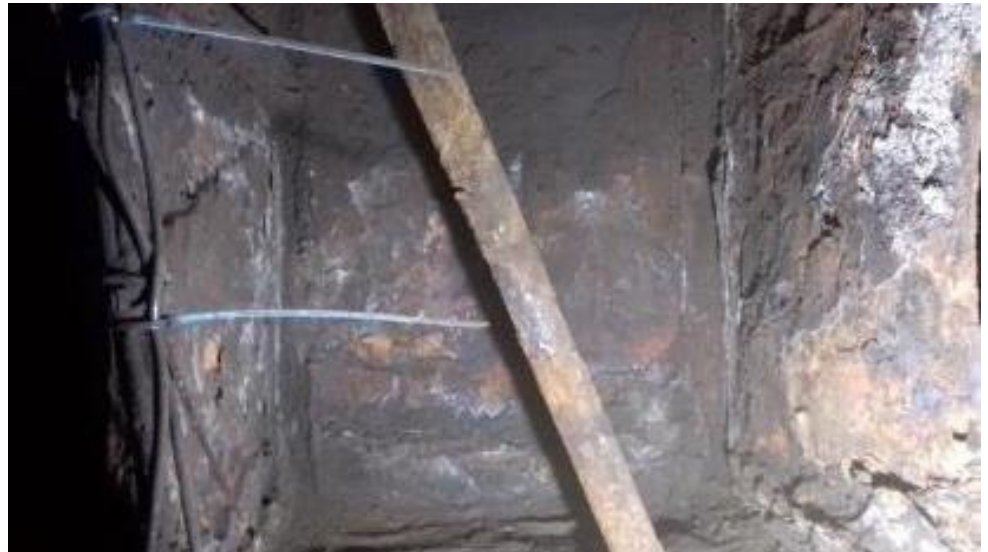
BALLAST TANK IN DOUBLE BOTTOM

Problem: Multiple bulkheads and the tank top were corroded and leaking sea water.

Solution: Repair was conducted during the vessel's voyage from Hamburg to Antwerp.

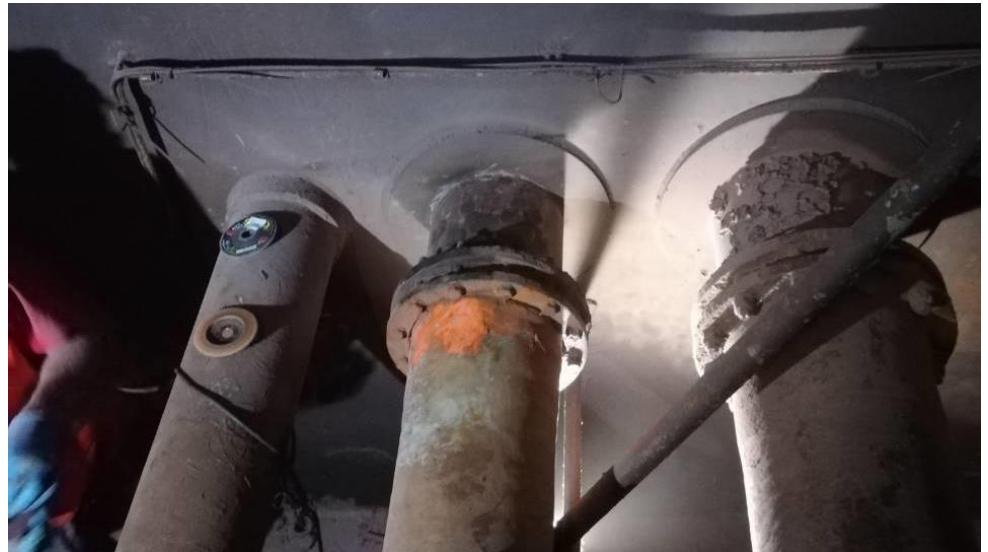
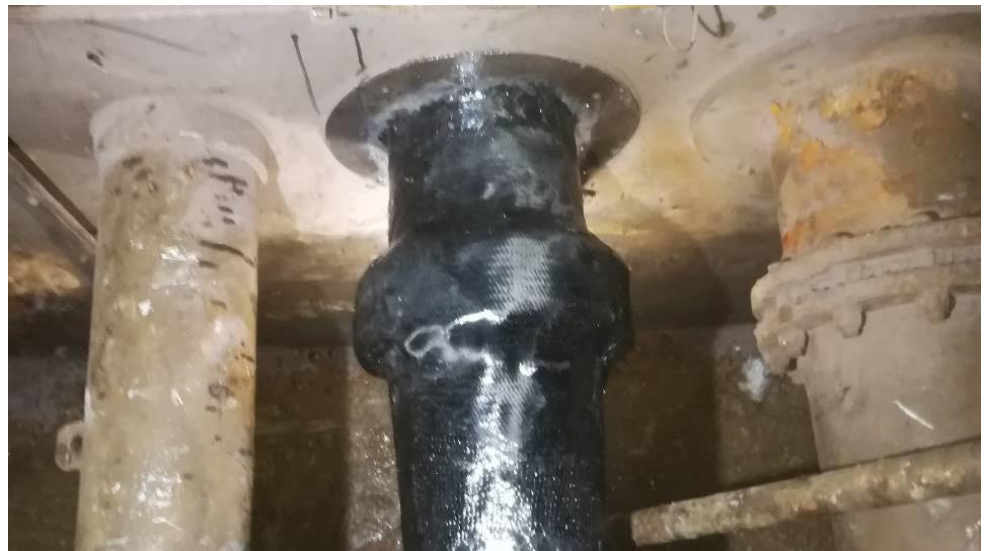
BALLAST PIPE IN HEELING TANK

Problem: Flange connecting steel and fibreglass pipe was corroded and leaking sea water.

Solution: Repair was conducted during the vessel's stay in Antwerp port.

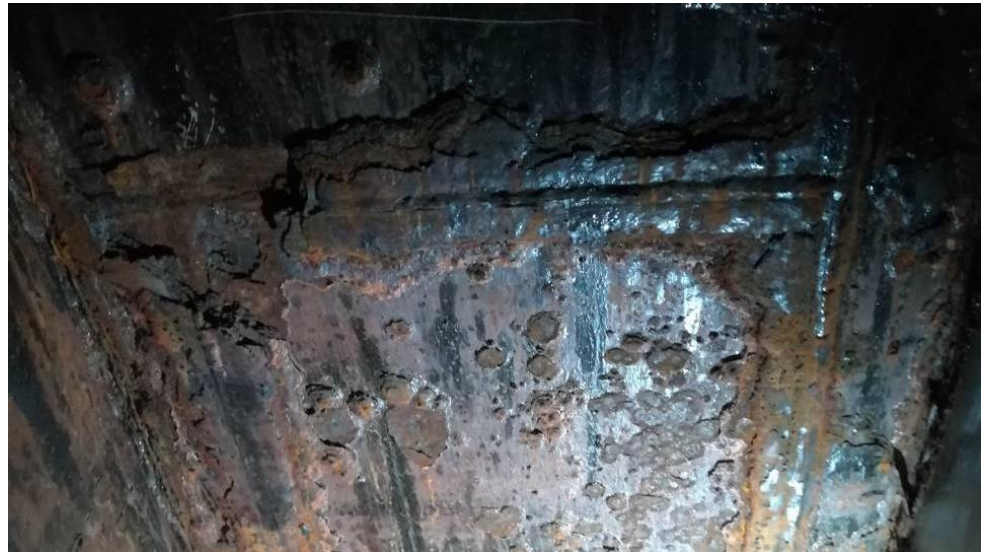
BULKHEAD BETWEEN BALLAST AND HFO TANK

Problem: The bulkhead was corroded and it was leaking HFO into the ballast tank.

Solution: Repair's conducted during the vessel's stay in Antwerp port.

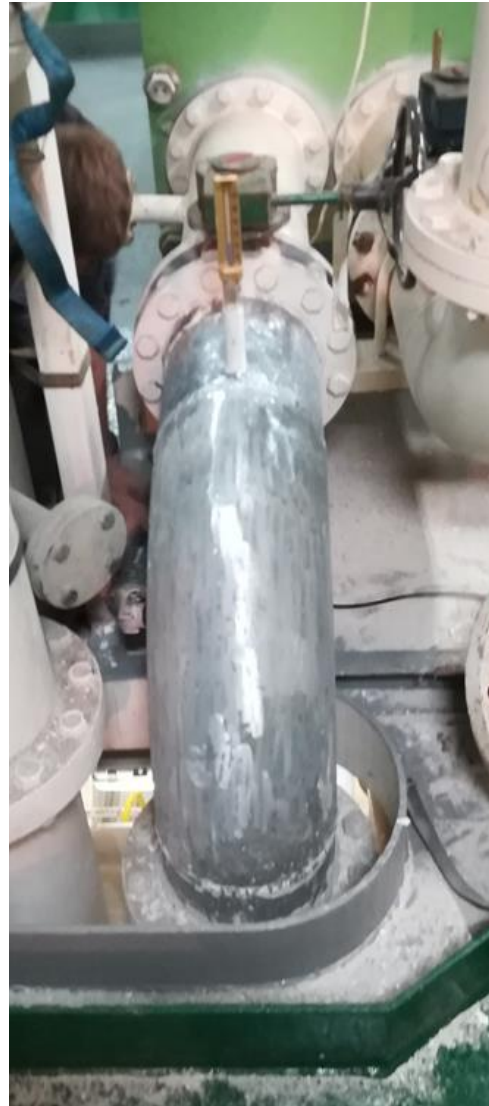
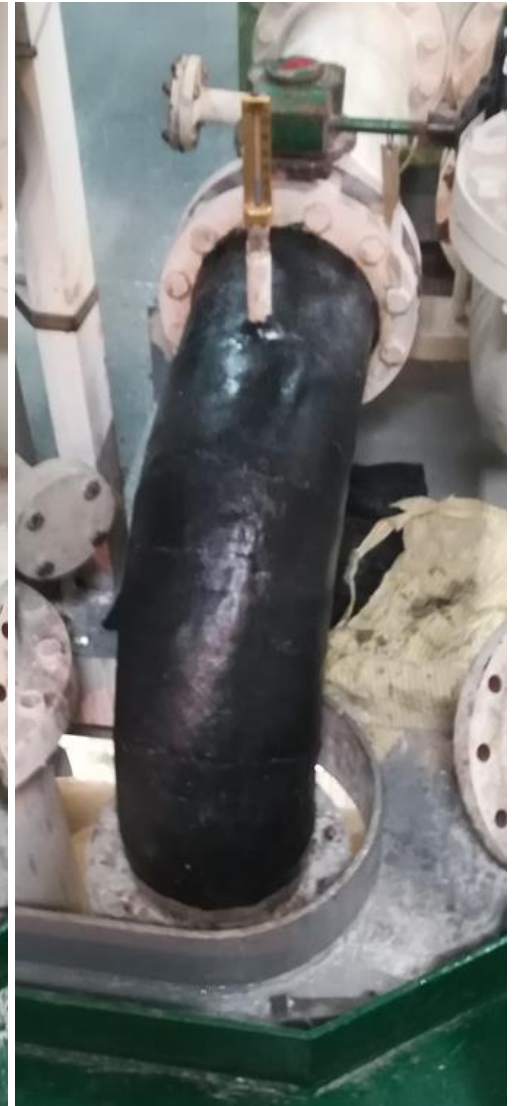
BALLAST PIPE IN ENGINE ROOM

Problem: Multiple pipes were corroded and leaking sea water.

Solution: Repair was conducted during the vessel's stay in Antwerp port.

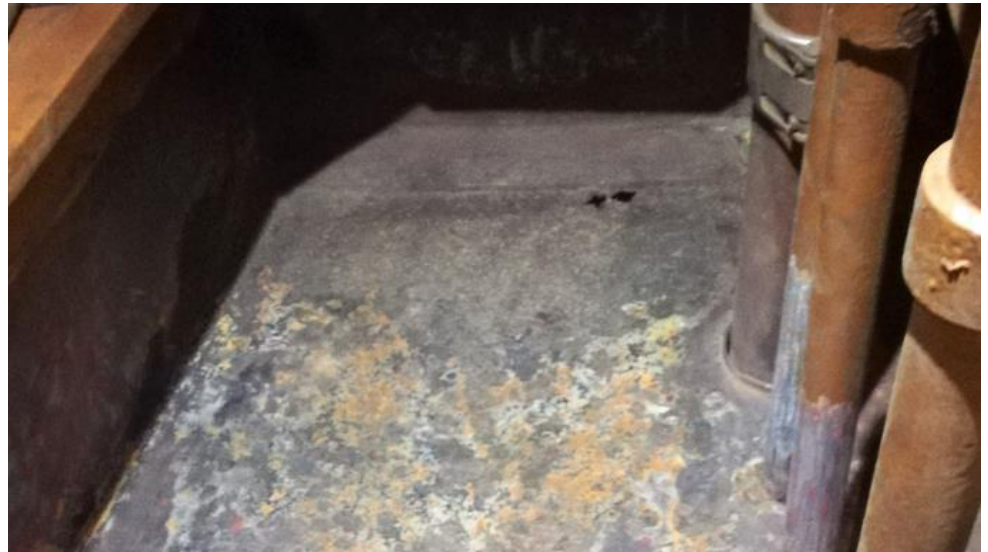
HEELING TANK FLOOR AND BALLAST TANK BULKHEAD

Problem: The ballast tank floor and bulkhead were corroded and HFO was leaking into the ballast and heeling tanks from adjacent tank.

Solution: Repair was conducted during the vessel's sail.

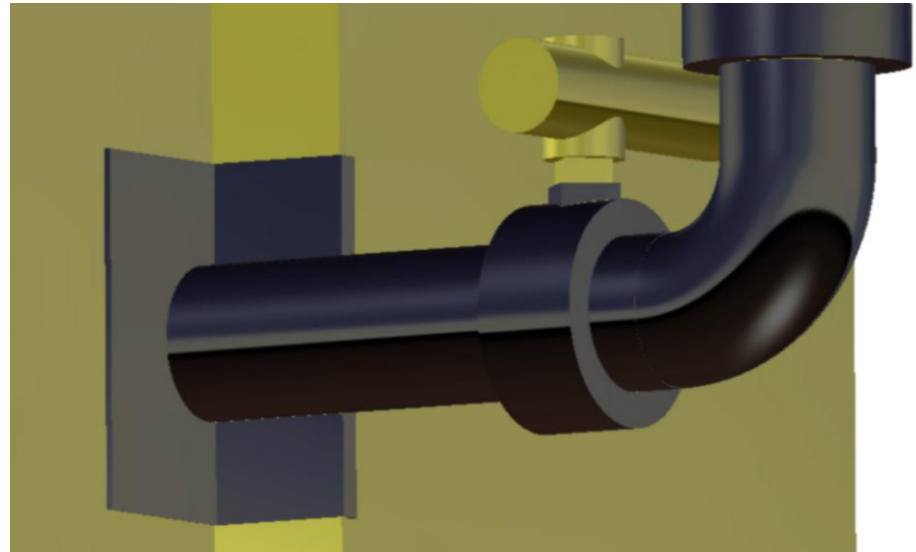
SEA WATER PIPE ON AN LNG CARRIER

Problem: Sea water pipe was corroded and leaking water.

Solution: Repair was conducted during the vessel's stay in Rotterdam port.

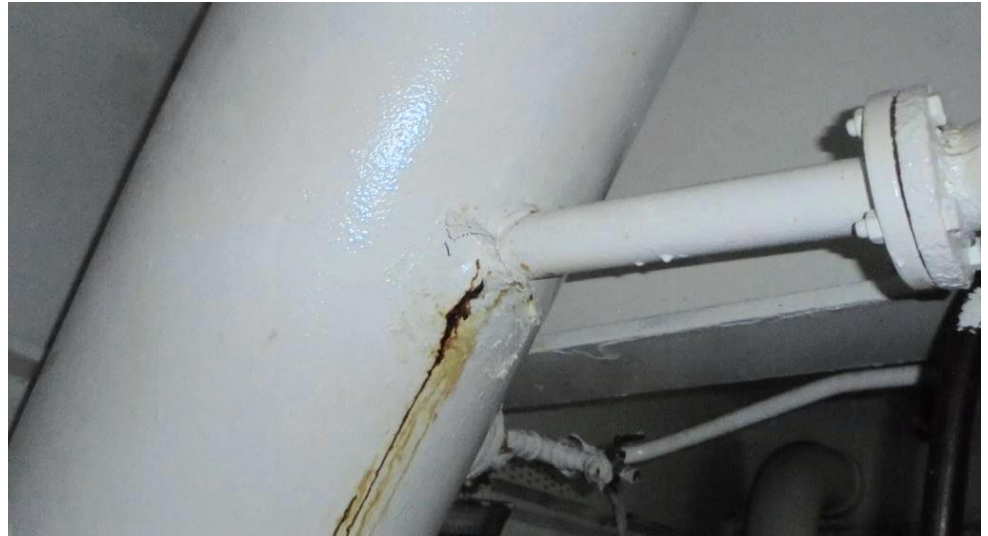
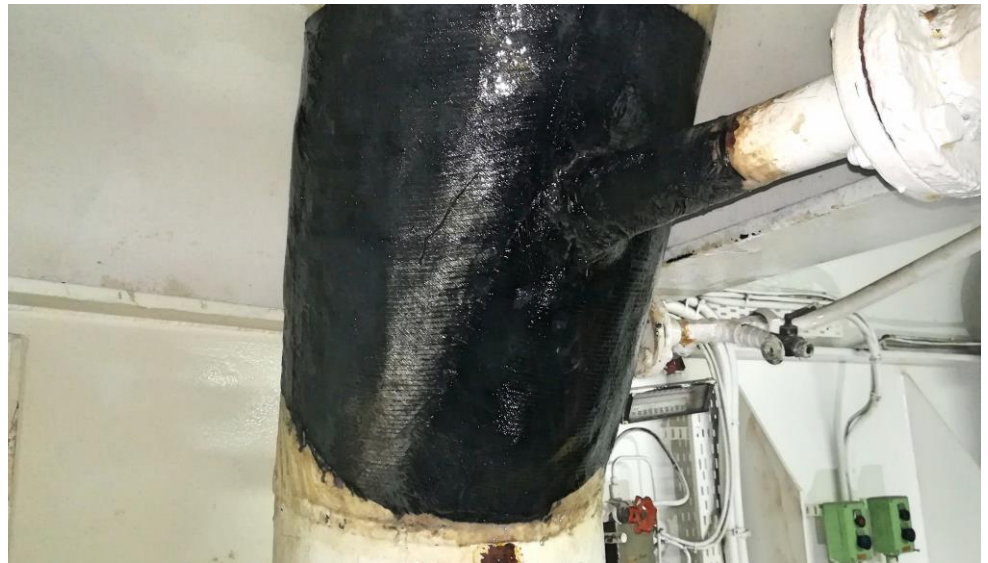
SEA WATER PIPE ON RO-RO SHIP

Problem: Sea water pipe was corroded and leaking water.

Solution: Repair was conducted during the vessel's stay in Antwerp port.

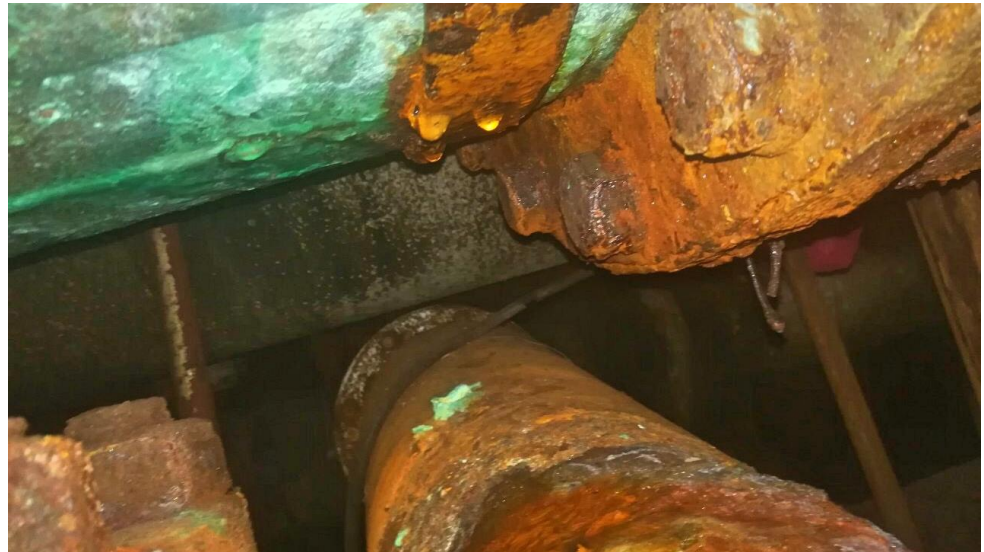
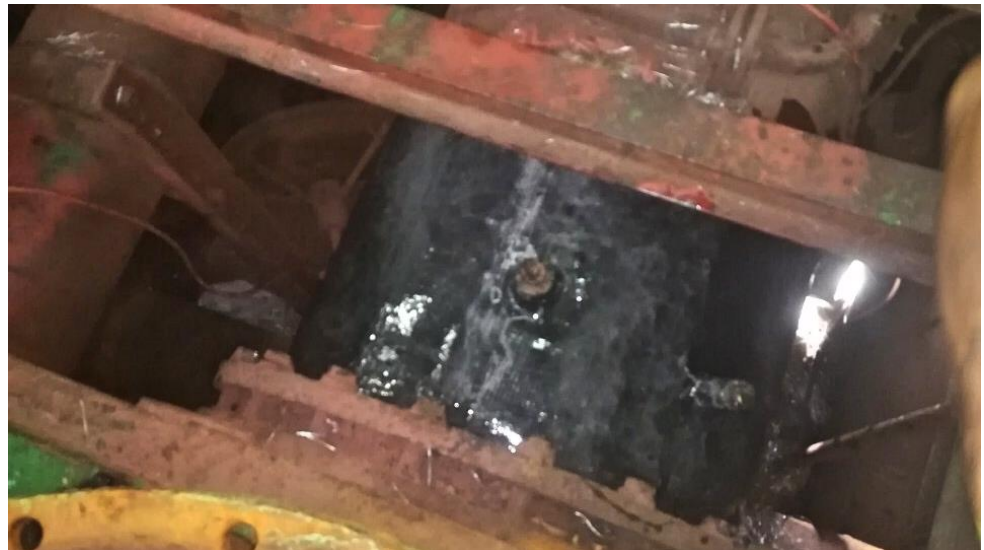
CORRODED MAIN SEA WATER PIPE

Problem: COMPA patches needed to be applied from the inside and the outside of leaking main sea water pipe.

Solution: Repair was conducted during the vessel's stay in Genova port.

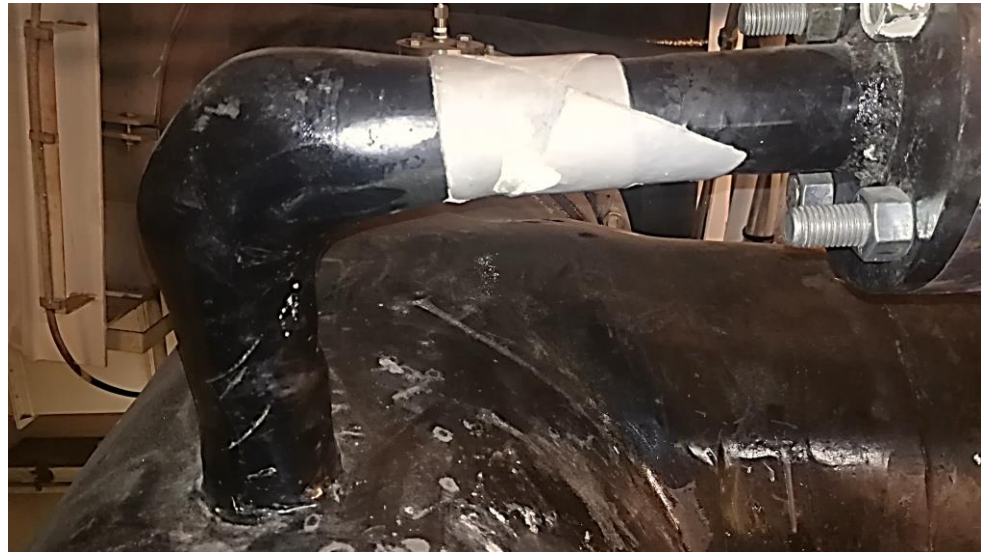
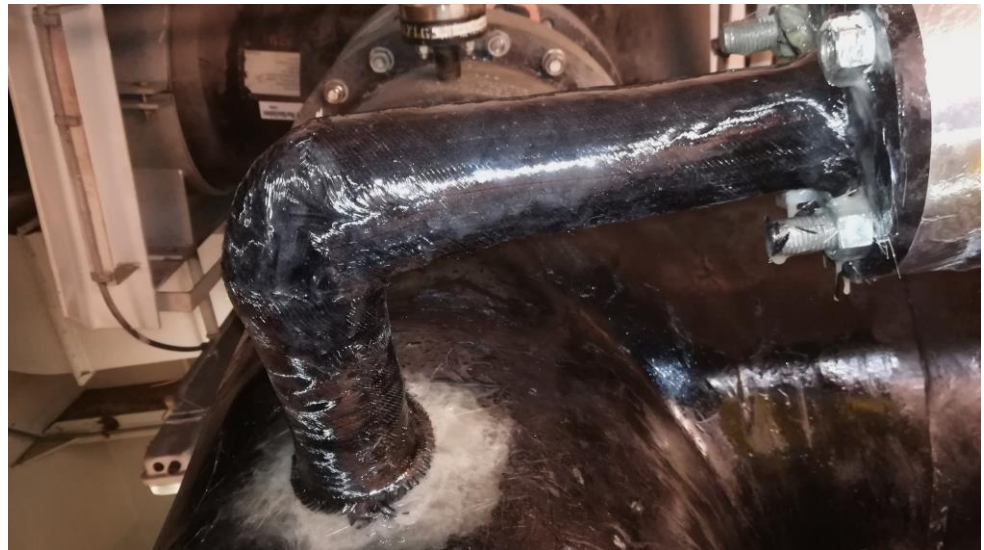
SCRUBBER SYSTEM NaOH PIPE

Problem: The pipe was unsuccessfully repaired using glass fibres, so COMPA patch was applied to stop the leakage.

Solution: Repair was conducted during the vessel's stay in Antwerp port.

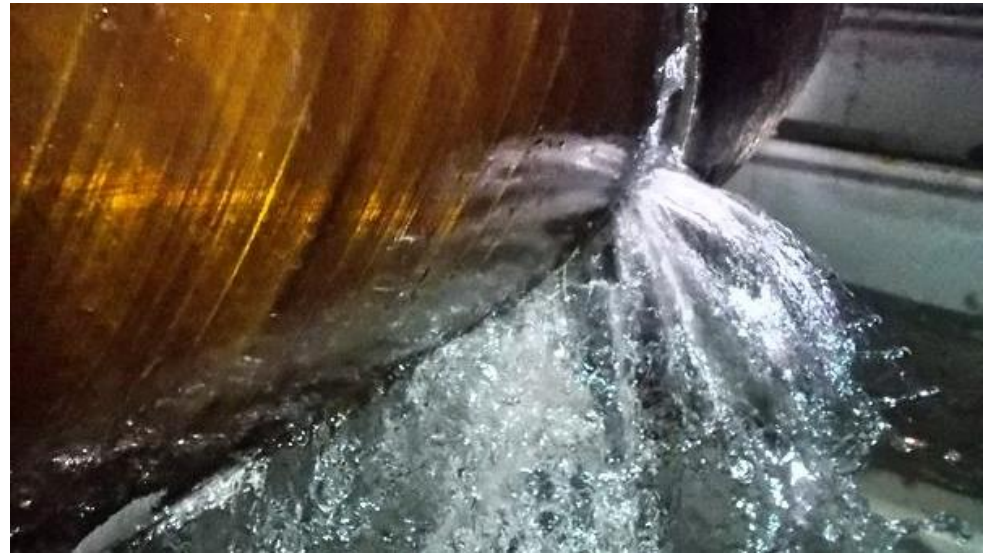
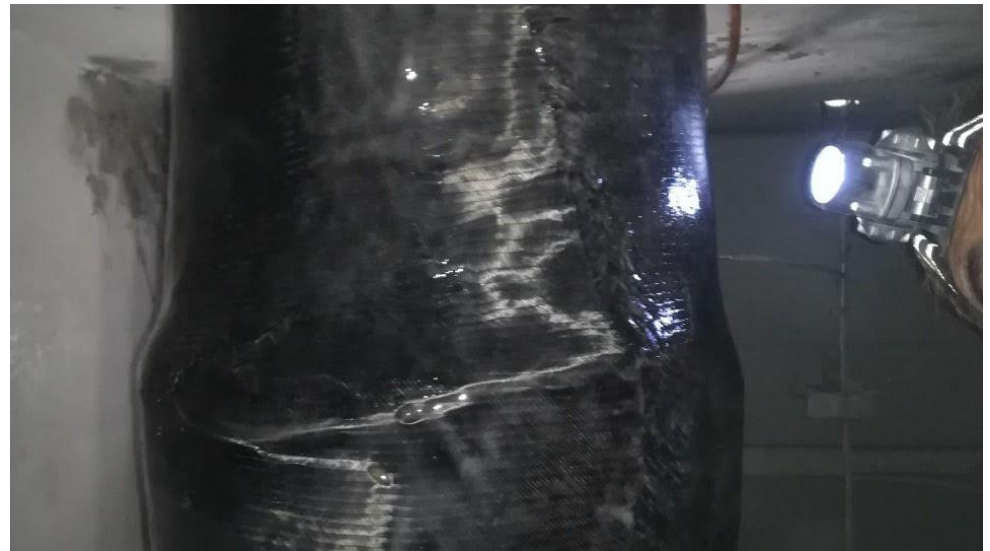
THE ANTI-HEELING SYSTEM PIPE

Problem: The anti-heeling system had a large crack in the glass-fibre pipe and was leaking heavily.

Solution: Repair was conducted during navigation between Hamburg and Antwerp ports.
