COMPAREPAIRS
Repairs and
Reinforcements with
Composite Materials

**Technology Overview and
Application Cases**

COMPA Repairs cases of completed repairs

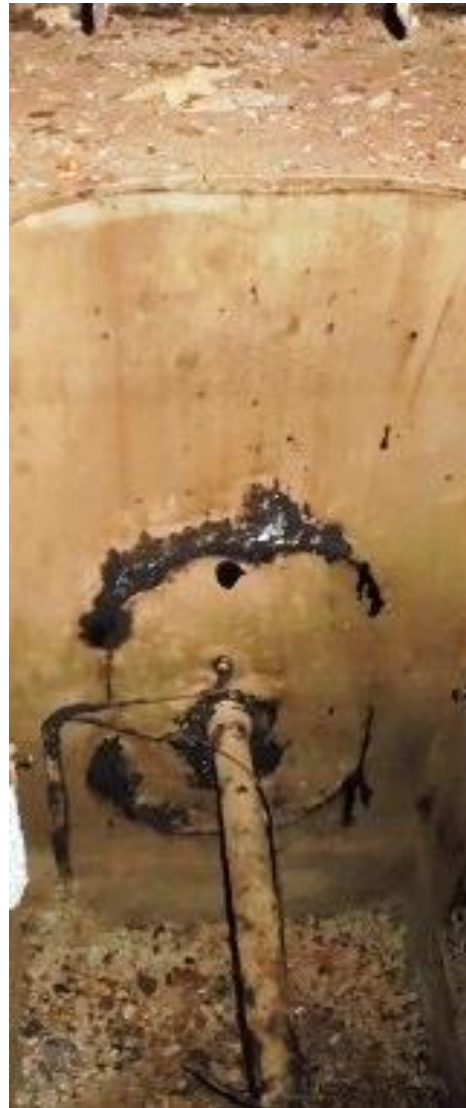
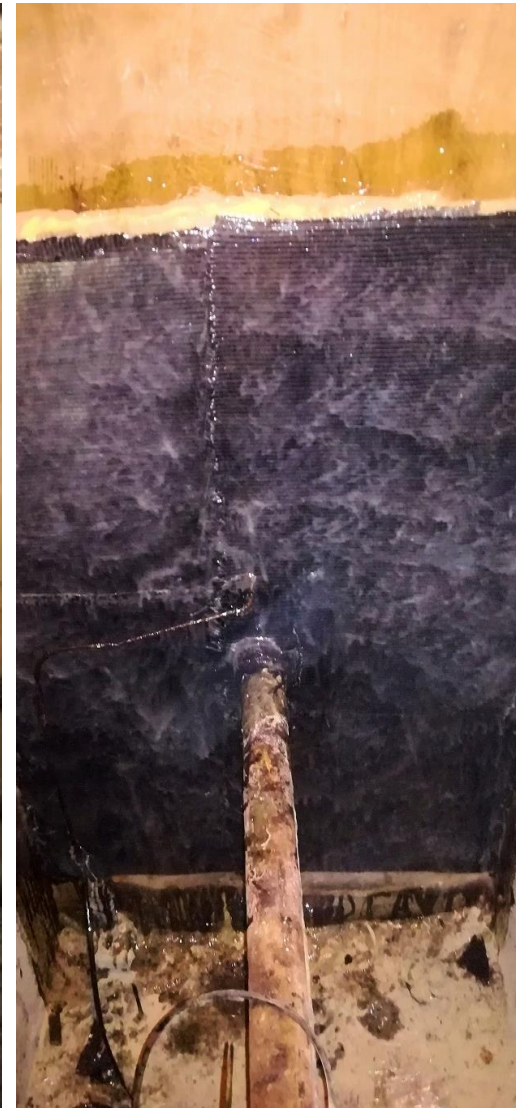
TANK BULKHEAD

Problem: The leakage of heavy fuel occurred on the blind manhole between water ballast and heavy fuel tank.

Solution: Repair was conducted during the vessel's stay in Antwerp port.

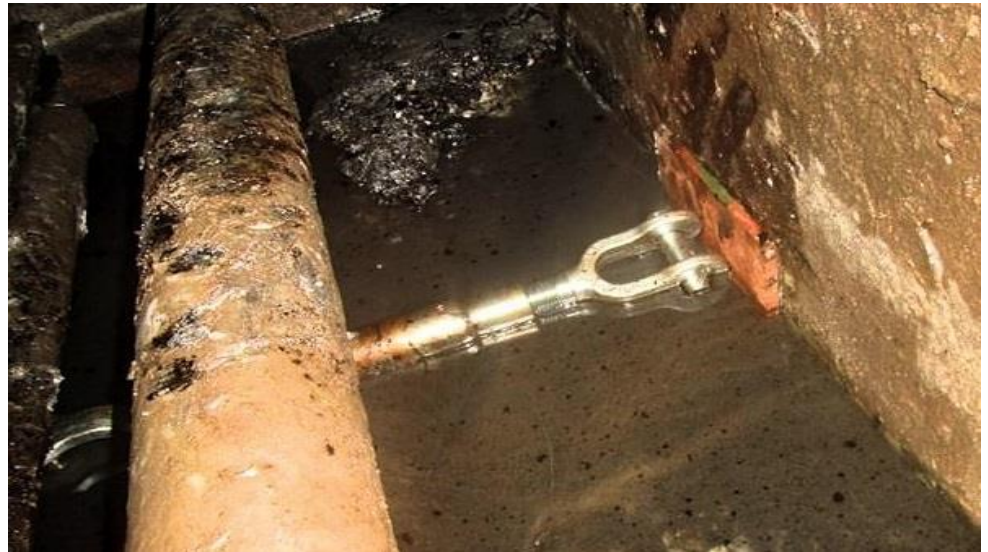
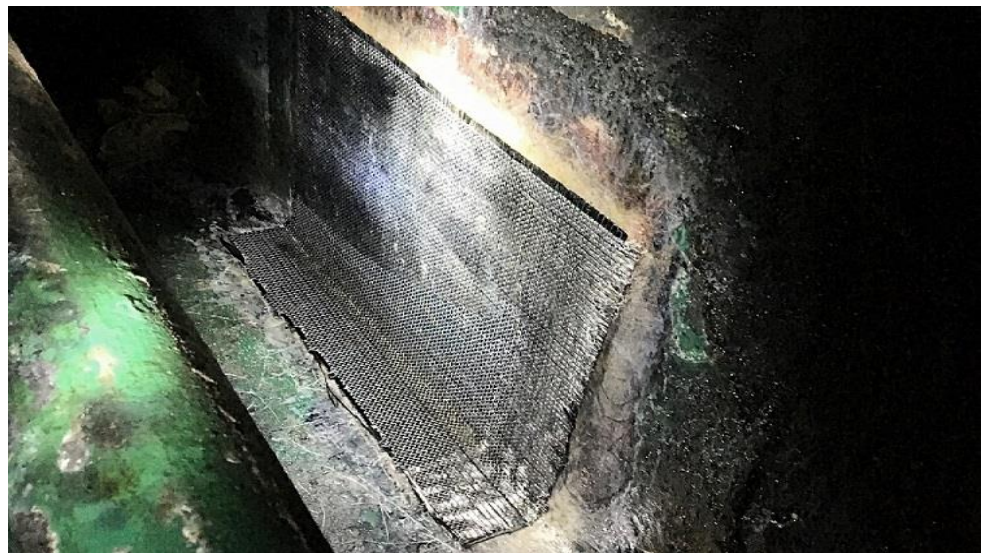
LEAKING FUEL TANK

Problem: The crack appeared on tank plate between ballast and heavy fuel tank and the fuel was leaking into the ballast tank.

Solution: Repair was conducted during the vessel's stay in Genova port.

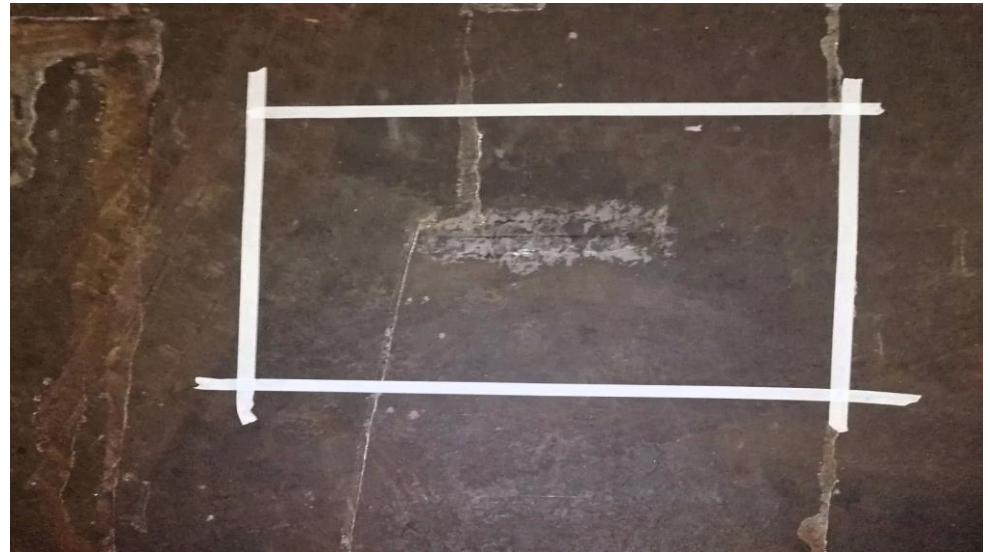
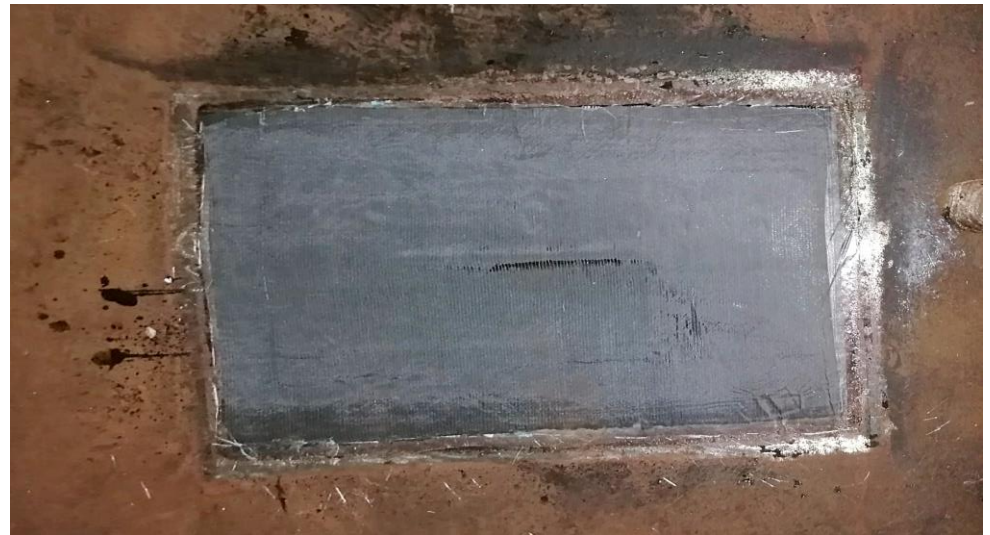
CRACKED HFO DOUBLE BOTTOM TANKS

Problem: Two cracks of about 30 cm in length appeared on the double bottom plating just above HFO tank.

Solution: Repair was conducted during the vessel's stay in Antwerp port.

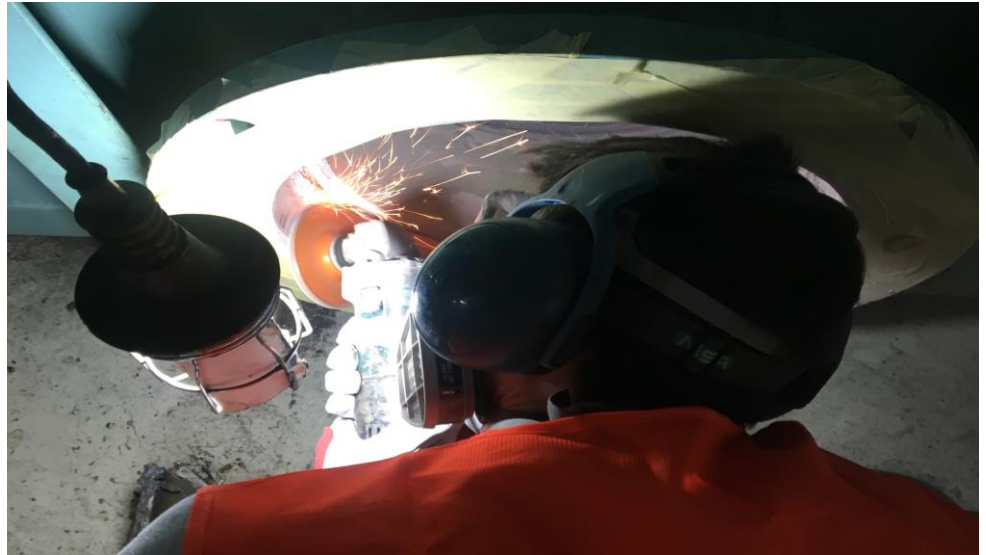
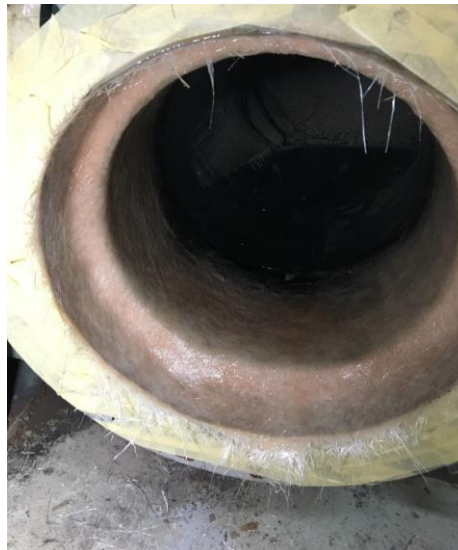
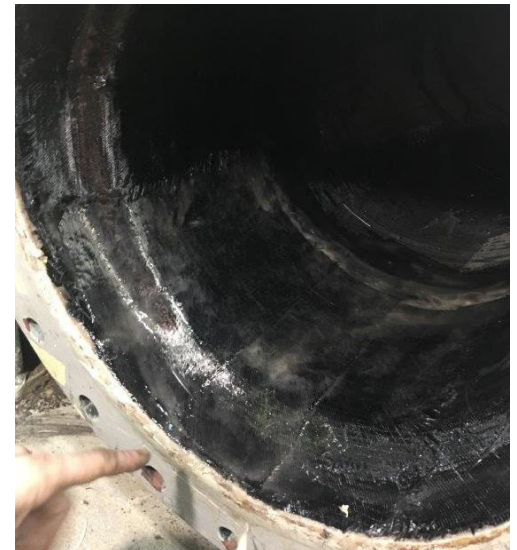
FLANGE ON THE PROCESS TANK

Problem: Acidic medium caused the crack and the leakage of the flange of the process tank that is a part of the scrubber system.

Solution: Repair was conducted during the vessel's stay in Civitavecchia port.
