COMPAREPAIRS
Repairs and
Reinforcements with
Composite Materials

**Technology Overview and
Application Cases**

COMPA Repairs cases of completed repairs

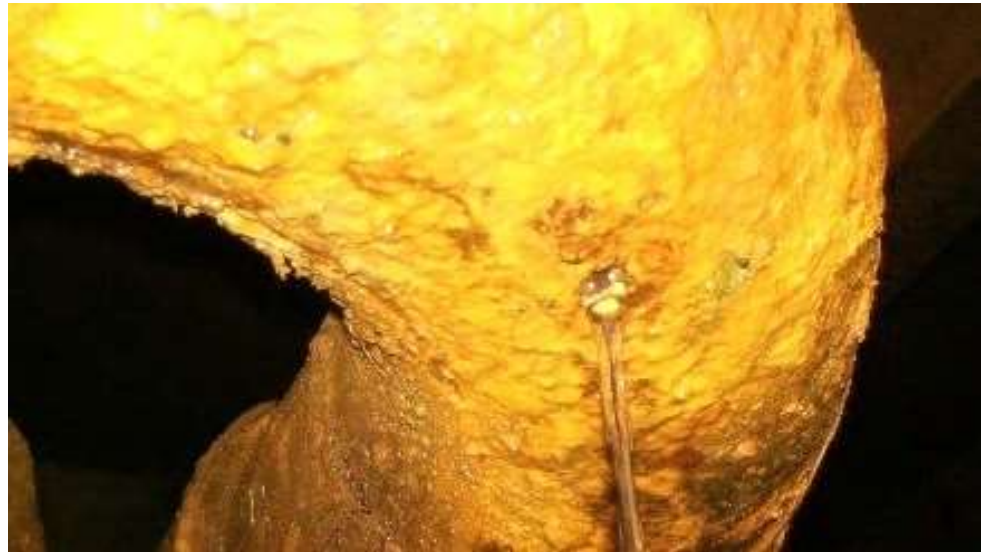
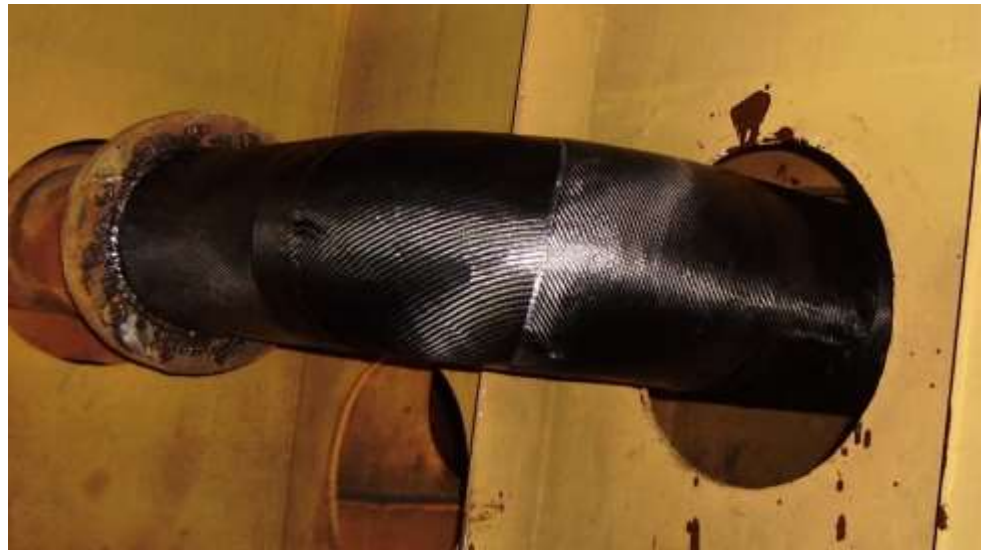
500m of BALLAST PIPING

Problem: 500m of corroded piping was leaking sea water.

Solution: The repair was conducted during the vessel's dry docking.

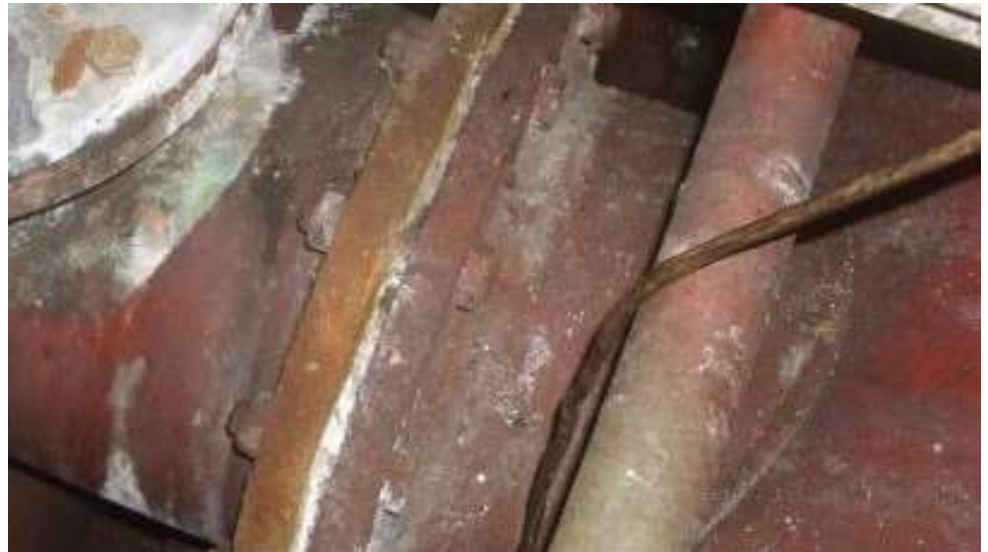
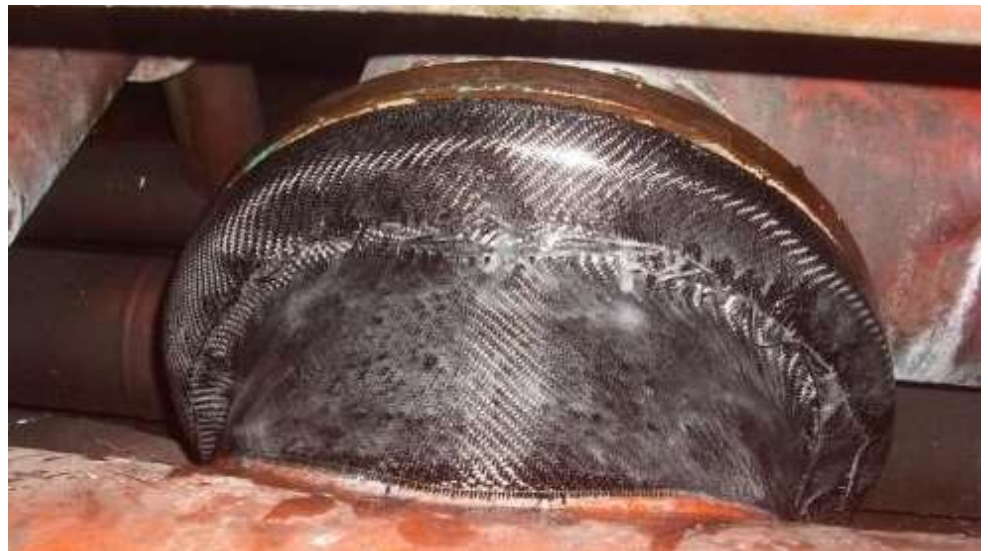
FLANGE ON MAIN SEA WATER INTAKE PIPE

Problem: Corroded flange was leaking sea water.

Solution: COMPA repair was conducted during the vessel's stay in port of Valencia.

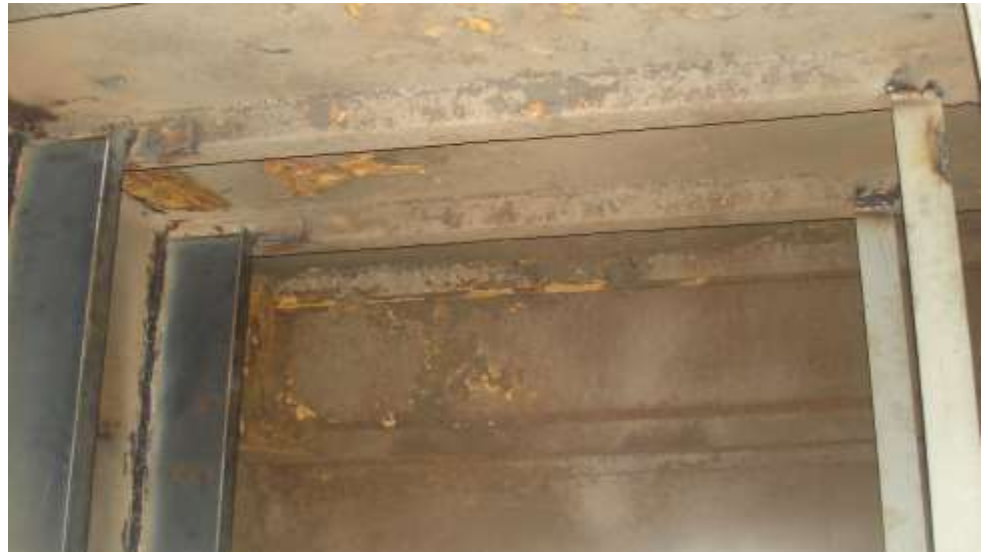
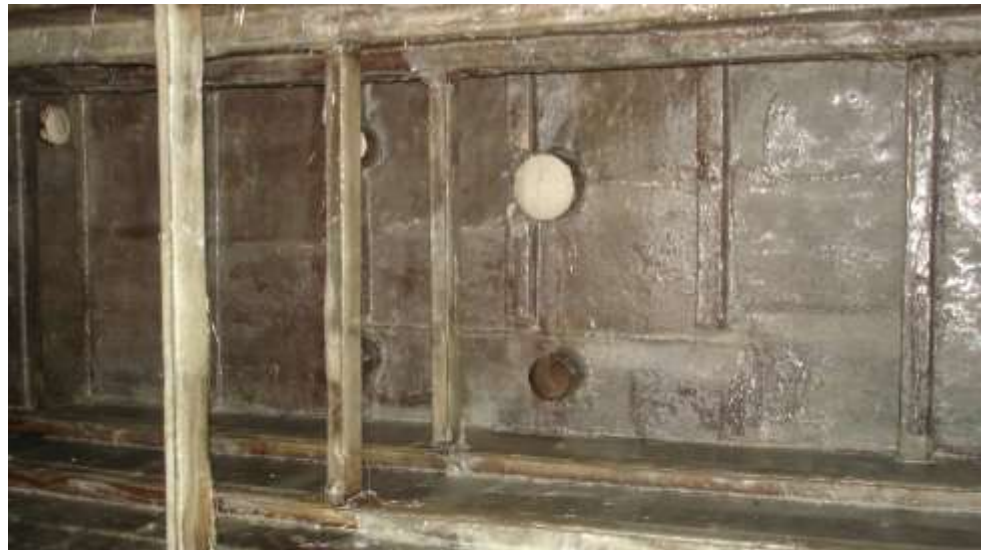
SEWAGE TANK

Problem: Sewage tanks' plating and profiles have undergone extensive corrosion.

Solution: The repair of the 300m² was conducted during the vessel's dry docking in Luxor, Egypt.

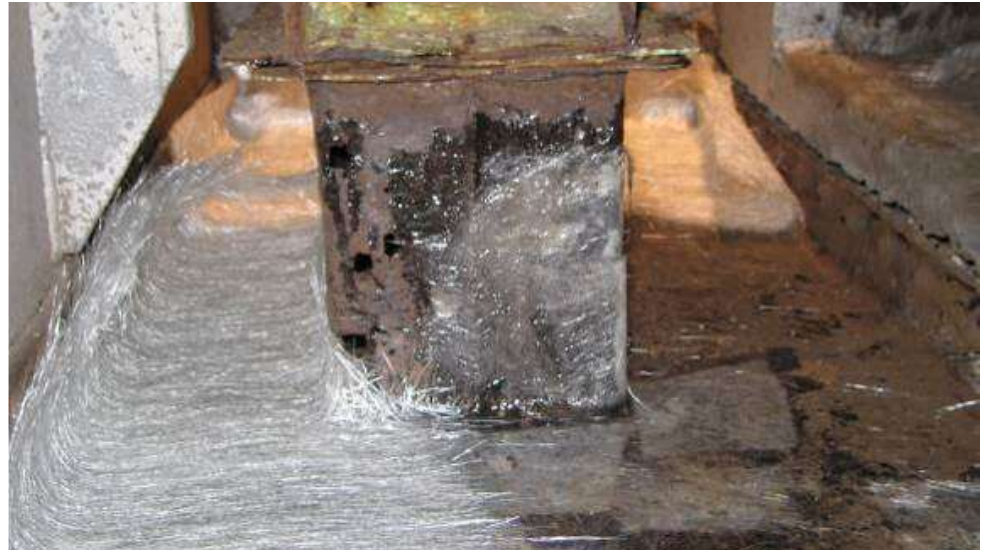
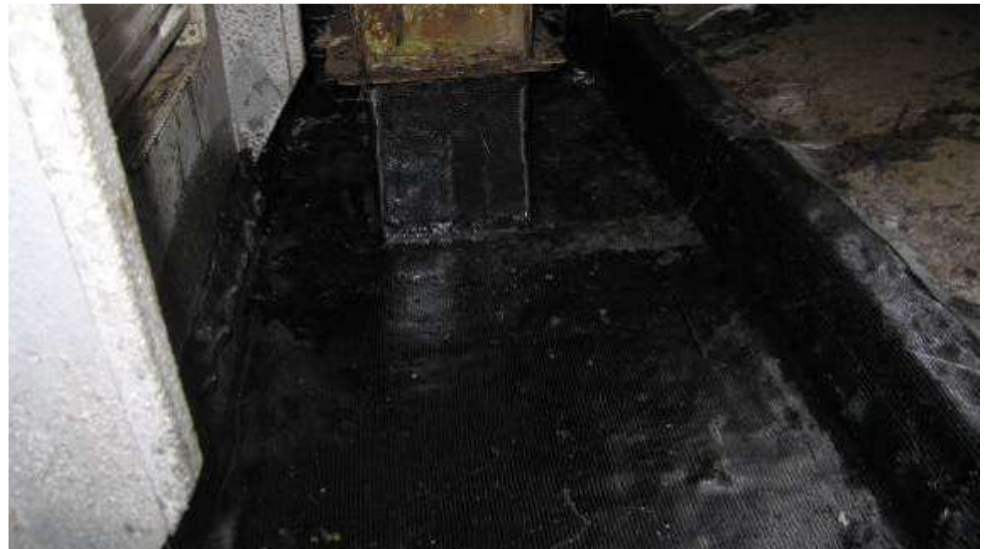
AIR-CONDITIONING UNIT SPACE

Problem: Air-conditioning unit's steel flange and floor exhibited heavy corrosion.

Solution: The repair was conducted during the vessel's dry docking.

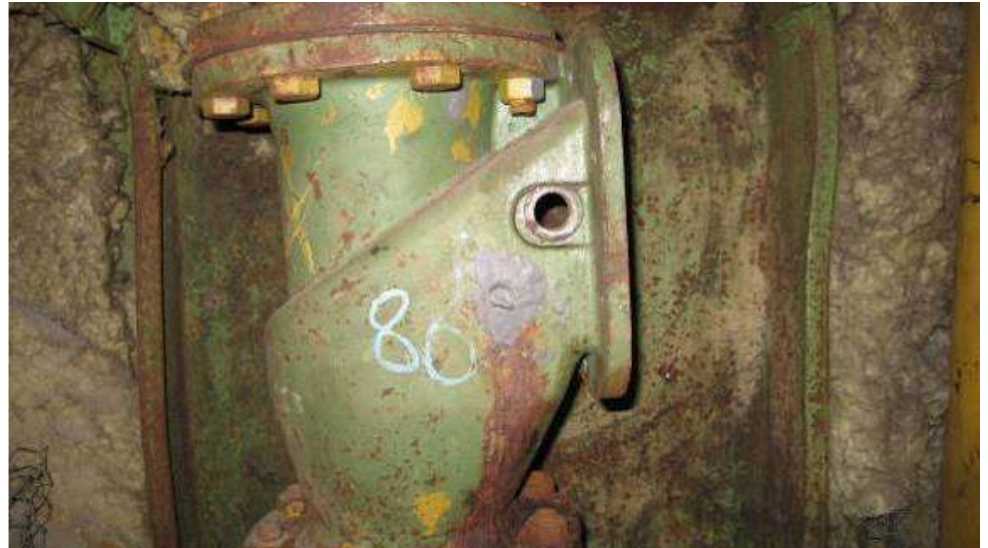
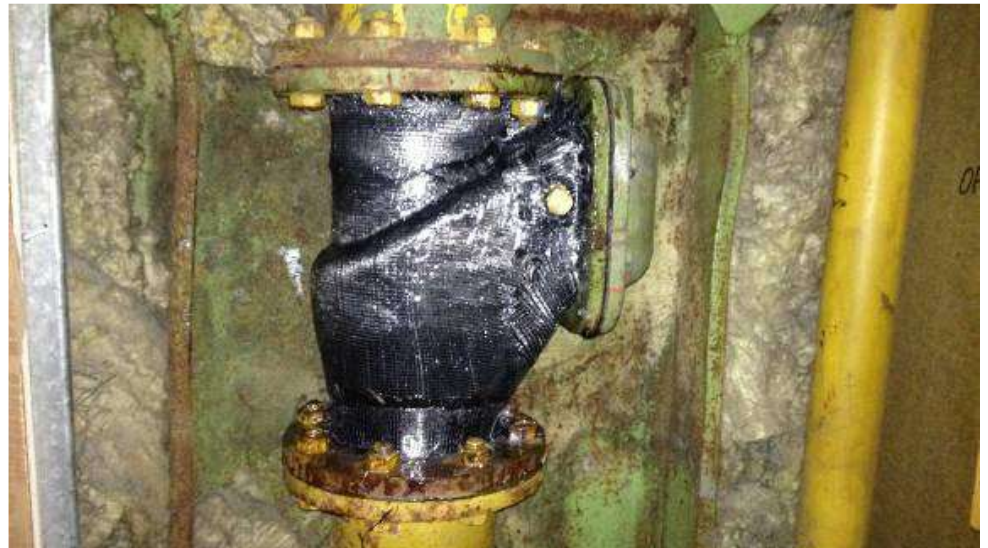
CLAPET VALVE

Problem: Two clapet valves have undergone extensive corrosion.

Solution: The repair was conducted during the vessel's dry docking.

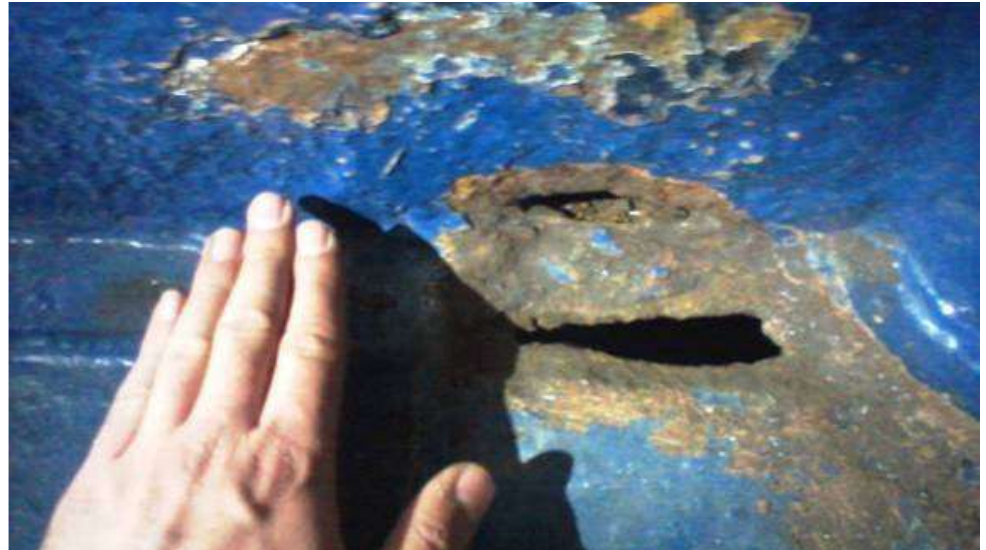
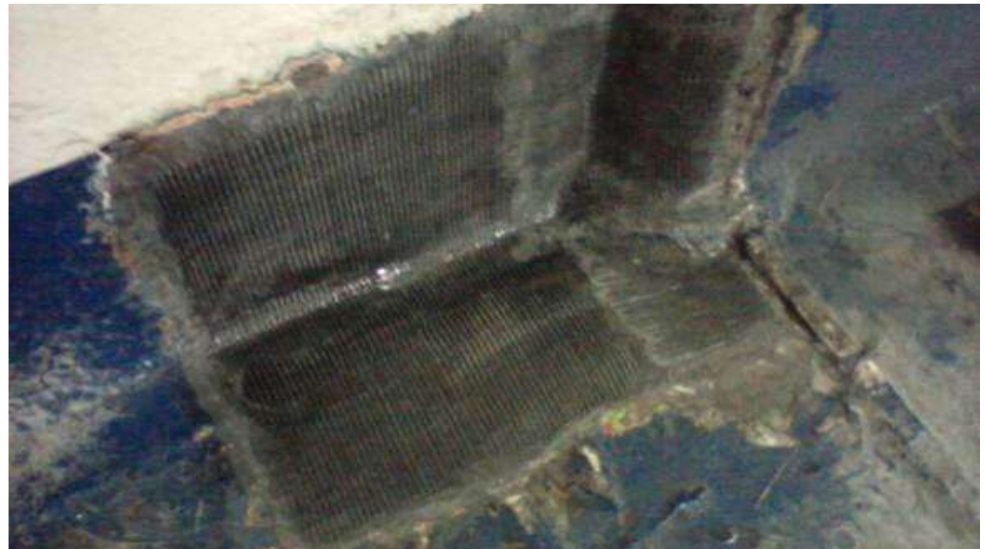
GARAGE FLOOR DETAIL

Problem: The damage on the garage floor was caused by severe corrosion in the corners where the water collects due floor inclination.

Solution: The repair was conducted during the vessel's dry docking.

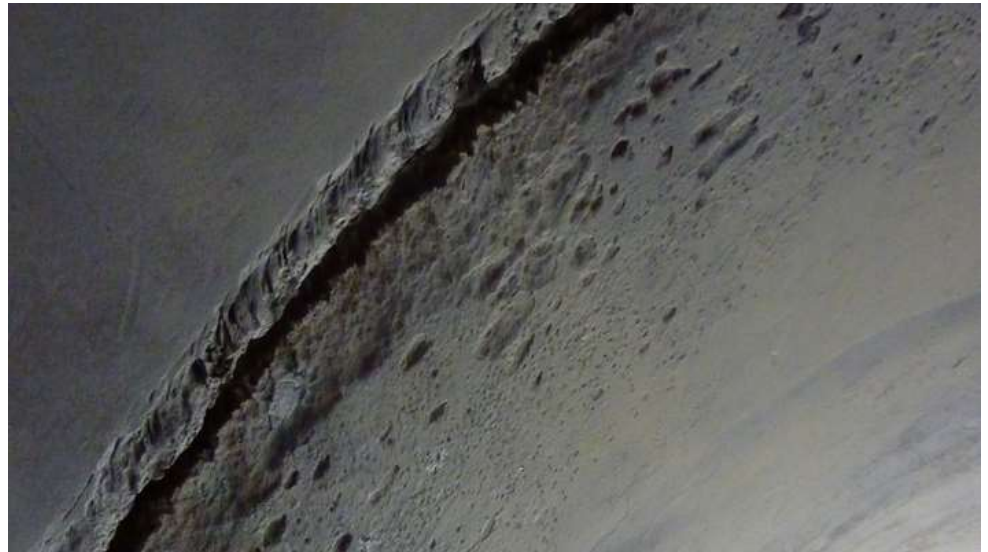
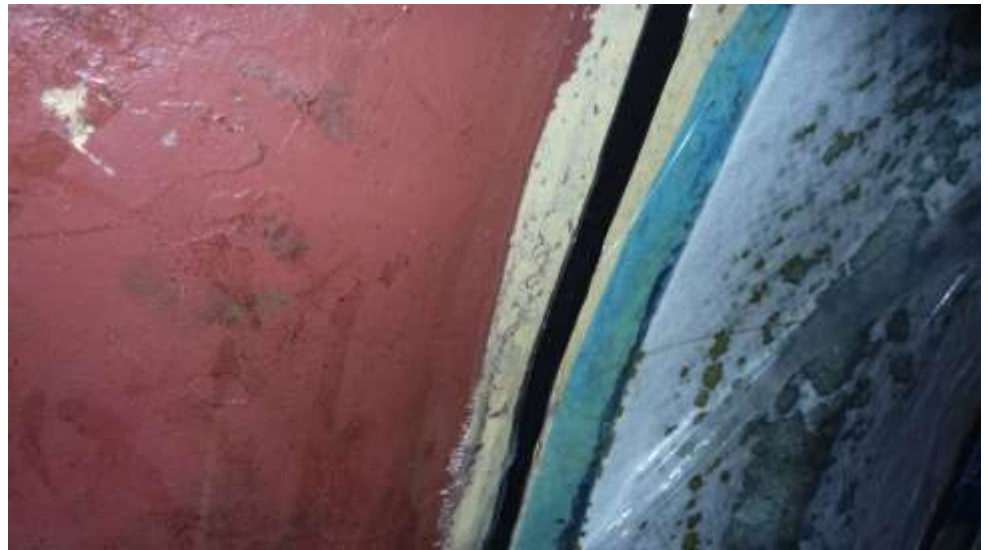
BOW THRUSTER TUNNEL

Problem: Bow thruster tunnel surface damage.

Solution: The repair was conducted during the vessel's dry docking.

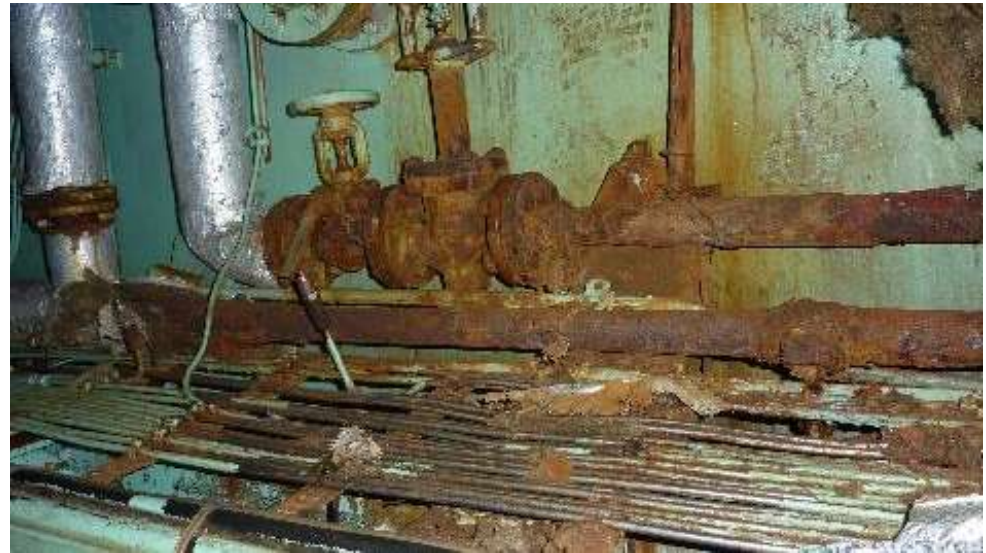
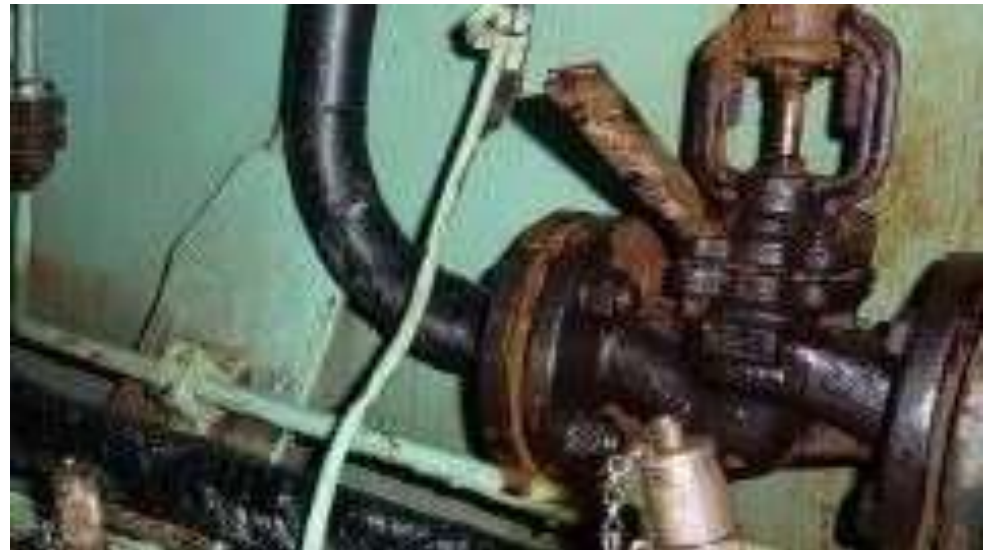
20m OF THERMAL OIL PIPING IN KEEL TUNNEL

Problem: The mineral-oil pipes, located in keel tunnel, were heavily corroded.

Solution: The repair was conducted during the vessel's dry docking.

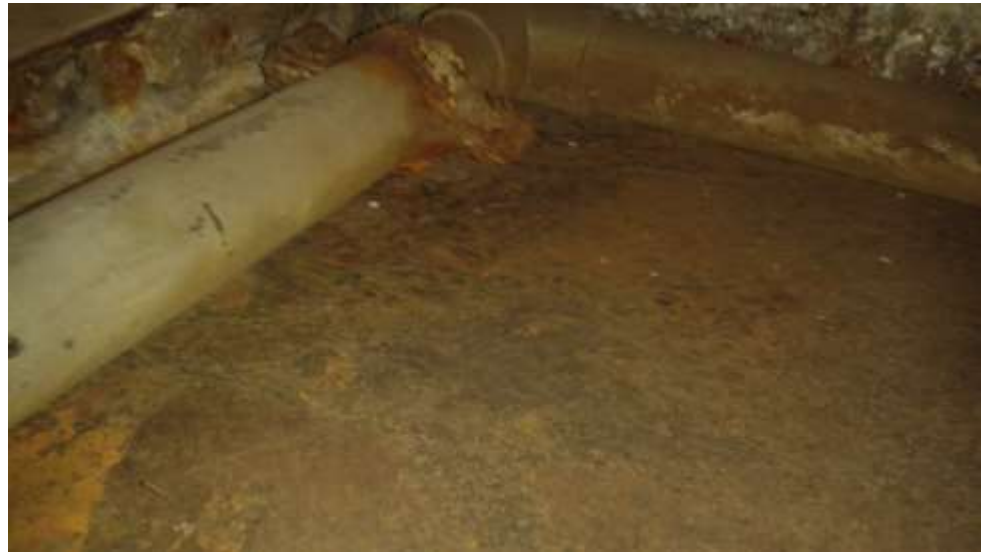
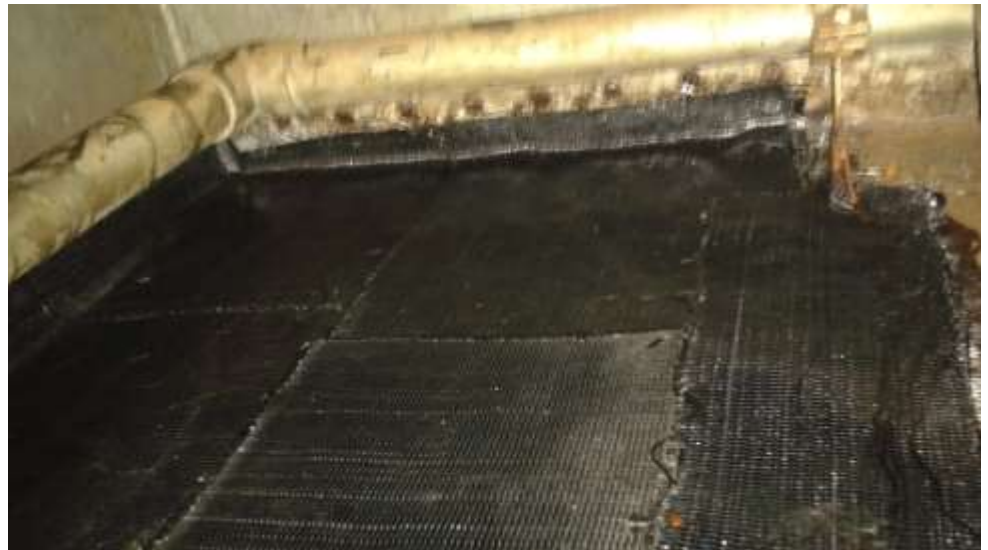
DECK UNDER AC STATION

Problem: Deck under AC station was leaking sea water.

Solution: The repair was conducted during the vessel's stay in port.

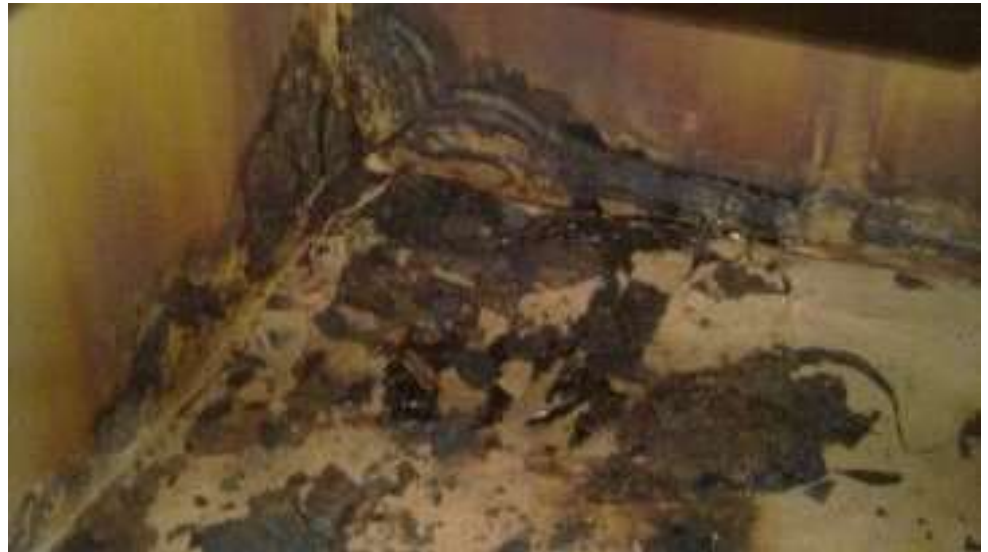
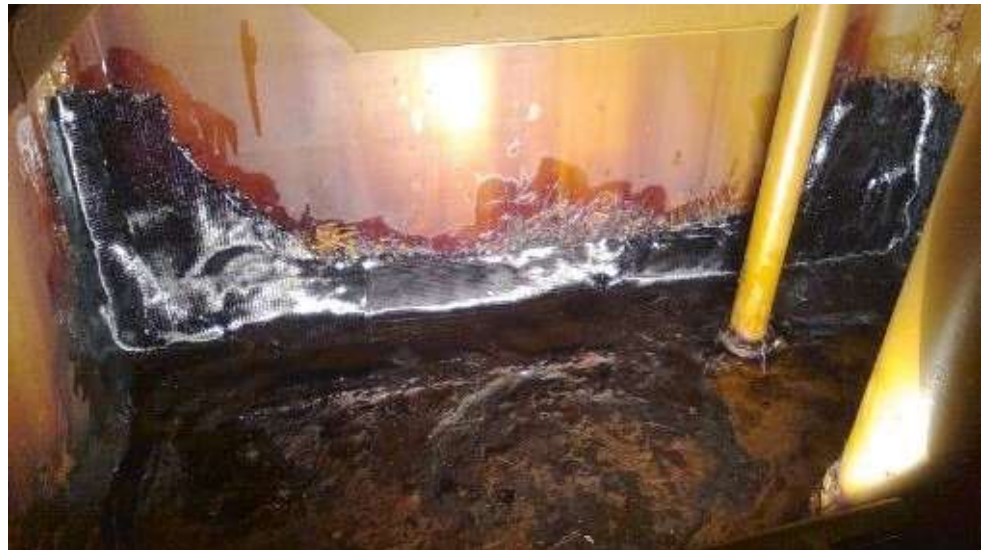
BULKHEAD OF THE BALLAST TANK

Problem: Heavily corroded bulkhead was leaking HFO.

Solution: The repair was conducted during the vessel's stay in Savona port.

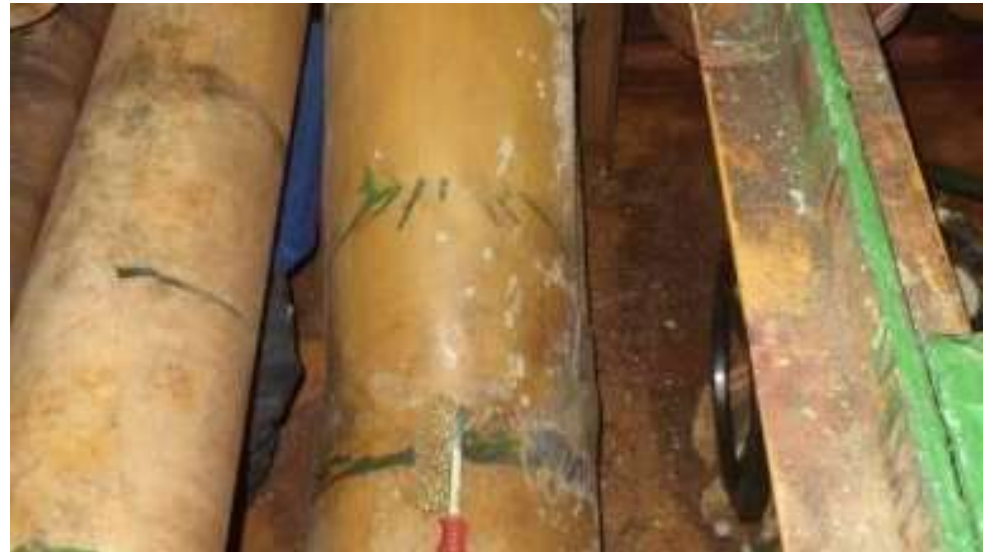
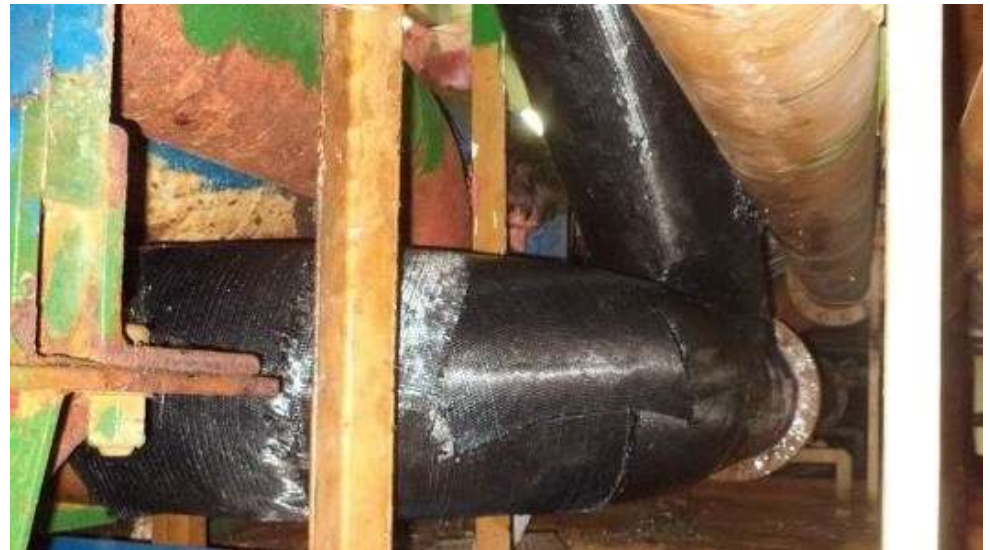
Y-JUNCTION BALLAST INTAKE PIPE

Problem: Heavily corroded Y-junction was leaking sea water.

Solution: Conducted during the vessel's stay in Salerno port.

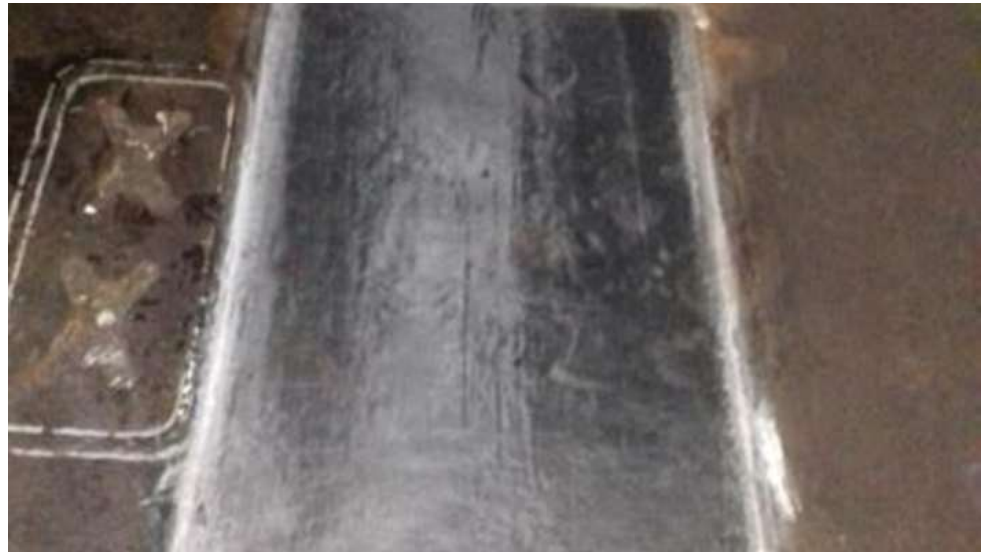
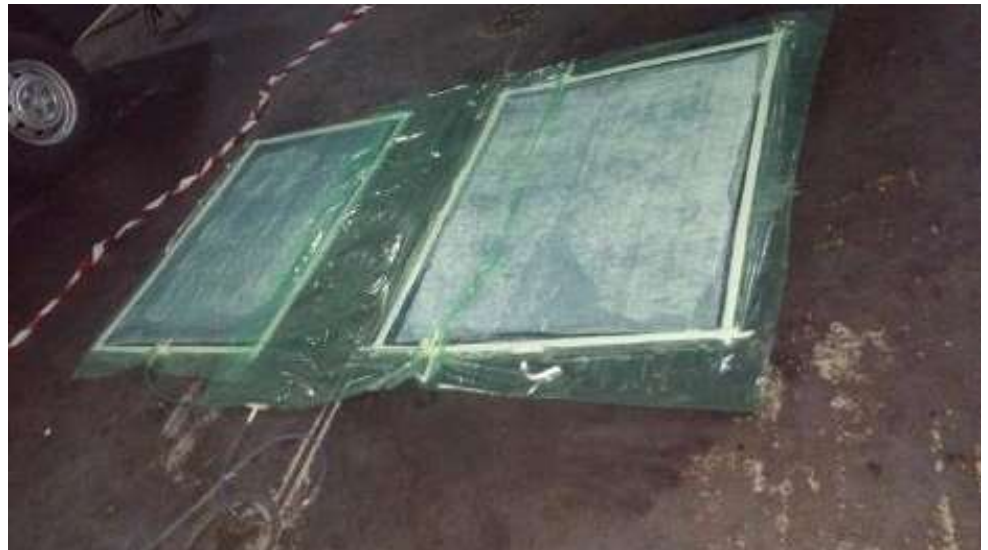
HFO TANK TOP

Problem: Cracked tank top was leaking HFO in rough seas.

Solution: Conducted during the vessel's stay in Savona port.

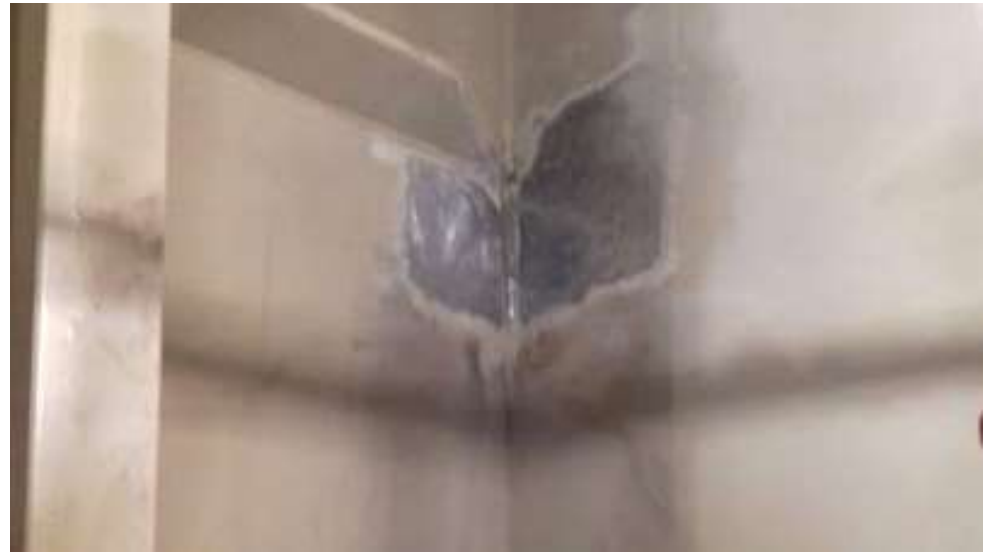
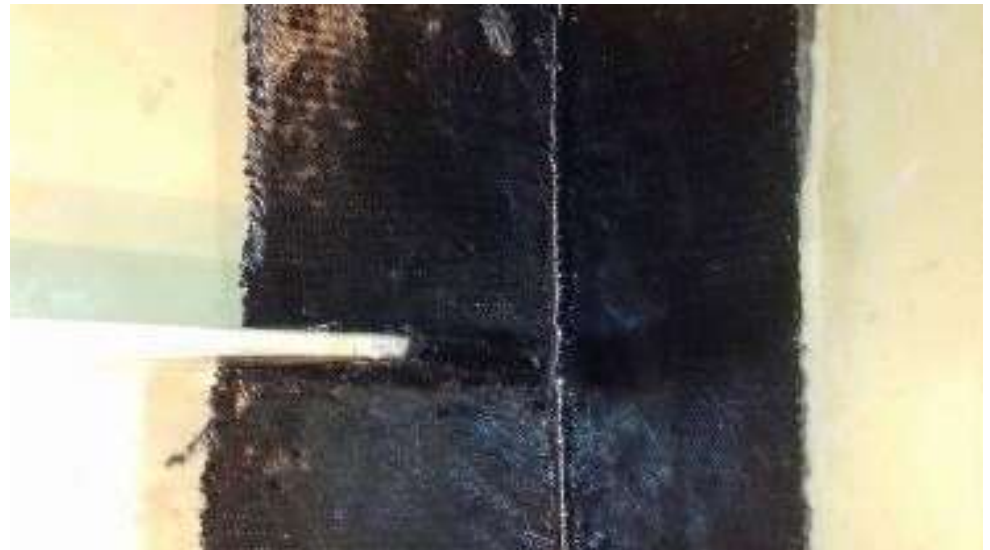
BULKHEAD OF THE MDO FUEL TANK

Problem: Cracked bulkhead was leaking MDO.

Solution: Repair was conducted during the vessel's stay in Antwerp port.

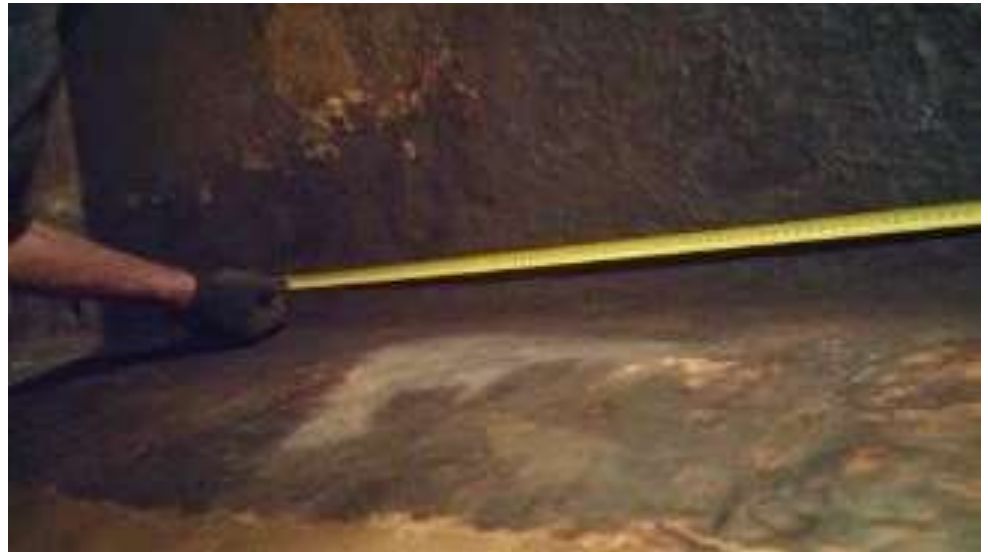
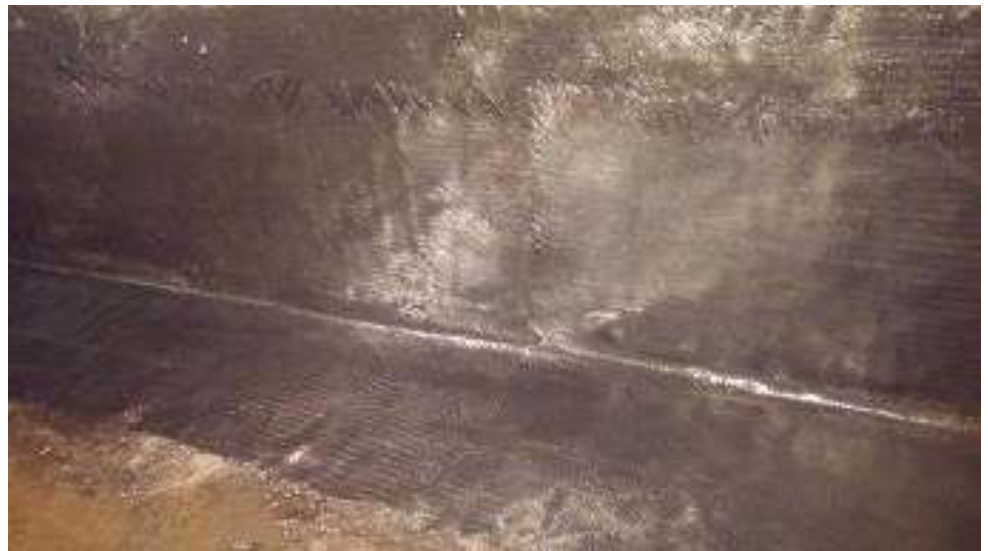
BULKHEAD OF THE HFO FUEL TANK

Problem: A heavily corroded bulkhead was leaking HFO.

Solution: Repair was conducted during the vessel's voyage from Le Havre to Antwerp.

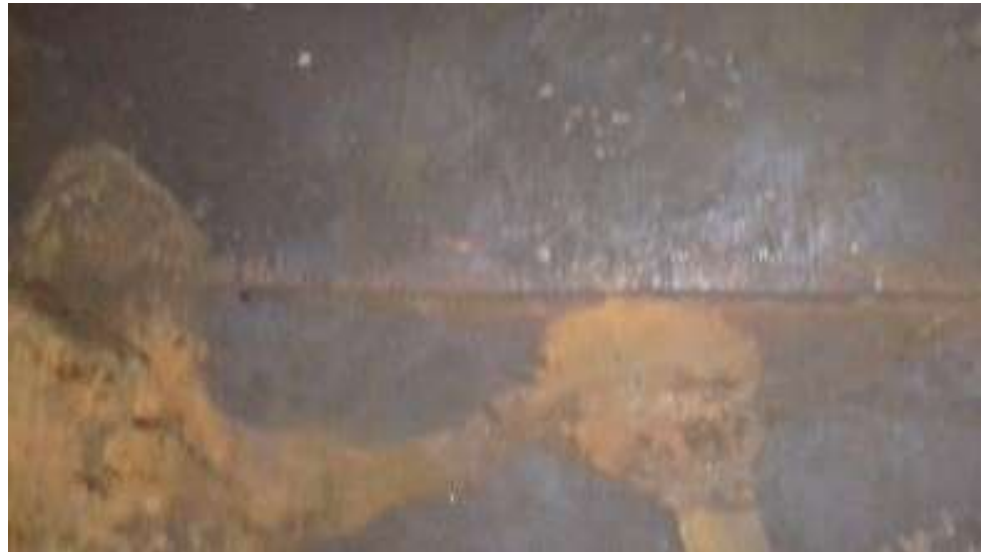
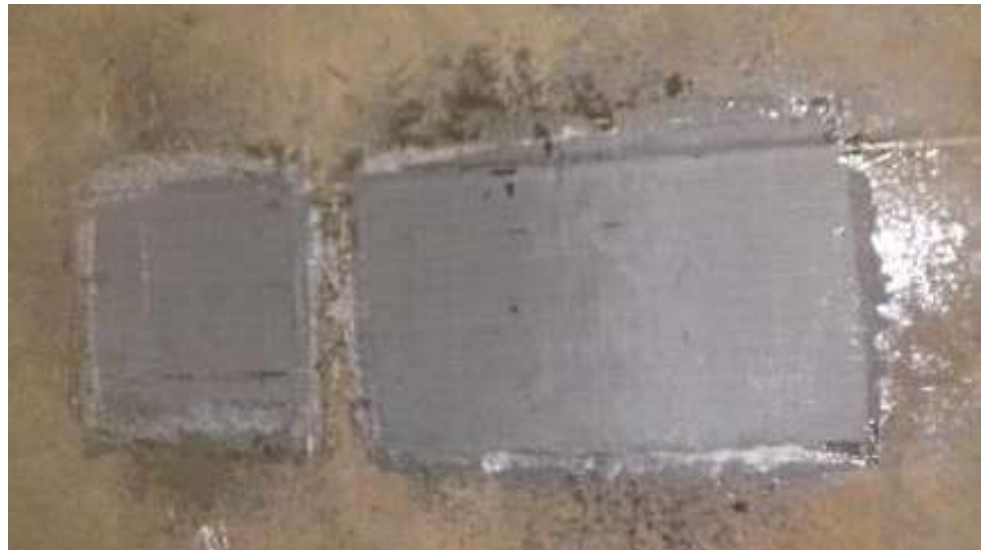
HFO TANK TOP

Problem: A heavily corroded bulkhead was leaking HFO.

Solution: Repair of 5 cracks was conducted during the vessel's stay in Antwerp port.

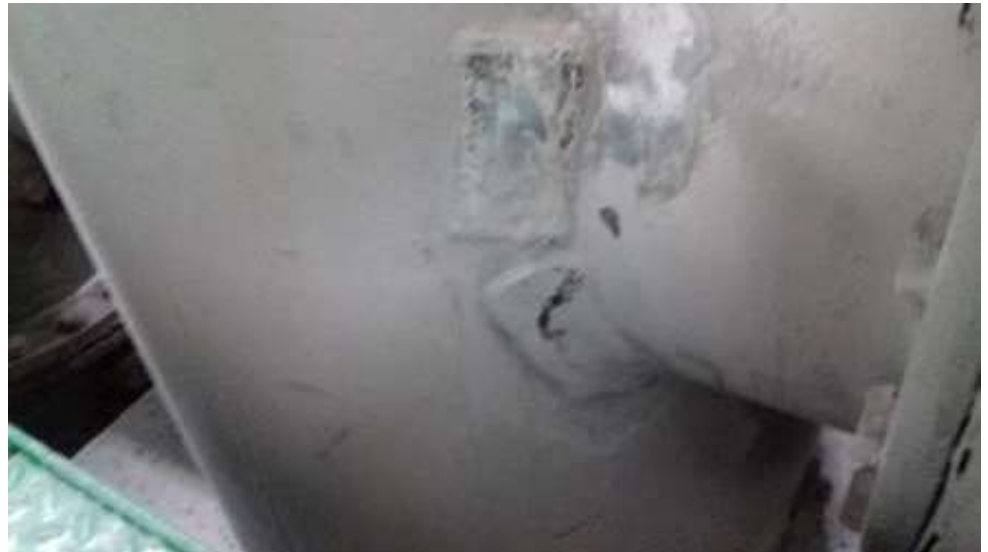
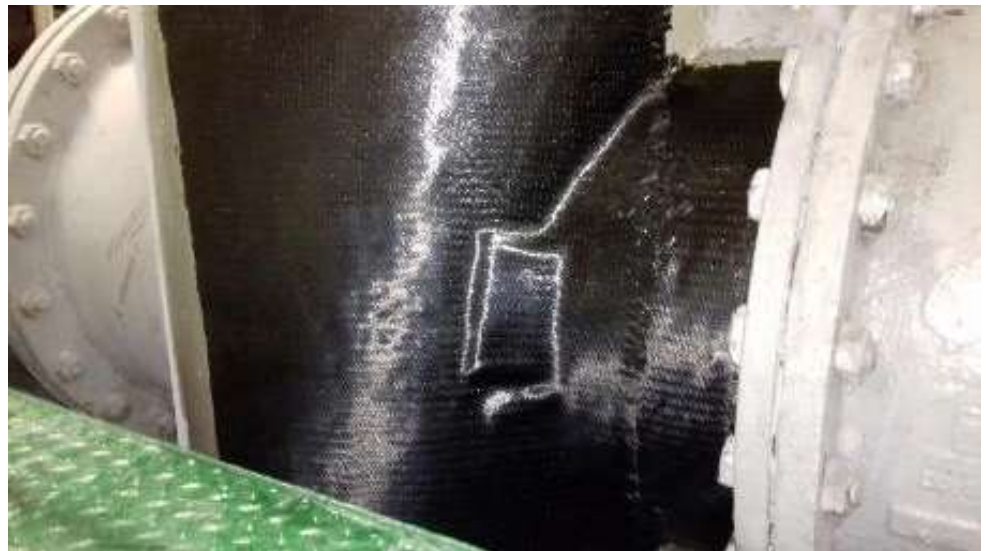
SEA CHEST

Problem: Corrosion on the inner side caused leakage of the sea water.

Solution: Repair was conducted during the vessel's stay in Antwerp port.

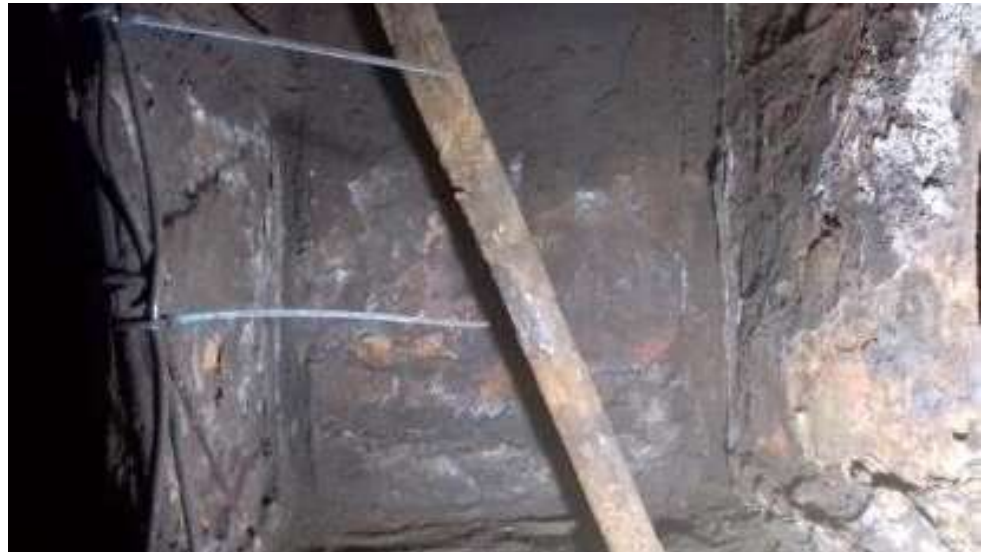
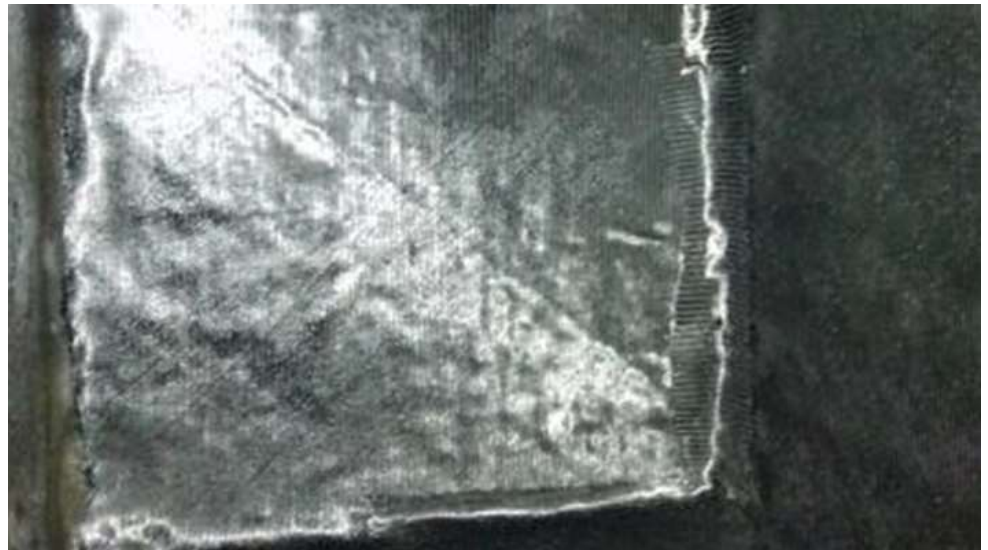
BALLAST TANK IN DOUBLE BOTTOM

Problem: Multiple bulkheads and the tank top were corroded and leaking sea water.

Solution: Repair was conducted during the vessel's voyage from Hamburg to Antwerp.

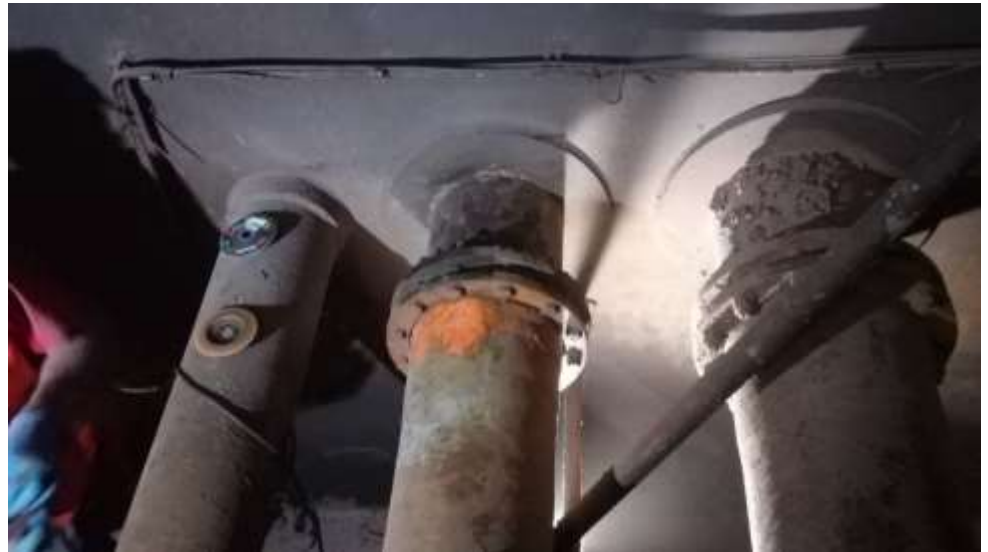
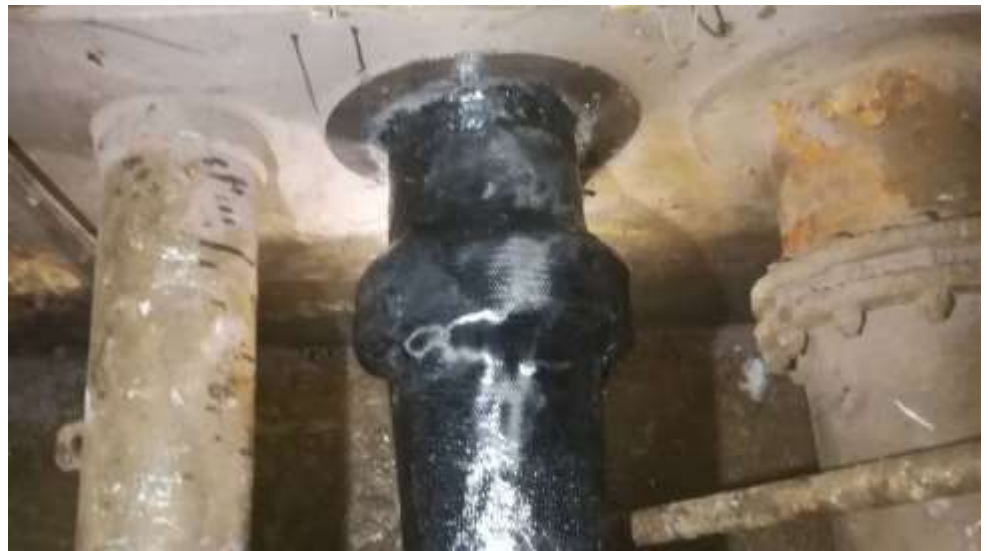
BALLAST PIPE IN HEELING TANK

Problem: Flange connecting steel and fibreglass pipe was corroded and leaking sea water.

Solution: Repair was conducted during the vessel's stay in Antwerp port.

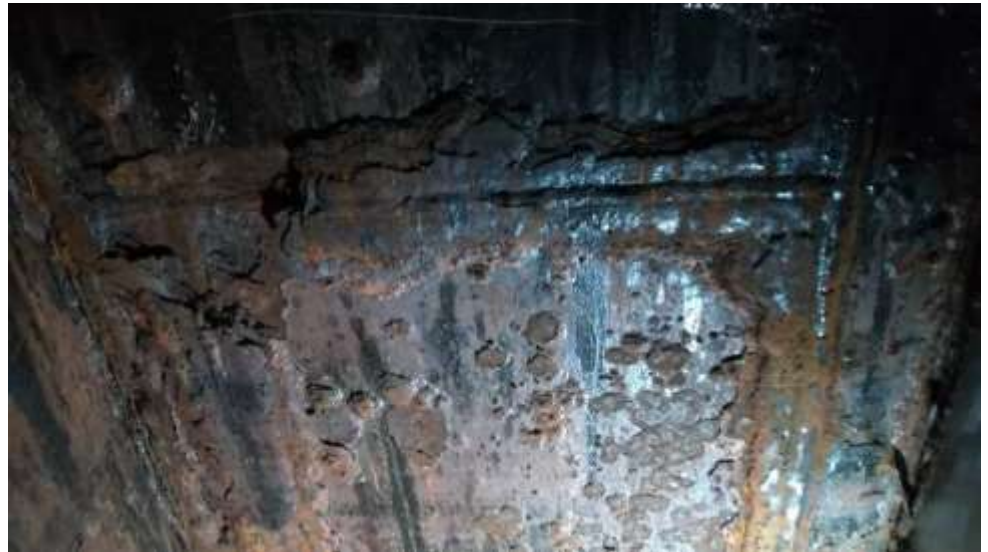
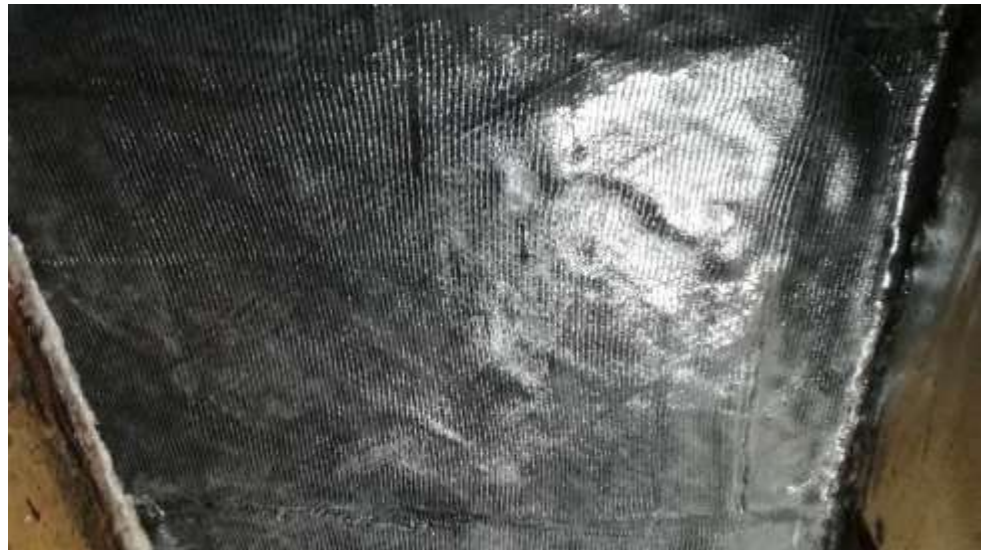
BULKHEAD BETWEEN BALLAST AND HFO TANK

Problem: The bulkhead was corroded and it was leaking HFO into the ballast tank.

Solution: Repair's conducted during the vessel's stay in Antwerp port.

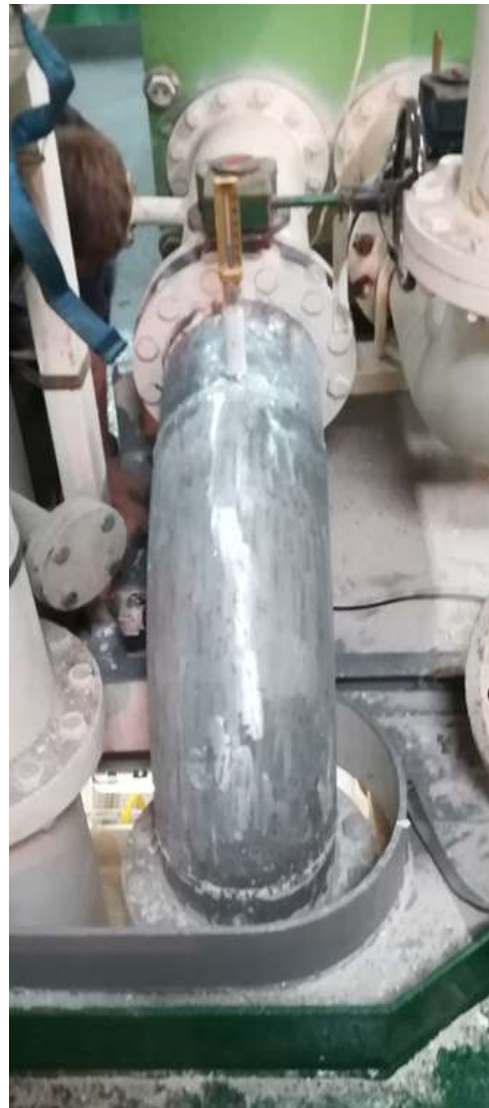
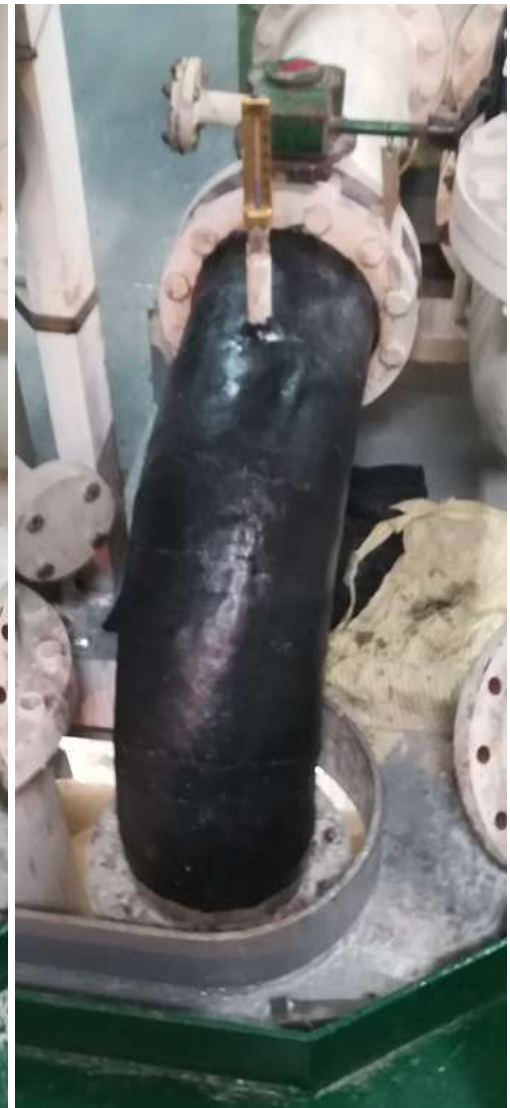
BALLAST PIPE IN ENGINE ROOM

Problem: Multiple pipes were corroded and leaking sea water.

Solution: Repair was conducted during the vessel's stay in Antwerp port.
