COMPAREPAIRS
Repairs and
Reinforcements with
Composite Materials

**Technology Overview and
Application Cases**

COMPA Repairs cases of completed repairs

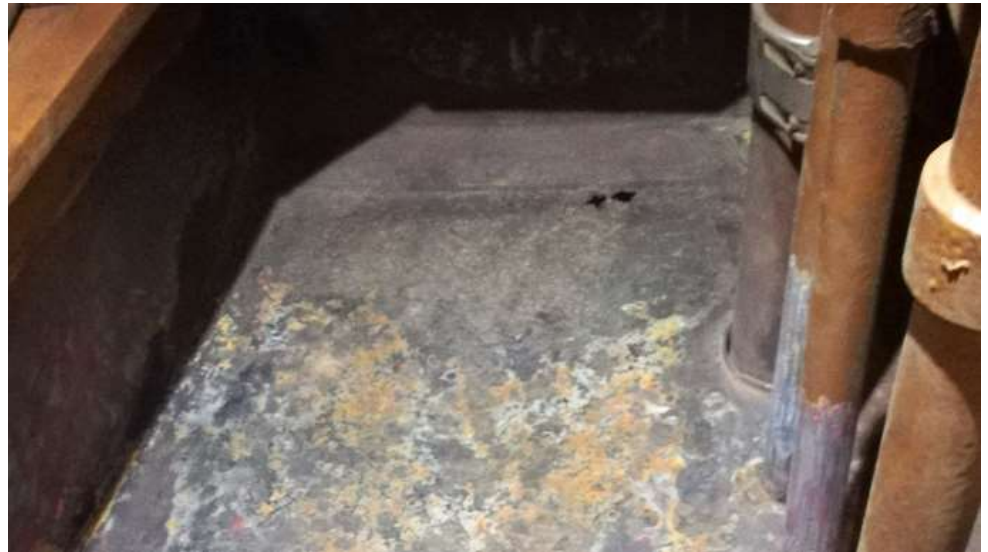
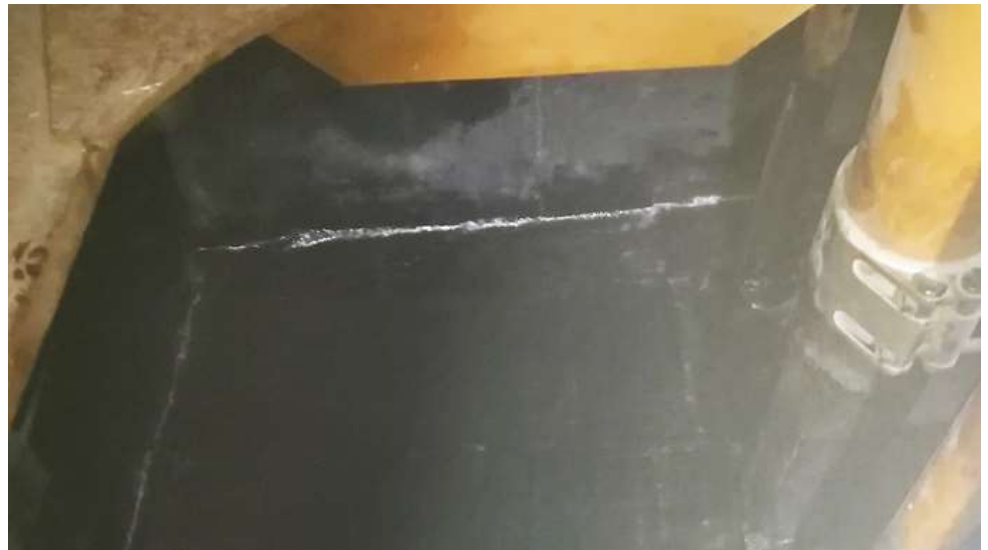
HEELING TANK FLOOR AND BALLAST TANK BULKHEAD

Problem: The ballast tank floor and bulkhead were corroded and HFO was leaking into the ballast and heeling tanks from adjacent tank.

Solution: Repair was conducted during the vessel's sail.

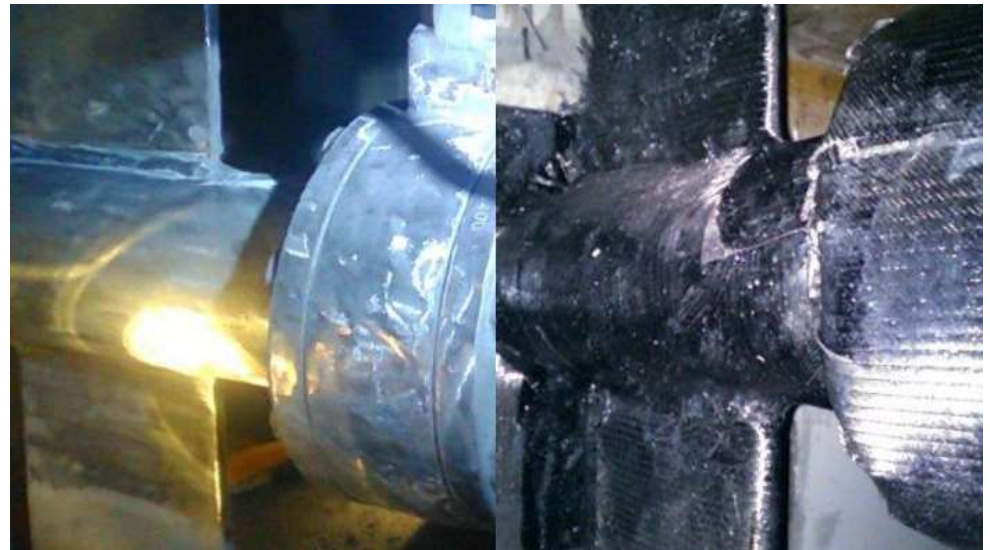
SEA WATER PIPE ON AN LNG CARRIER

Problem: Sea water pipe was corroded and leaking water.

Solution: Repair was conducted during the vessel's stay in Rotterdam port.

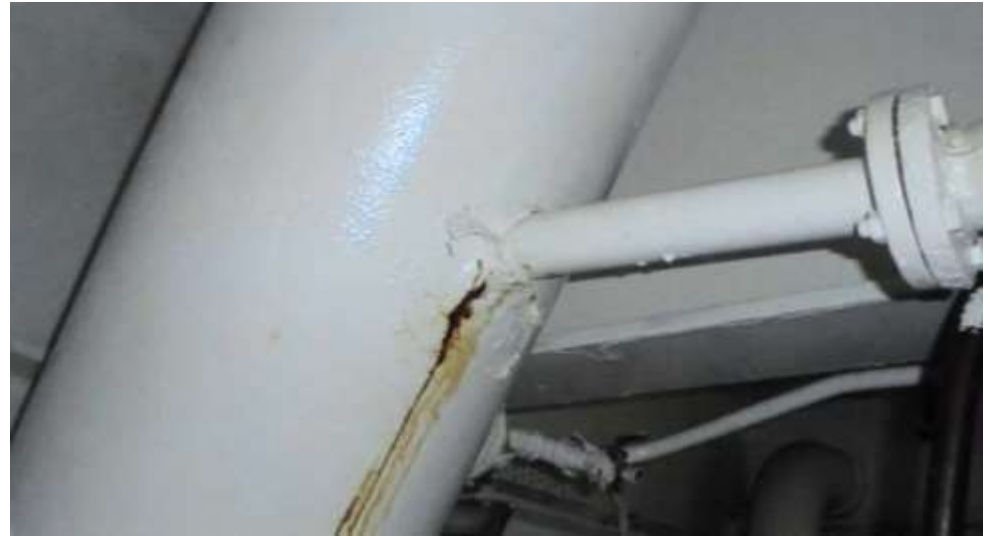
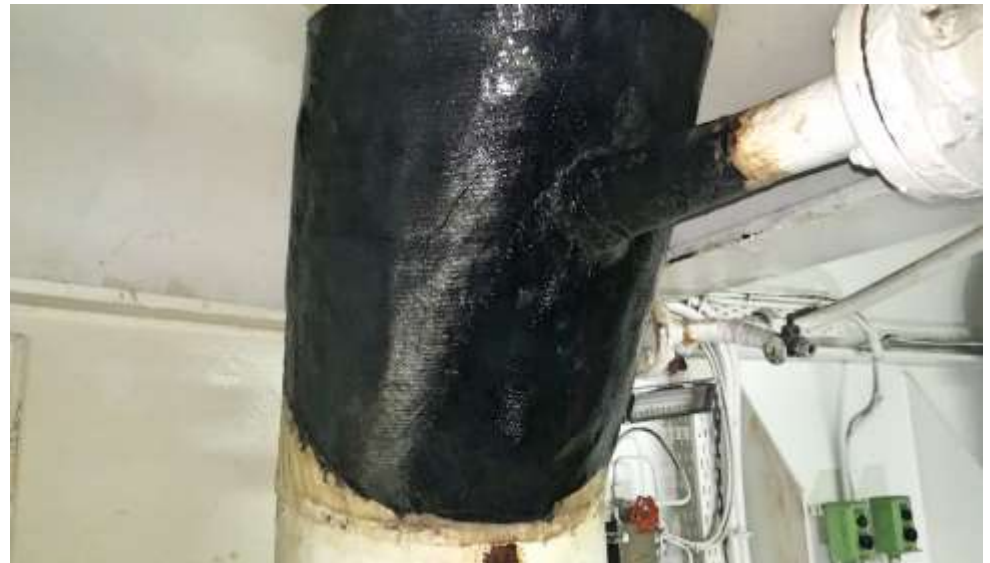
SEA WATER PIPE ON RO-RO SHIP

Problem: Sea water pipe was corroded and leaking water.

Solution: Repair was conducted during the vessel's stay in Antwerp port.

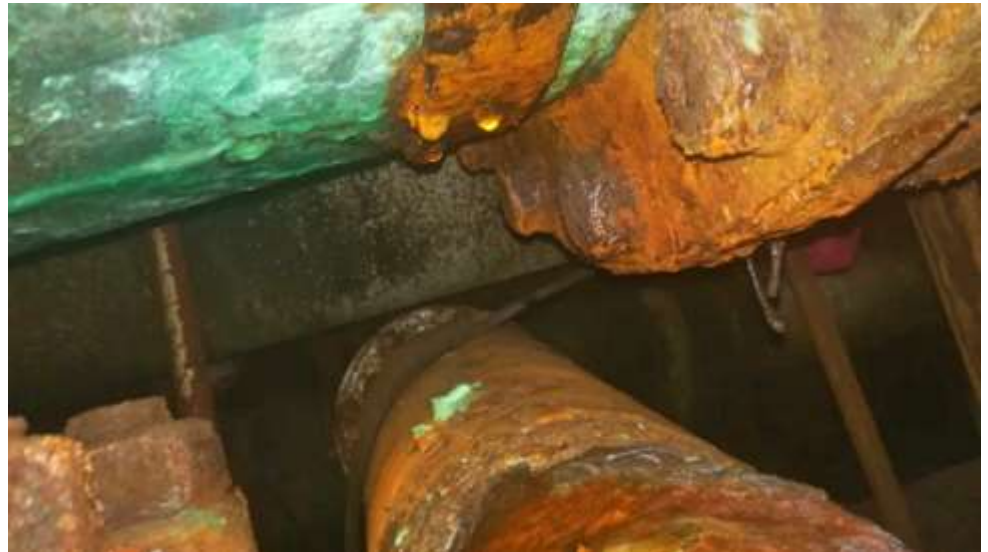
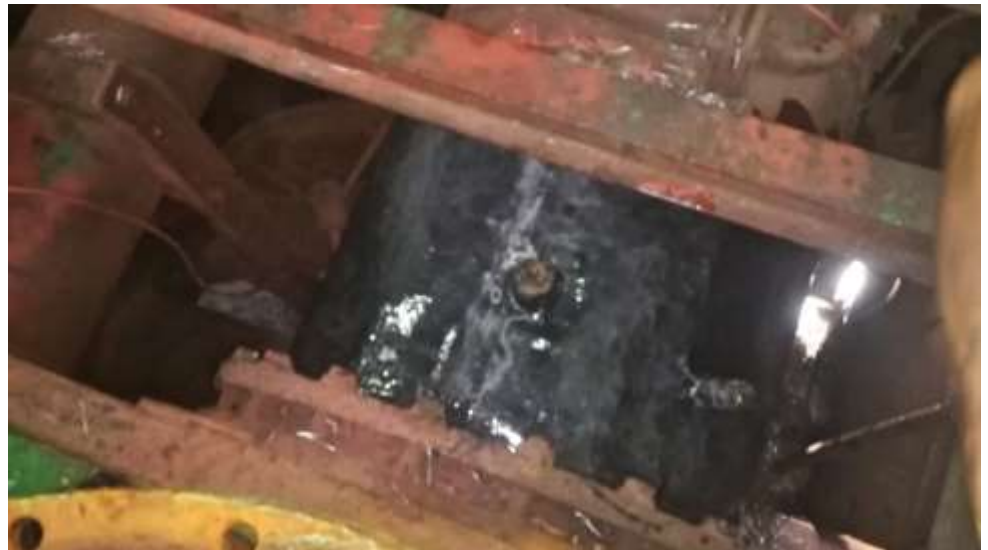
CORRODED MAIN SEA WATER PIPE

Problem: COMPA patches needed to be applied from the inside and the outside of leaking main sea water pipe.

Solution: Repair was conducted during the vessel's stay in Genova port.

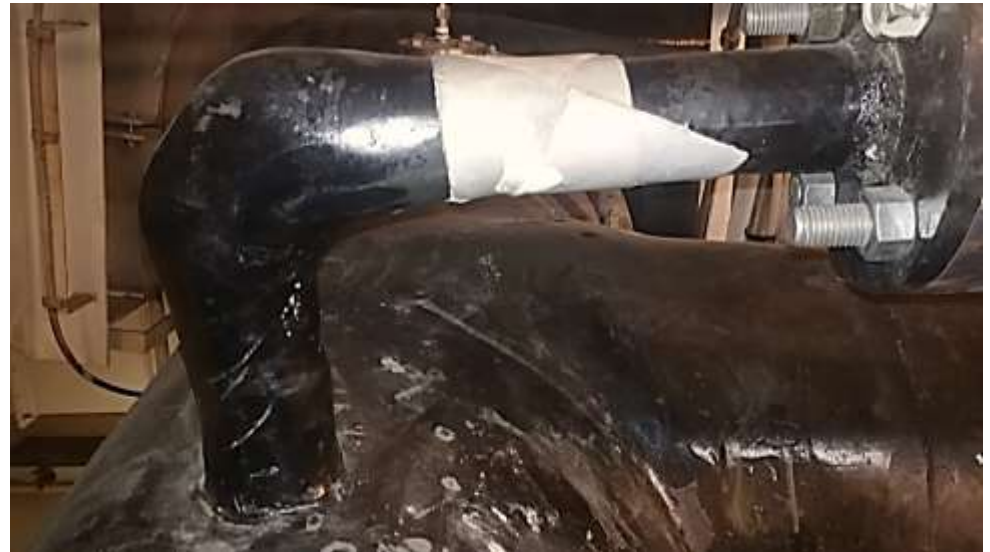
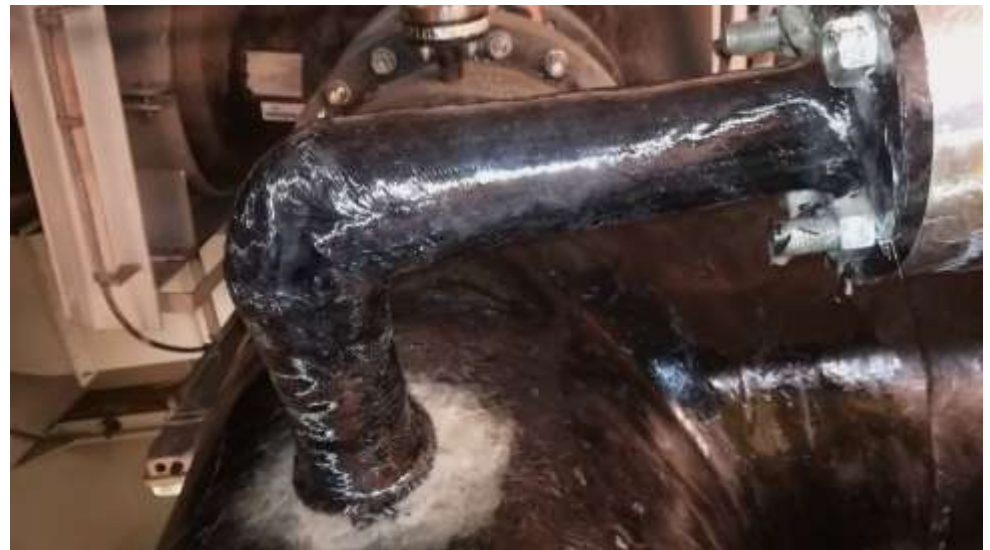
SCRUBBER SYSTEM NaOH PIPE

Problem: The pipe was unsuccessfully repaired using glass fibres, so COMPA patch was applied to stop the leakage.

Solution: Repair was conducted during the vessel's stay in Antwerp port.

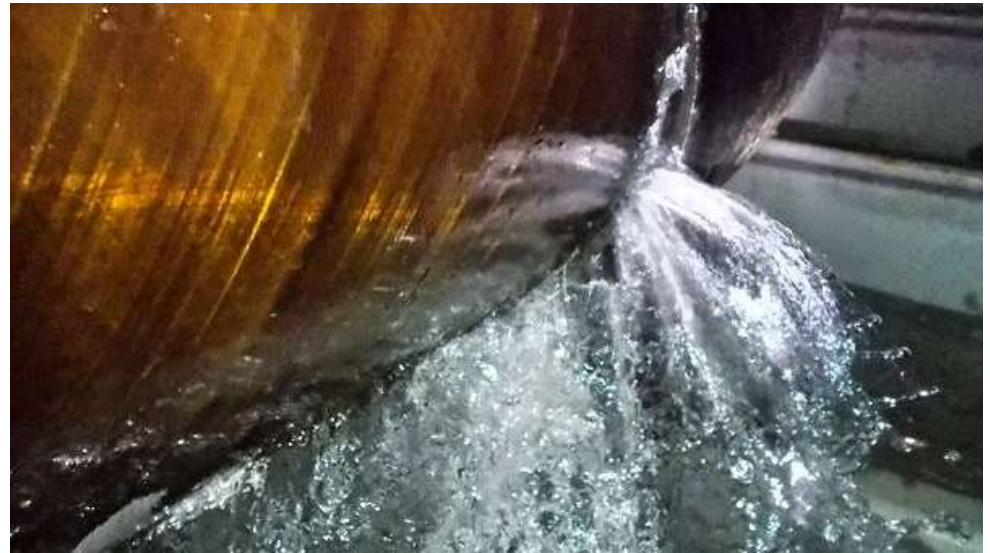
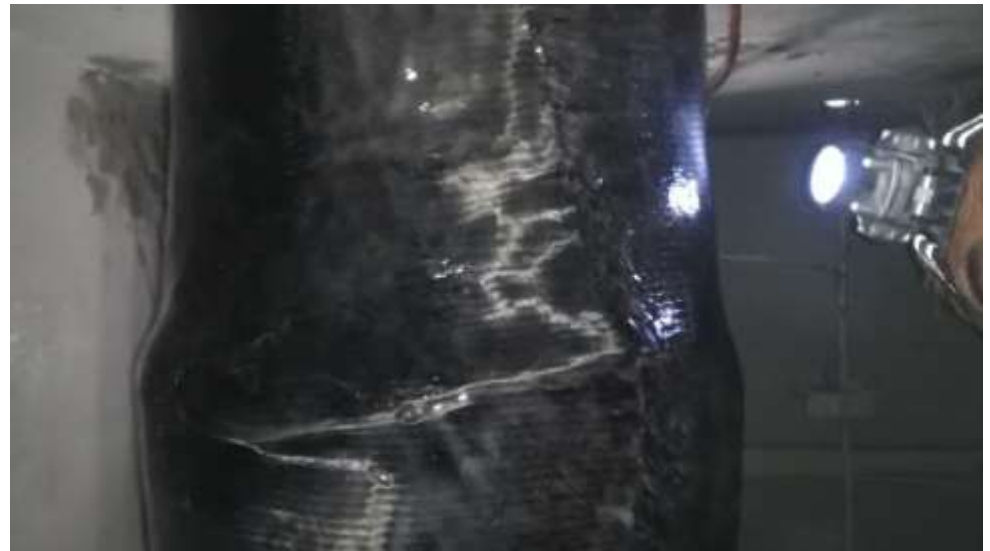
THE ANTI-HEELING SYSTEM PIPE

Problem: The anti-heeling system had a large crack in the glass-fibre pipe and was leaking heavily.

Solution: Repair was conducted during navigation between Hamburg and Antwerp ports.

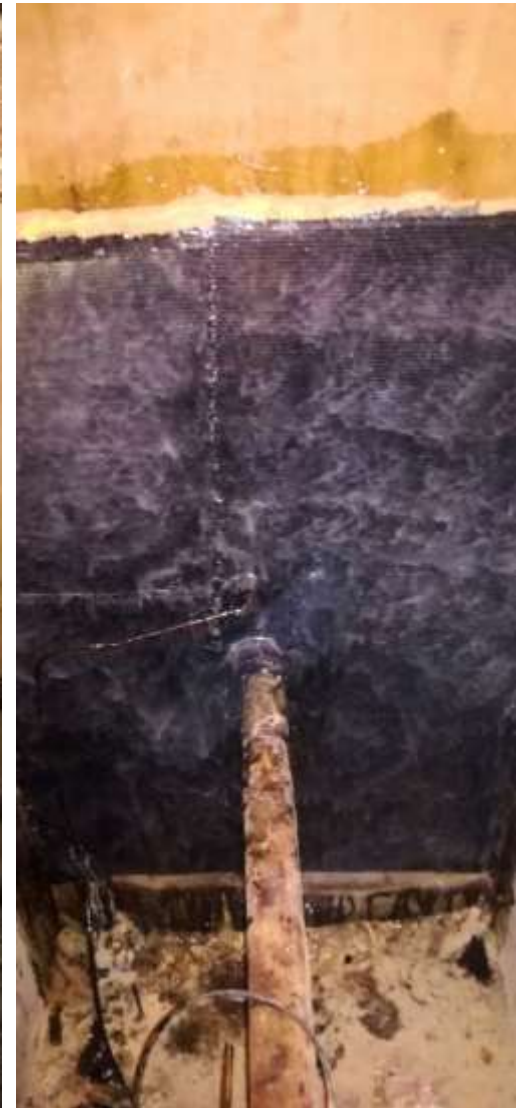
TANK BULKHEAD

Problem: The leakage of heavy fuel occurred on the blind manhole between water ballast and heavy fuel tank.

Solution: Repair was conducted during the vessel's stay in Antwerp port.

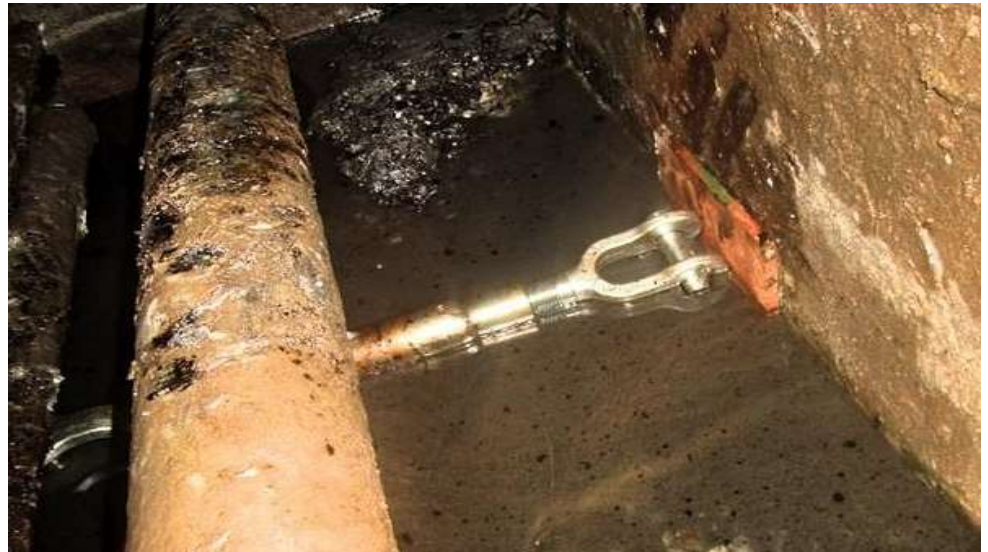
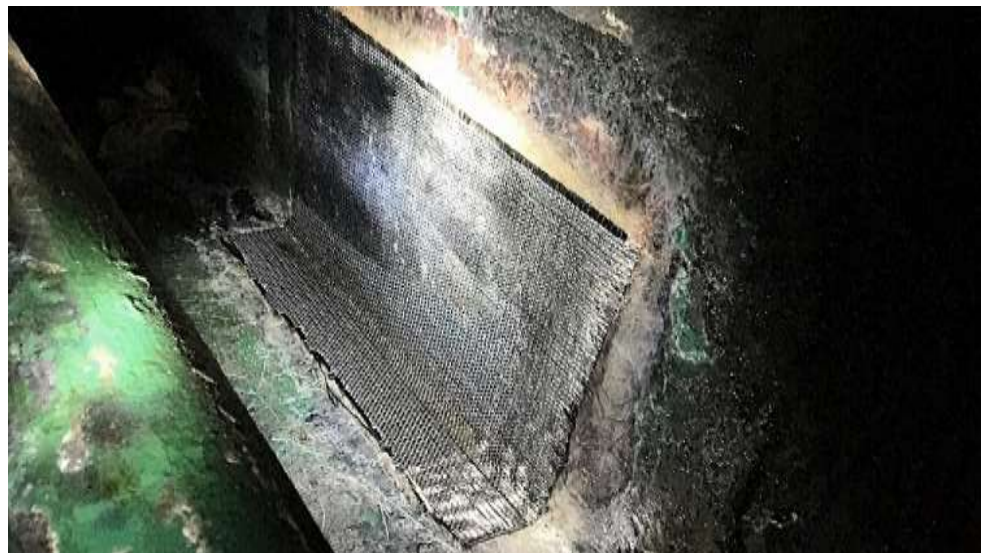
LEAKING FUEL TANK

Problem: The crack appeared on tank plate between ballast and heavy fuel tank and the fuel was leaking into the ballast tank.

Solution: Repair was conducted during the vessel's stay in Genova port.

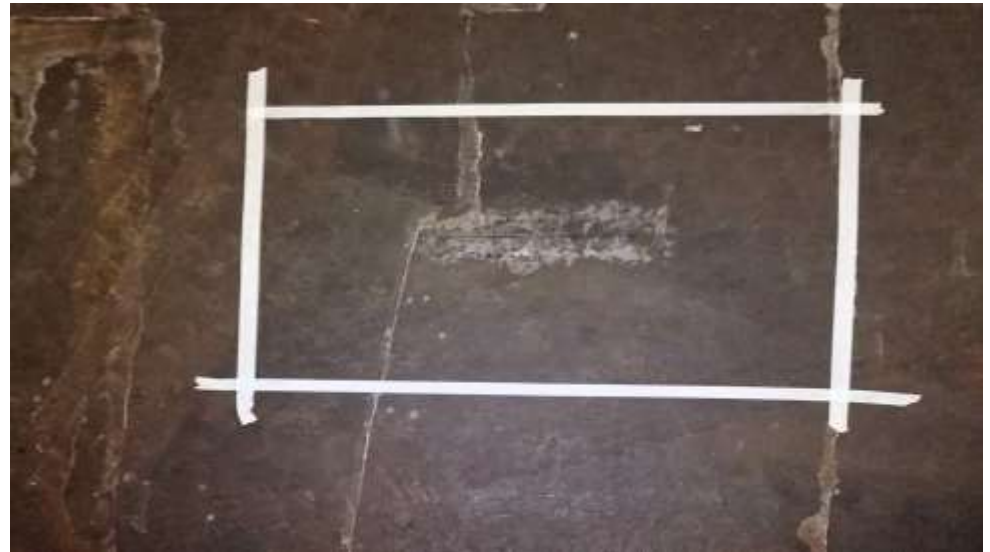
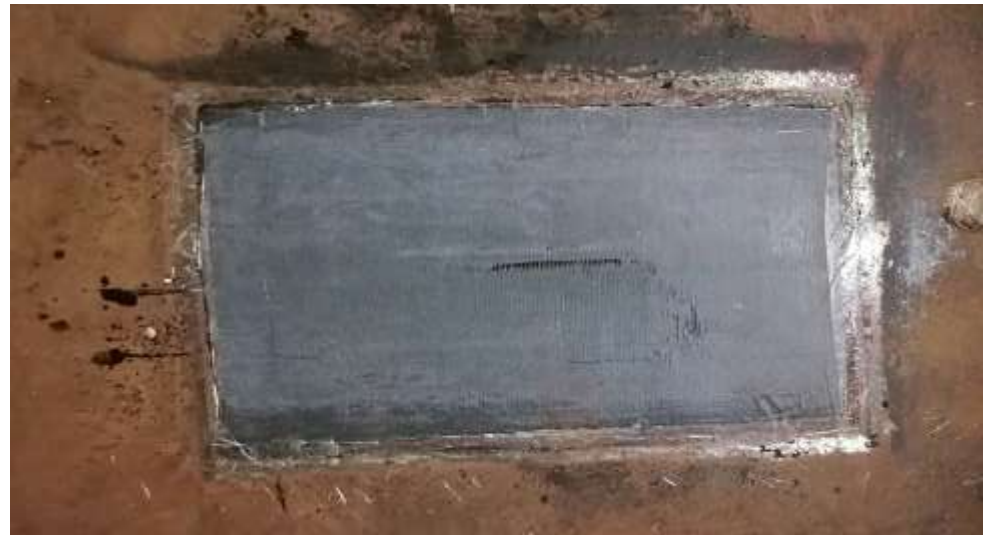
CRACKED HFO DOUBLE BOTTOM TANKS

Problem: Two cracks of about 30 cm in length appeared on the double bottom plating just above HFO tank.

Solution: Repair was conducted during the vessel's stay in Antwerp port.

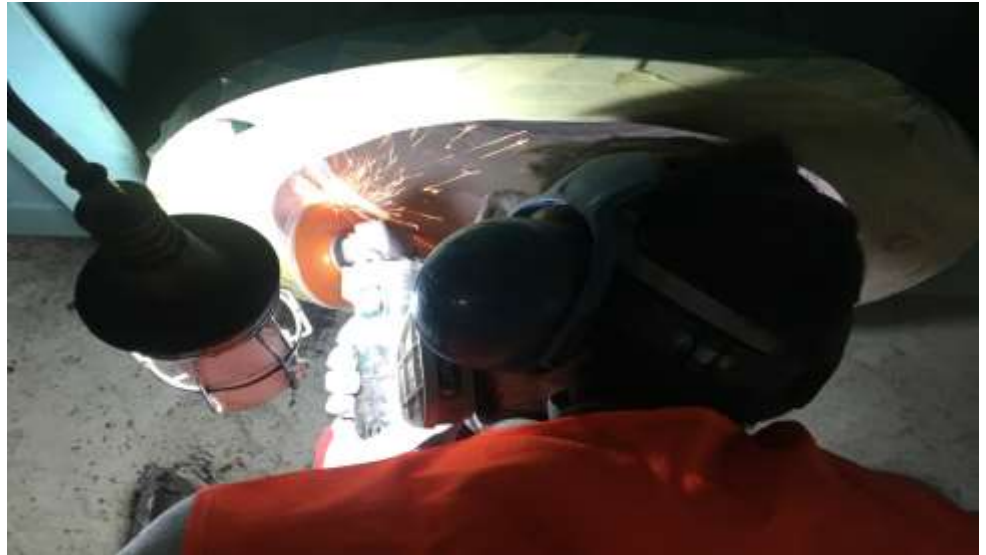
FLANGE ON THE PROCESS TANK

Problem: Acidic medium caused the crack and the leakage of the flange of the process tank that is a part of the scrubber system.

Solution: Repair was conducted during the vessel's stay in Civitavecchia port.

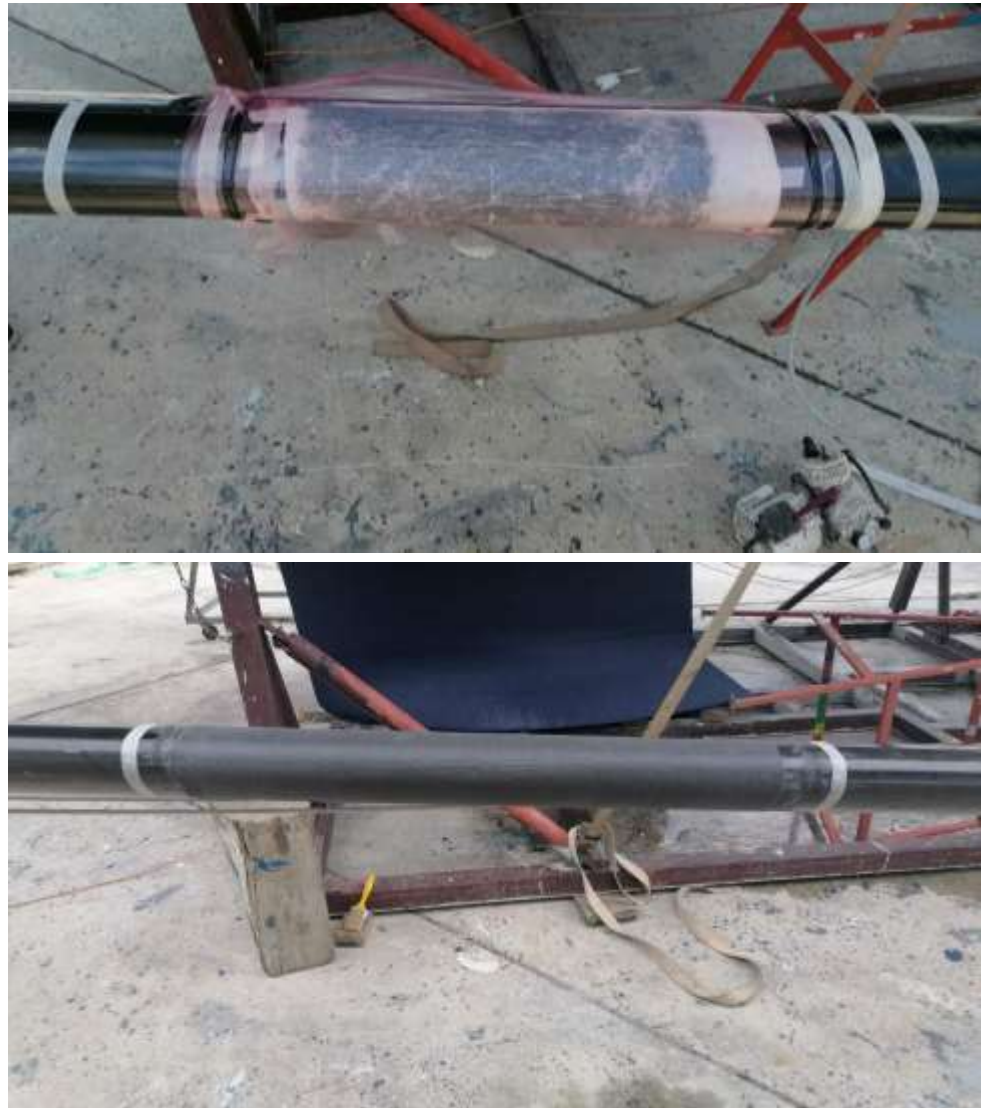
SAILBOAT MAST

Problem: Mechanically damaged mast made of carbon fibre needed fast repair.

Solution: Repair was conducted in Kaštela Marine, Croatia.

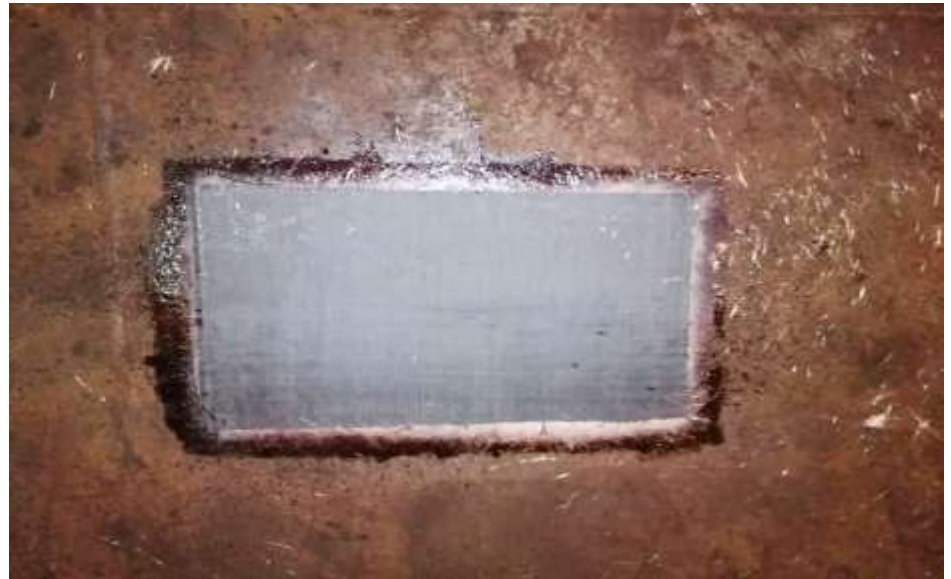
DOUBLER PALTES

Problem: Repair of two cracks length 1000 mm on cargo deck, above tanks of heavy fuel oil.

Solution:
Reinforcement was conducted during the vessel's stay in Antwerp port.

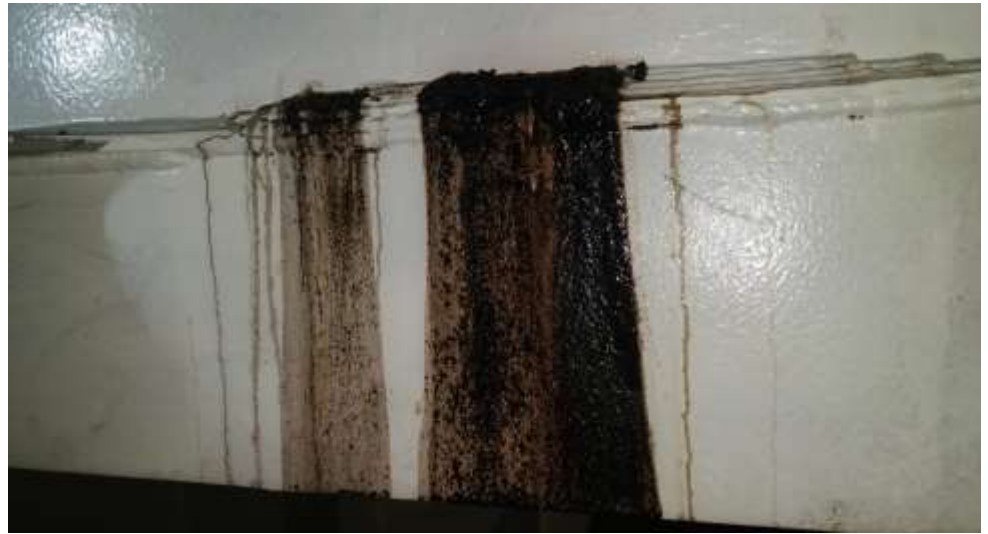
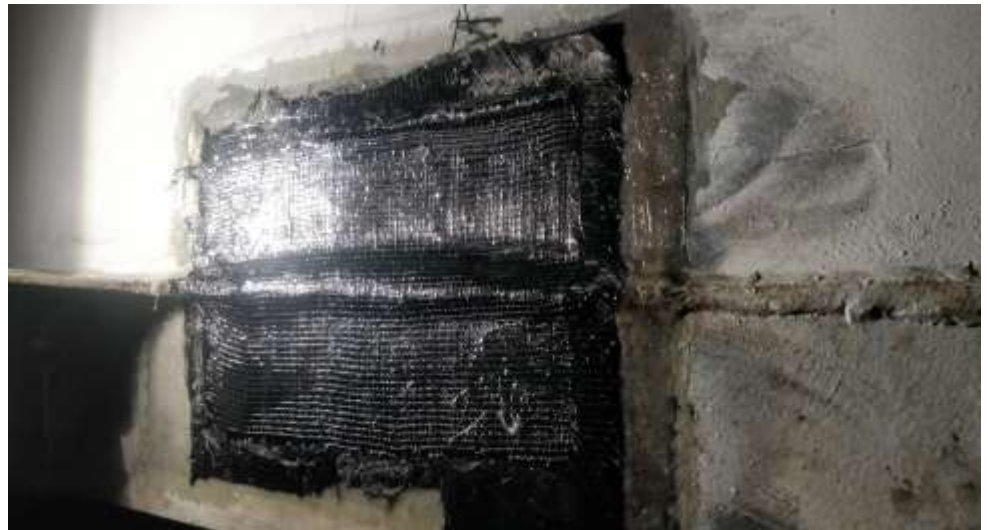
HFO BULKHEAD

Problem: Cracked bulkhead was leaking HFO.

Solution:
Reinforcement was conducted in Brindisi port.

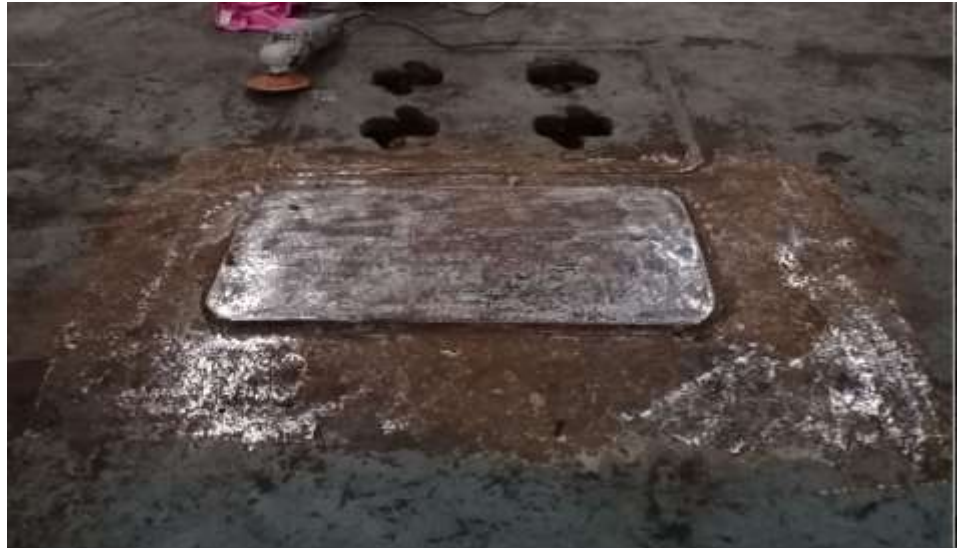
DOUBLER PALTES

Problem: Cracked doubler plates on the double bottom above ballast and fuel oil tanks.

Solution: Reinforcement was conducted in between phases of cargo operation of a vessel in Antwerp port.

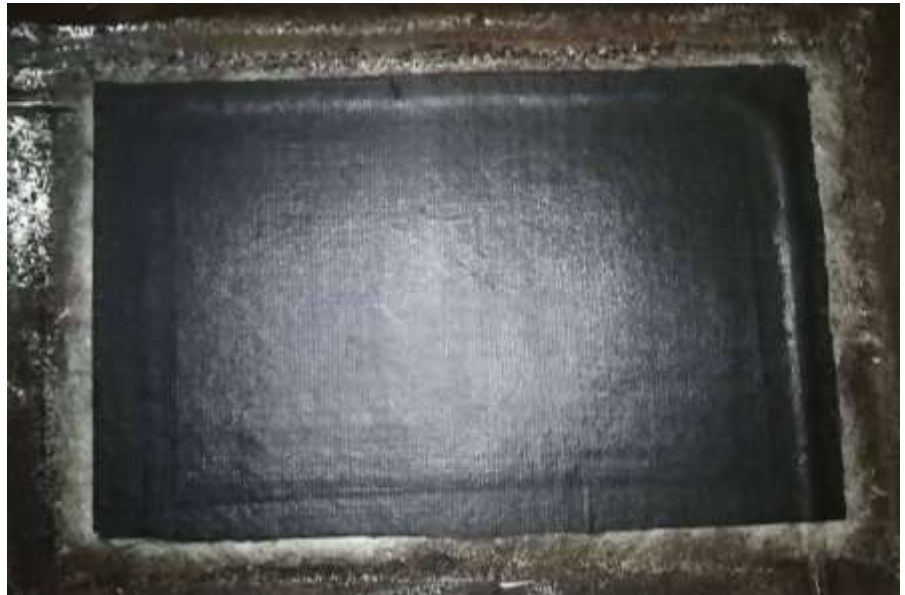
DOUBLE BOTTOM TANK TOPS

Problem: Multiple cracks appeared on the double bottom tank tops.

Solution: Repair was conducted during the vessel's voyage from Hamburg to Antwerp.

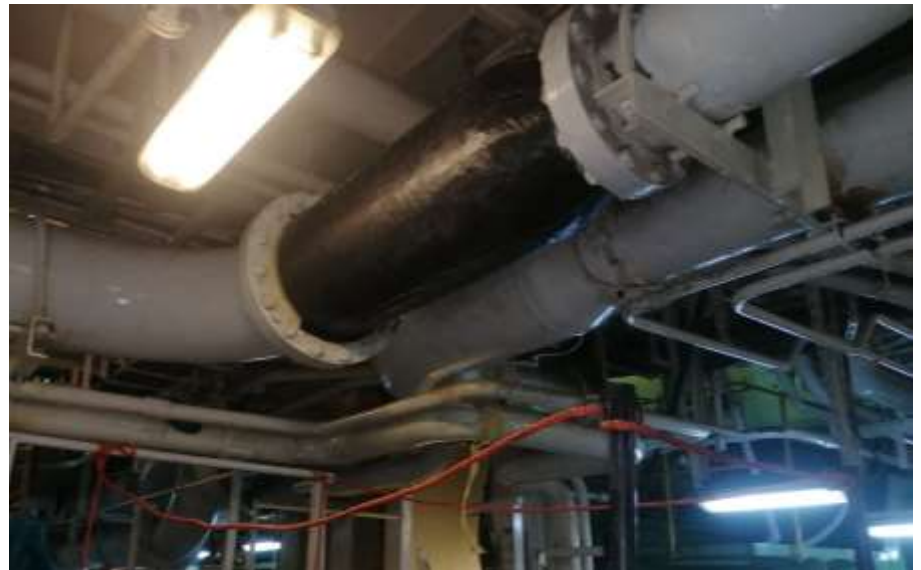
MAIN SEA WATER PIPE

Problem: Leakage appeared on sea water pipe in engine room.

Solution: Repair was conducted during the vessel's stay in Antwerp port.
