COMPAREPAIRS
Repairs and
Reinforcements with
Composite Materials

**Technology Overview and
Application Cases**

COMPA Repairs cases of completed repairs

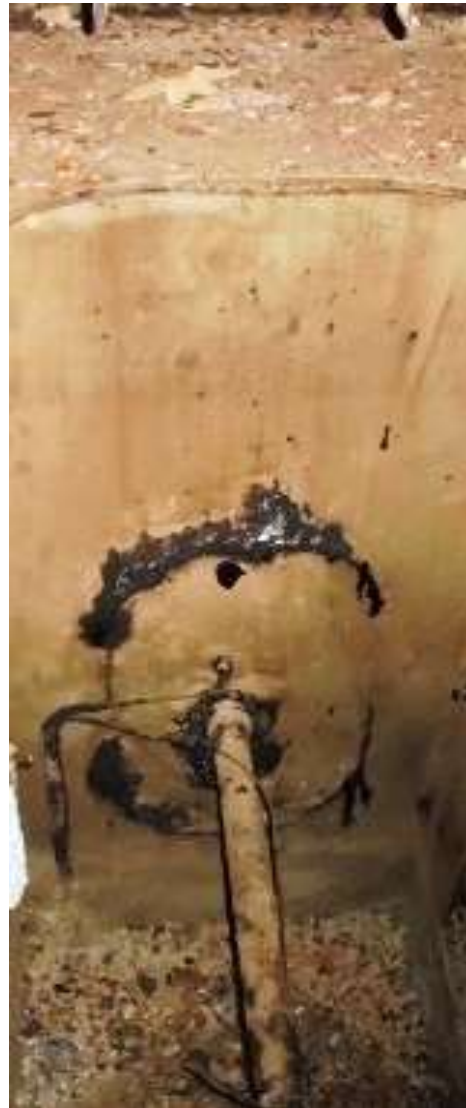
Problem: The leakage of heavy fuel occurred on the blind manhole between water ballast and heavy fuel tank.

Solution: Repair was conducted during the vessel's stay in Antwerp port.

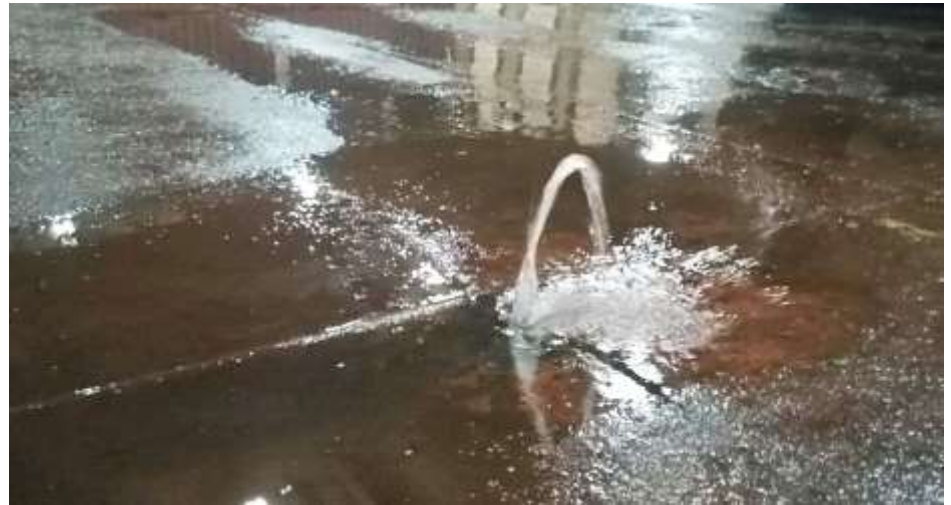
Problem: Repair of two cracks length 1000 mm on cargo deck, above tanks of heavy fuel oil.

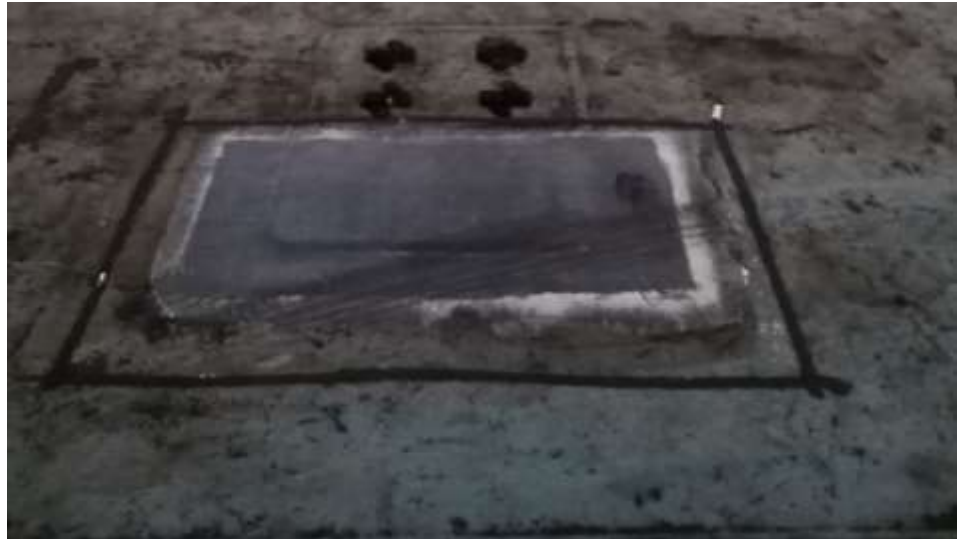
Problem: Cracked doubler plates on the double bottom above ballast and fuel oil tanks.

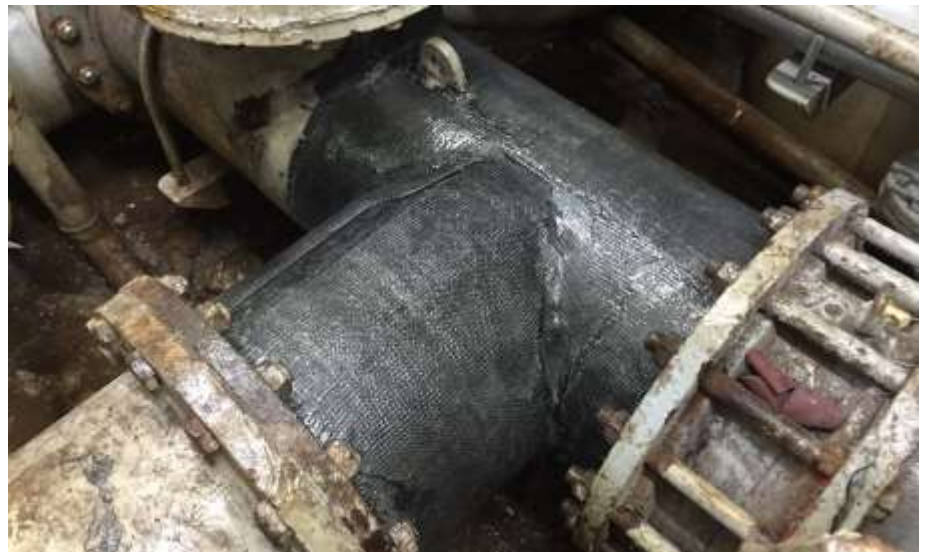
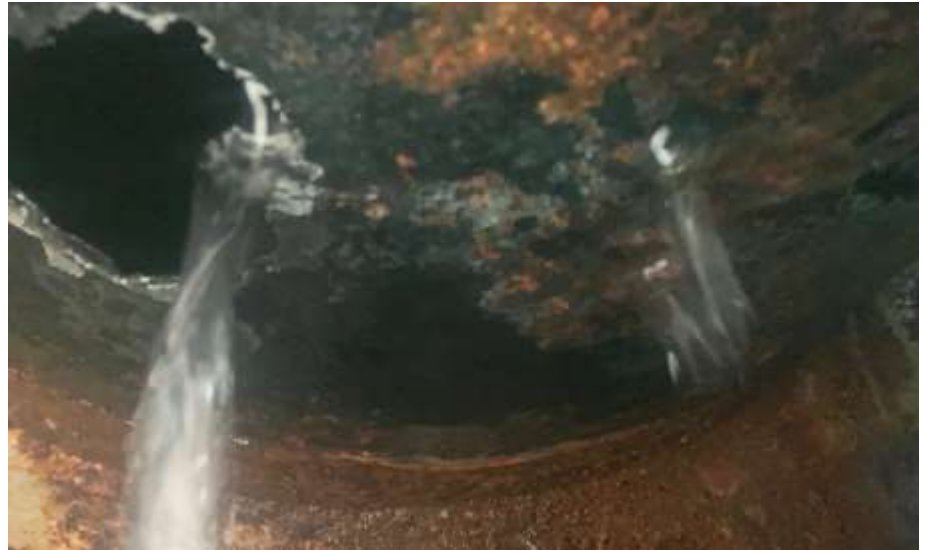
Problem: Three holes appeared on sea water pipe T-junction and caused leakage.

Solution: Repair was conducted during the vessel's stay in Olbia port.

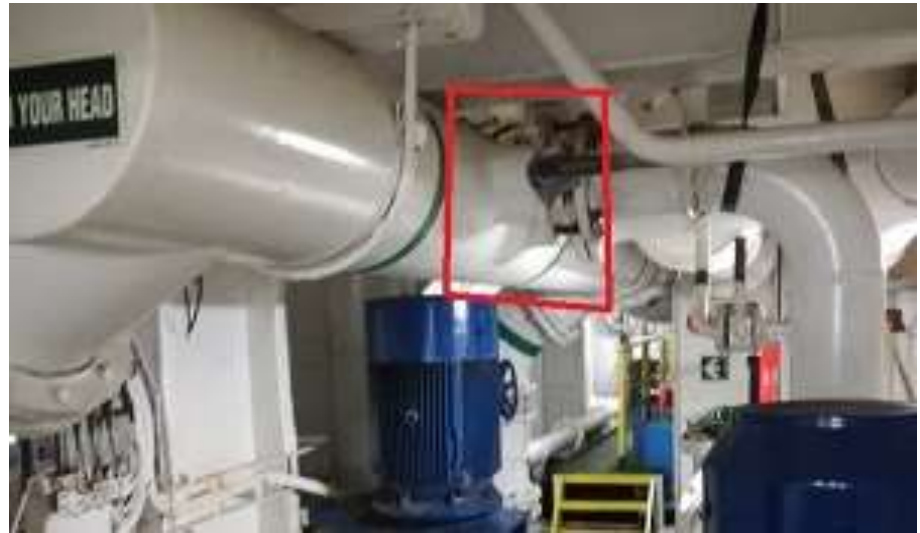
SEA WATER PIPE T-JUNCTION

Problem: Leakage appeared on sea water pipe T-junction.

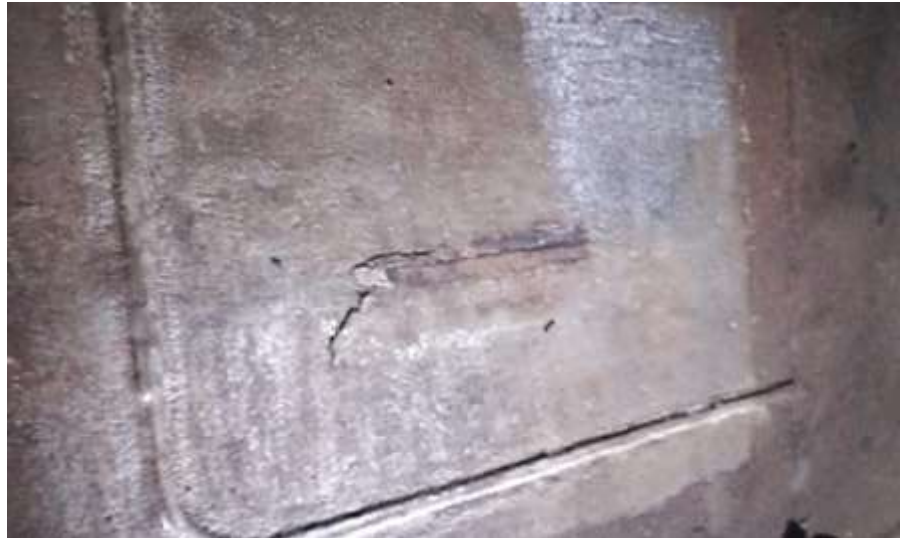
DOUBLE BOTTOM TANK TOPS

Problem: Multiple cracks appeared on the double bottom tank tops.

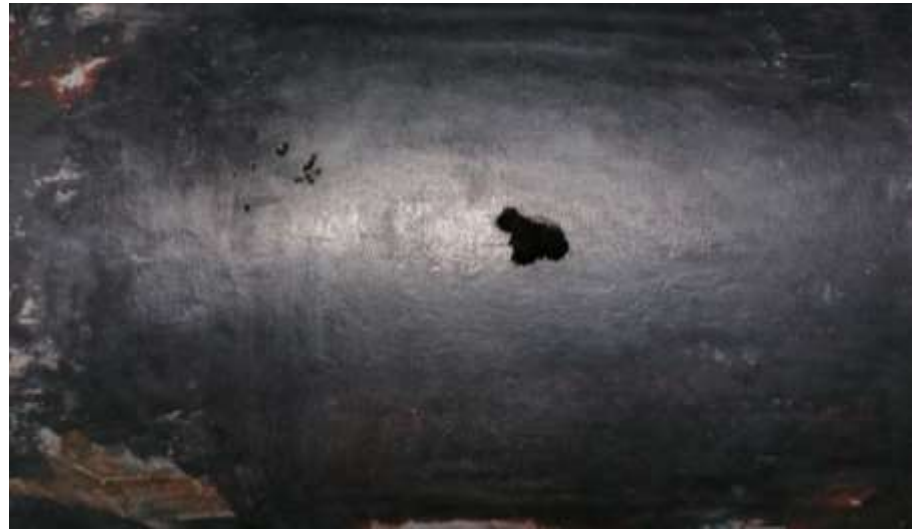
MAIN SEA WATER PIPE

Problem: Leakage appeared on sea water pipe in engine room.

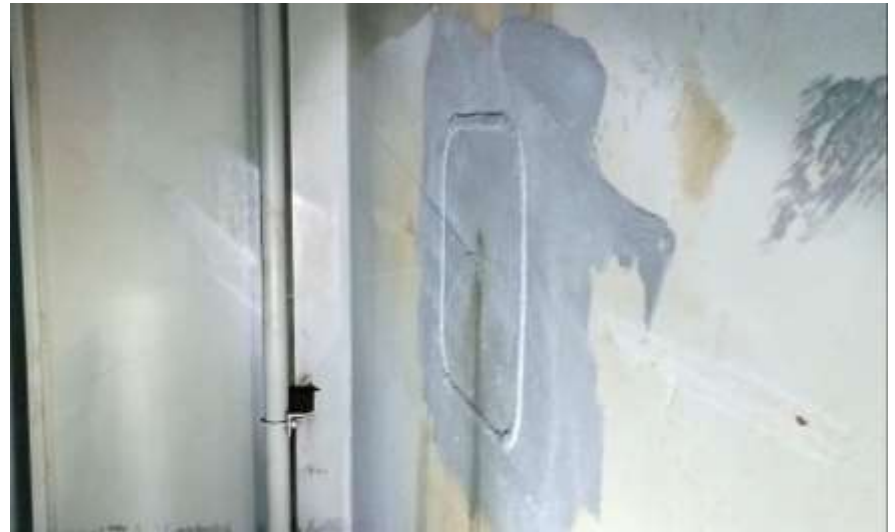
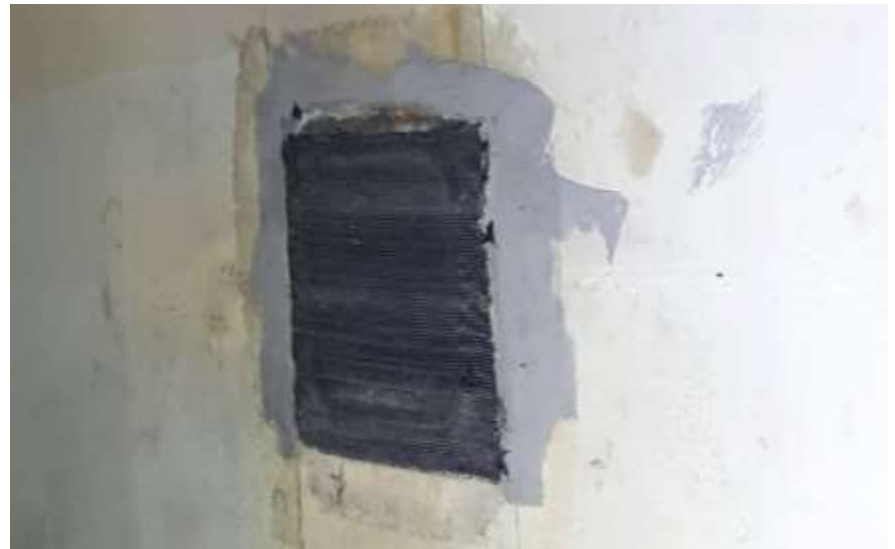
TANK BULKHEAD

Problem: Three cracks appeared on the bulkhead of heavy fuel tank.
